Building Prioritization: Methodology

BGS Subgrant Project - Priority Building Assessment

FLOOD HAZARD MITIGATION ASSESSMENT & ANALYSIS FOR STATE-OWNED BUILDINGS

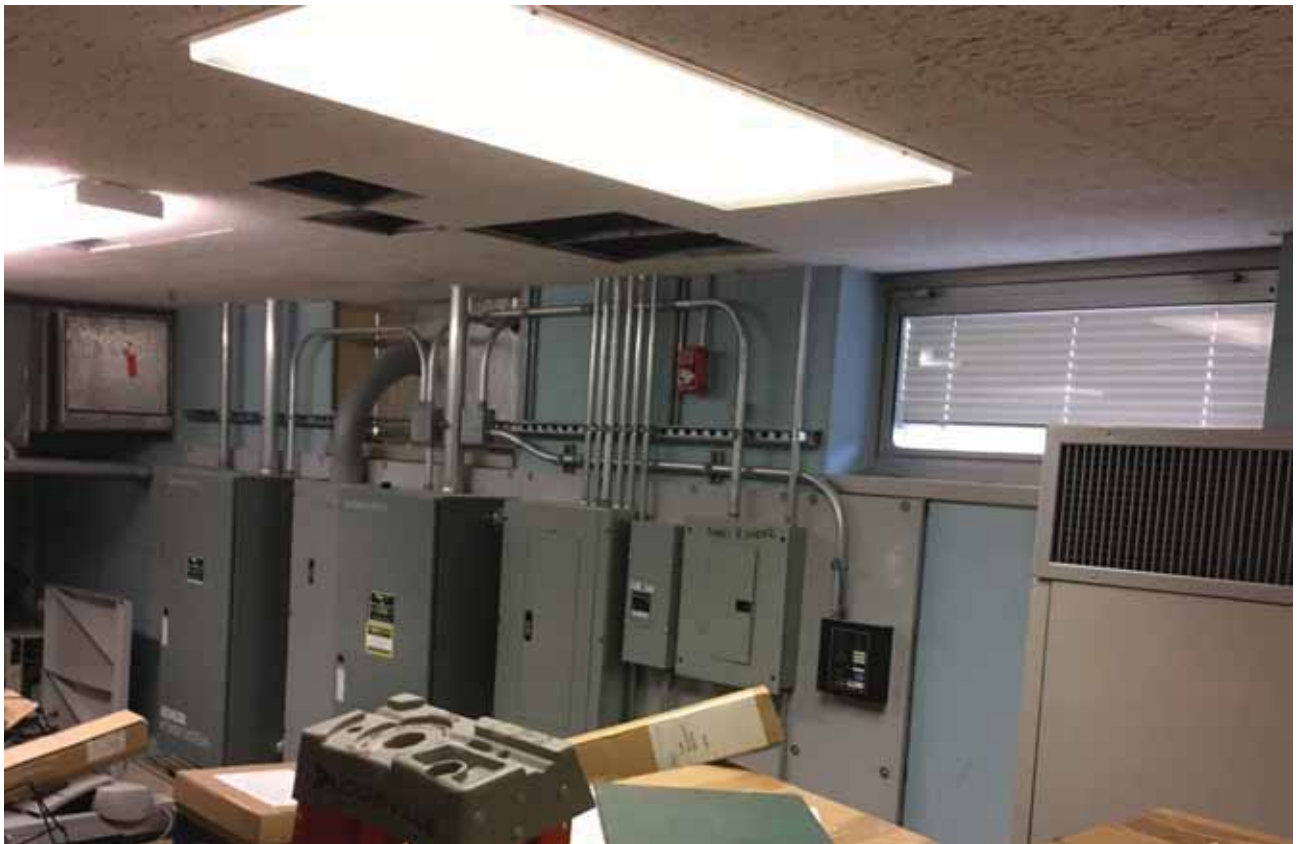
Figure 12: Basement electrical and mechanical equipment.

The items damaged during a flood include the majority of the building systems such as mechanical and electrical systems, plumbing and fire protection systems, Tel-com systems, and elevator controls. Damage also includes all porous finishes (wood, wainscoting, sheetrock, carpeting, etc.). All exterior and interior non-porous surfaces below flood levels would require clean up. All items stored at or below the flood levels would be damaged and potentially lost as well. Exterior mounted equipment including an emergency generator and chiller equipment located to the southeast of the building appears to be located outside of the FEMA Hazard Areas, although may be susceptible to flood damage. Additional information regarding potential flood damages is provided with the Recommendations.

It is recommended that the State investigate relocating the fire alarm, security, electrical, and Tel-com panels to spaces on upper levels to minimize renovation costs after a flood. Relocation of other heavier equipment and mechanicals such as boilers and hot water heater could take up too much valuable program space. To relocate select building utility systems, an estimated allowance of \$180,000 can be assumed.

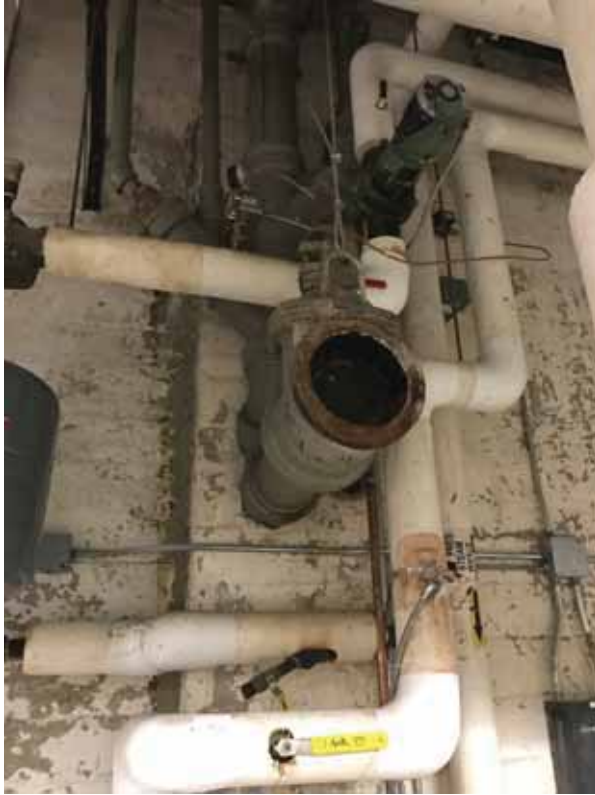
Figure 21: Multiple wall penetrations in sub-basement walls (potential for water infiltration)

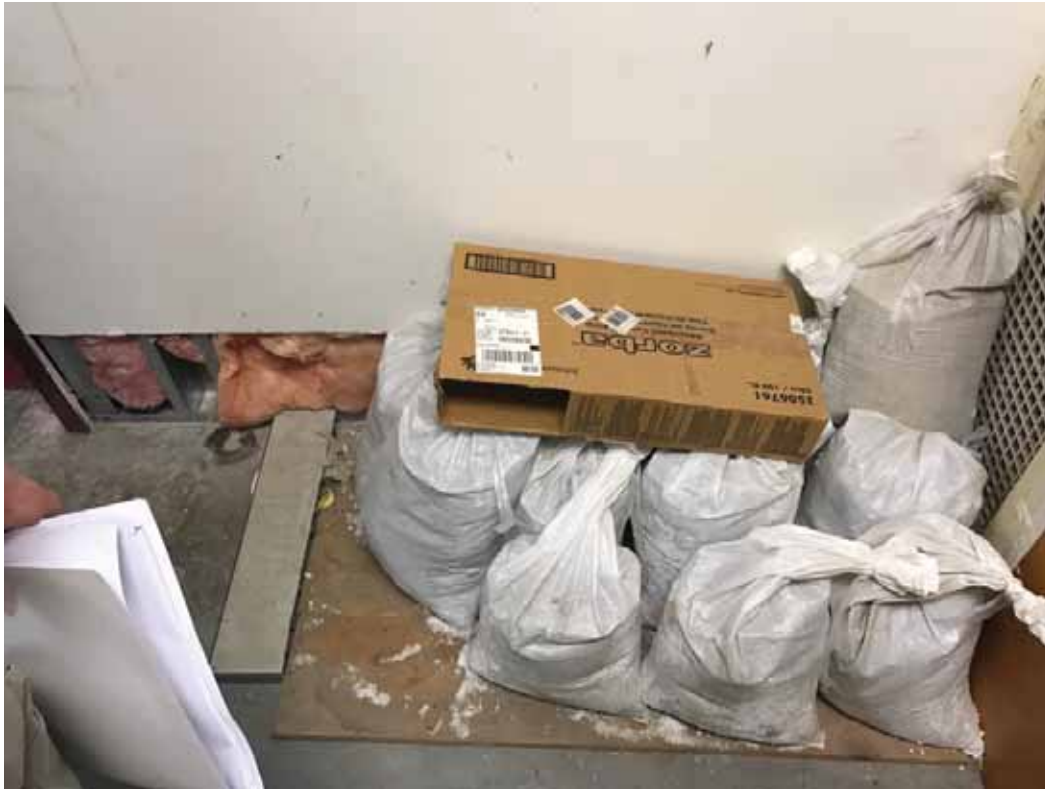
Figure 37: Pre-existing basement-level water damage observed in areas

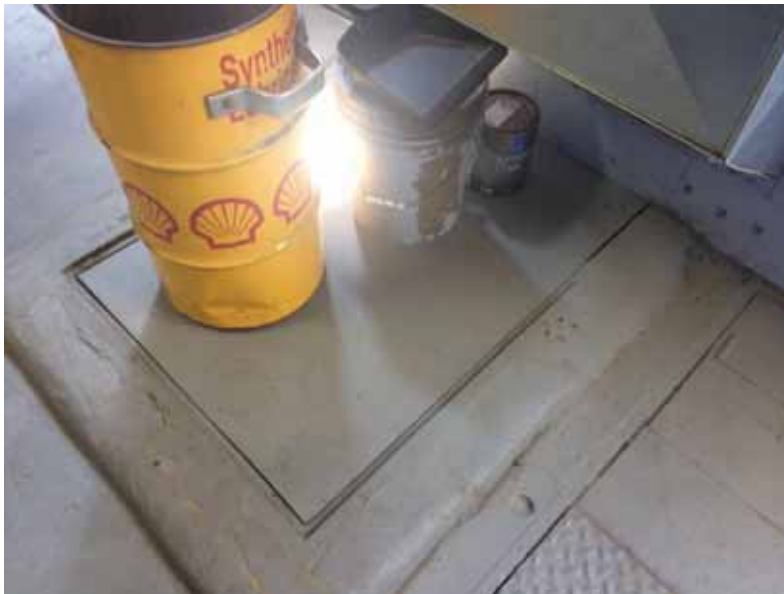
Contents could be hazardous if not addressed prior to flood event

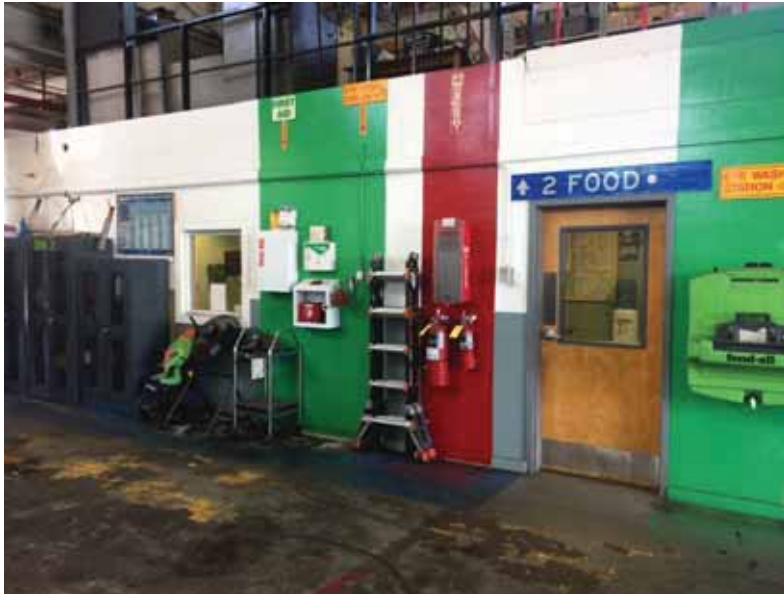
Contents could be hazardous if not addressed prior to flood event

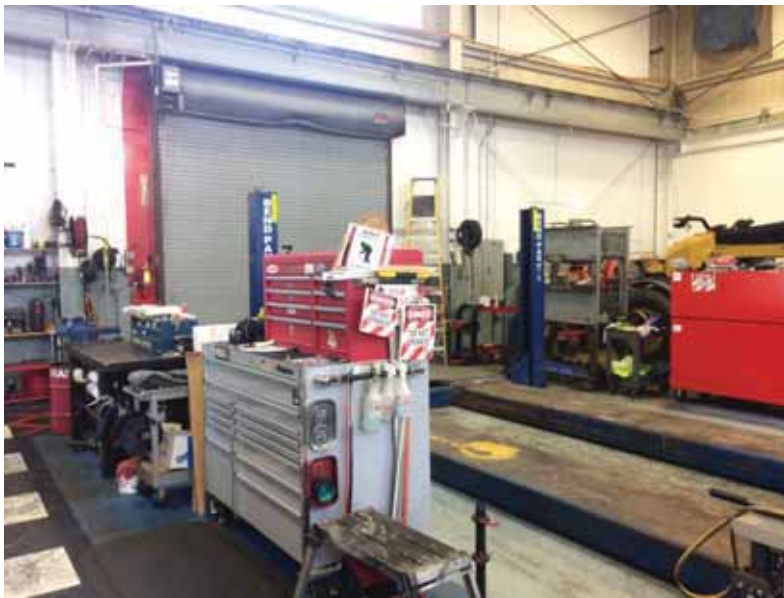
Contents could be hazardous if not addressed prior to flood event

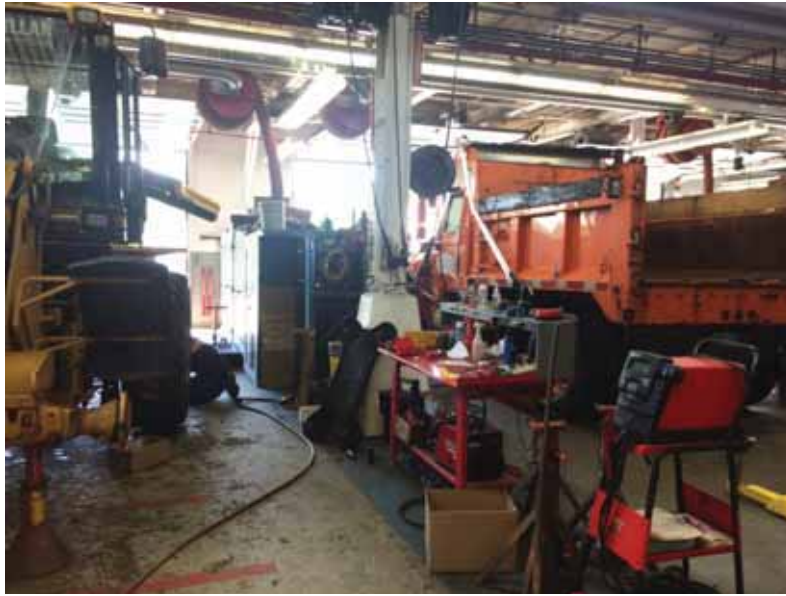
Contents could be hazardous if not addressed prior to flood event

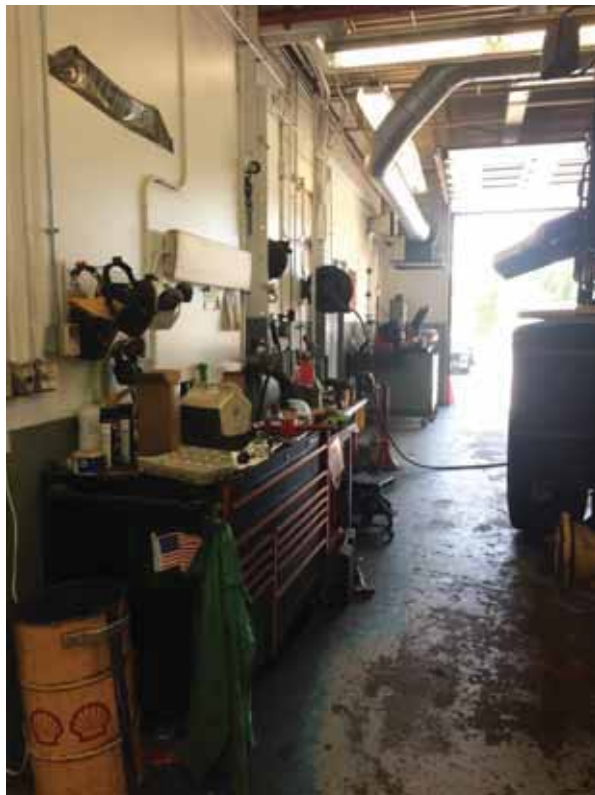
Contents could be hazardous if not addressed prior to flood event

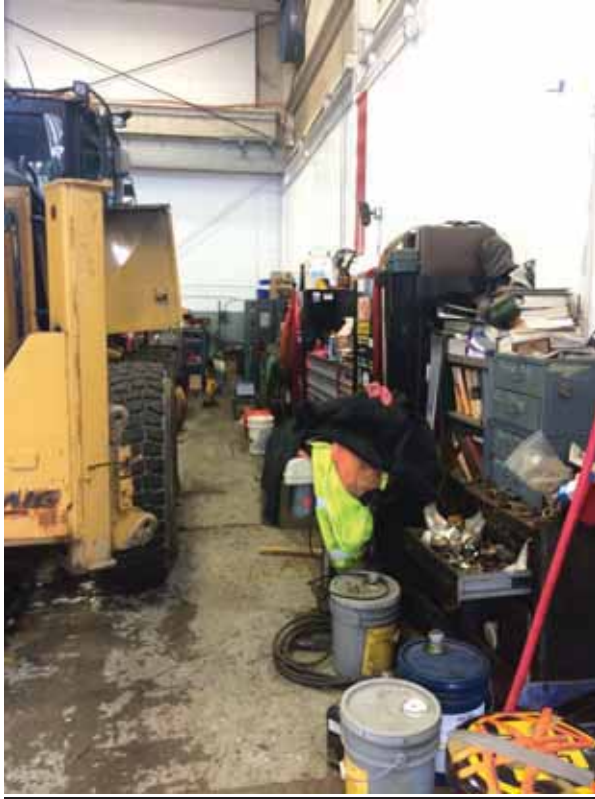
Contents could be hazardous if not addressed prior to flood event

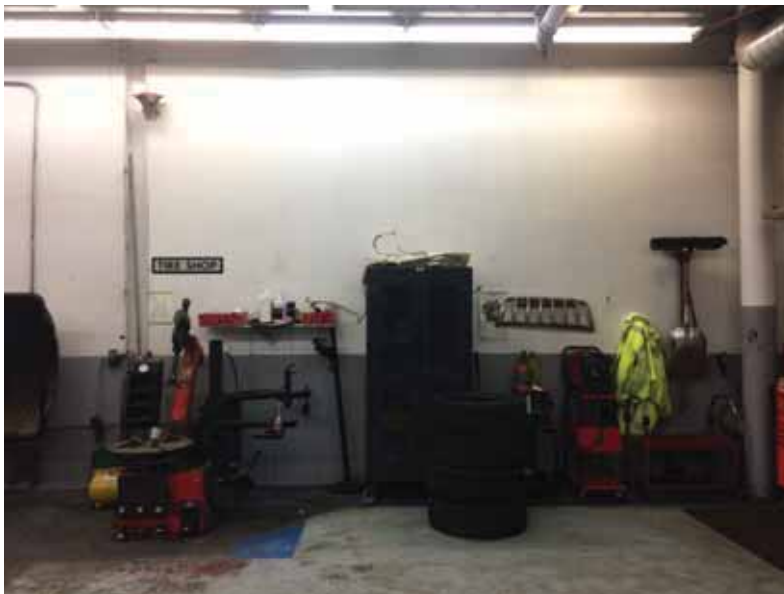
Contents could be hazardous if not addressed prior to flood event

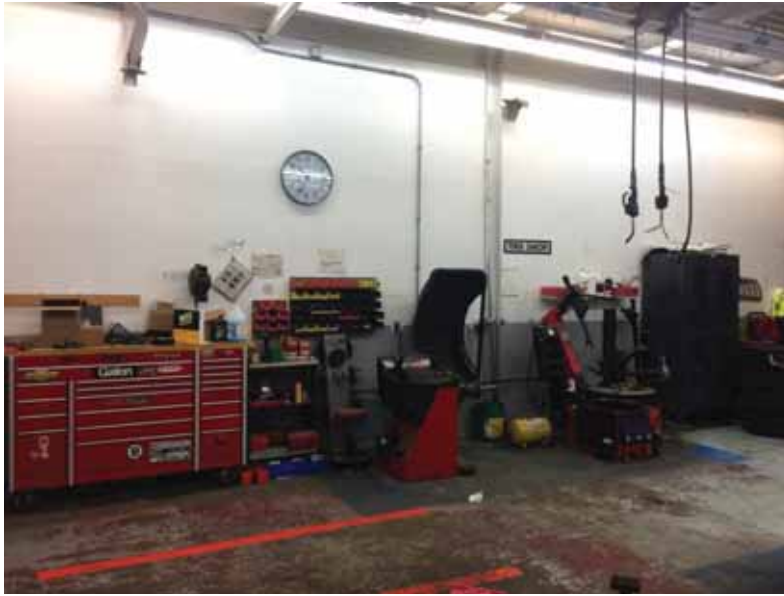
Contents could be hazardous if not addressed prior to flood event

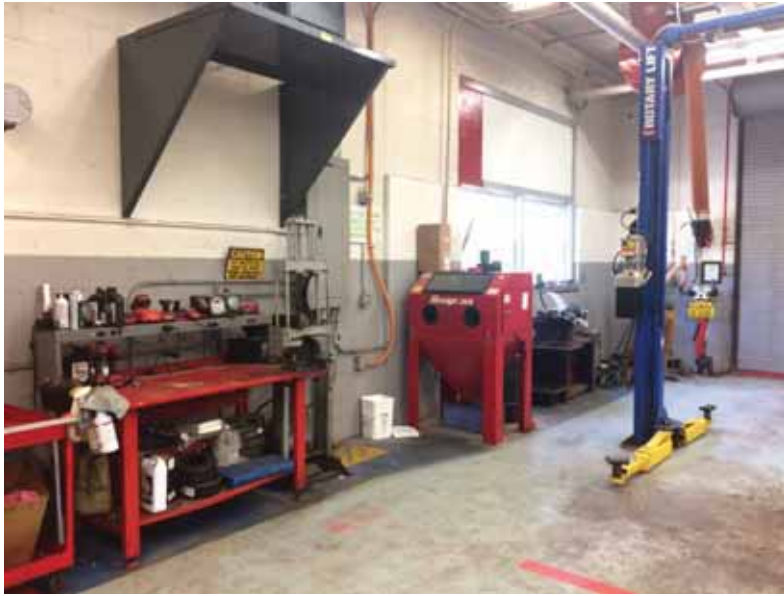
Contents could be hazardous if not addressed prior to flood event

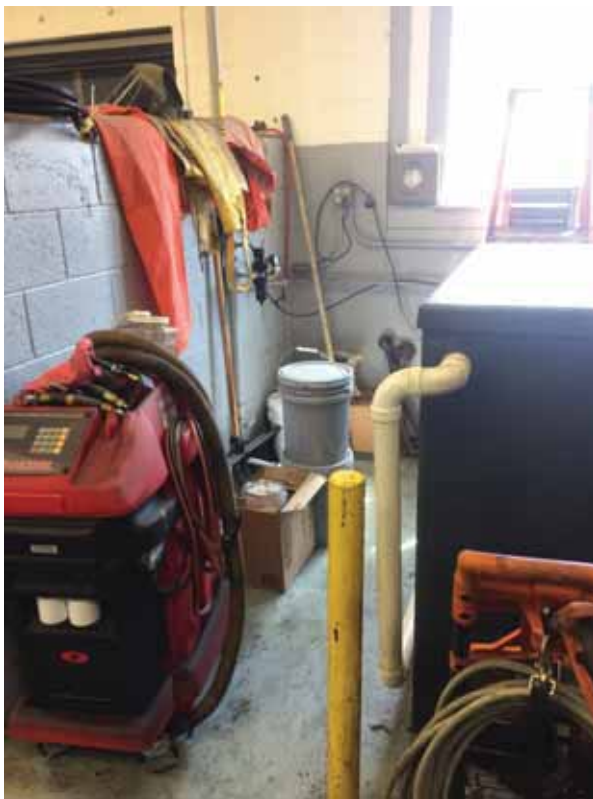
Contents could be hazardous if not addressed prior to flood event

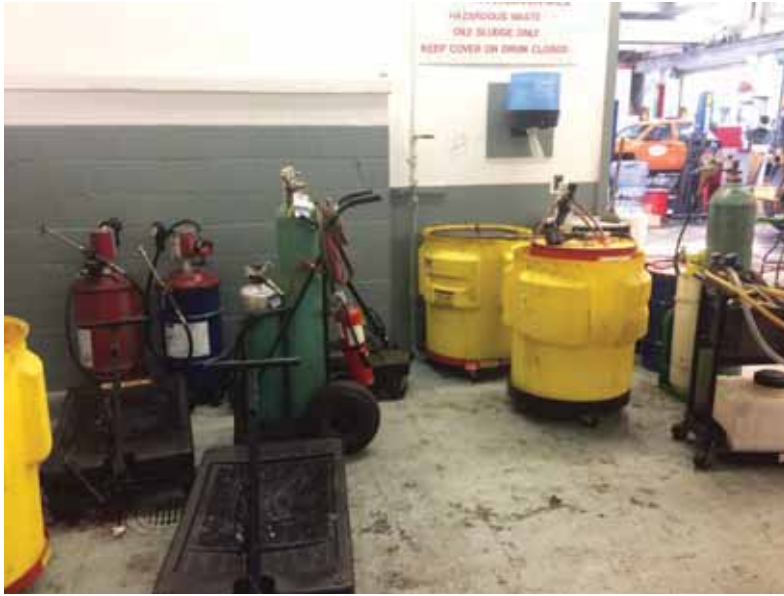
Contents could be hazardous if not addressed prior to flood event

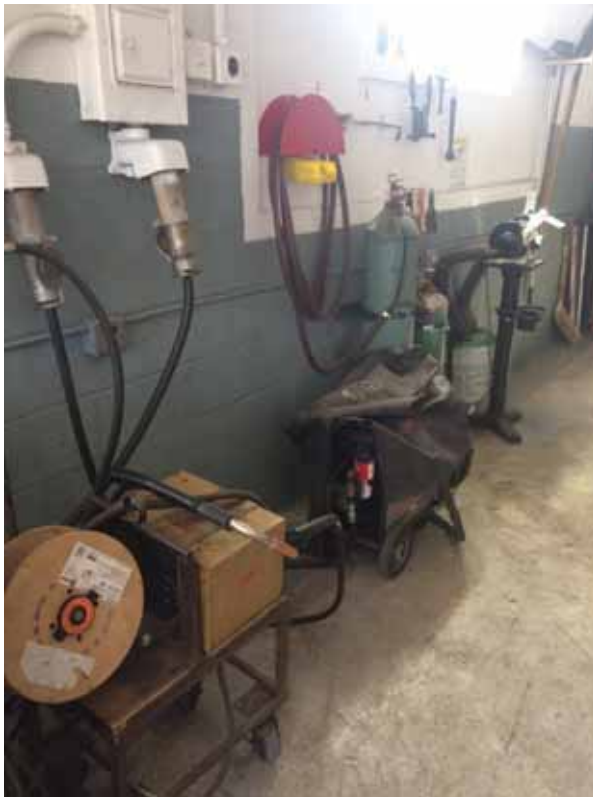
Contents could be hazardous if not addressed prior to flood event

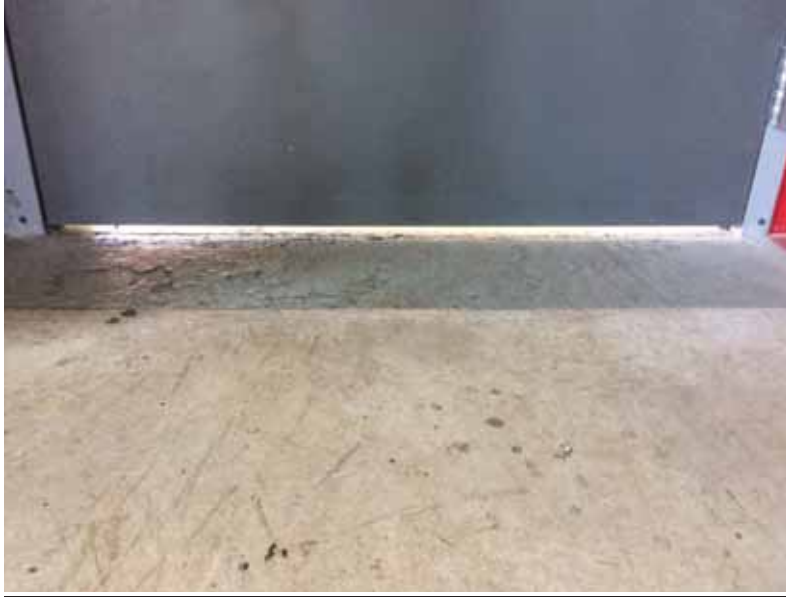
Door undercut
