Appendix - Section 3 - State & Local Capabilities Supplemental

Building Prioritization: Methodology

BGS Subgrant Project - Priority Building Assessment

BUILDING ASSESSMENT FORM

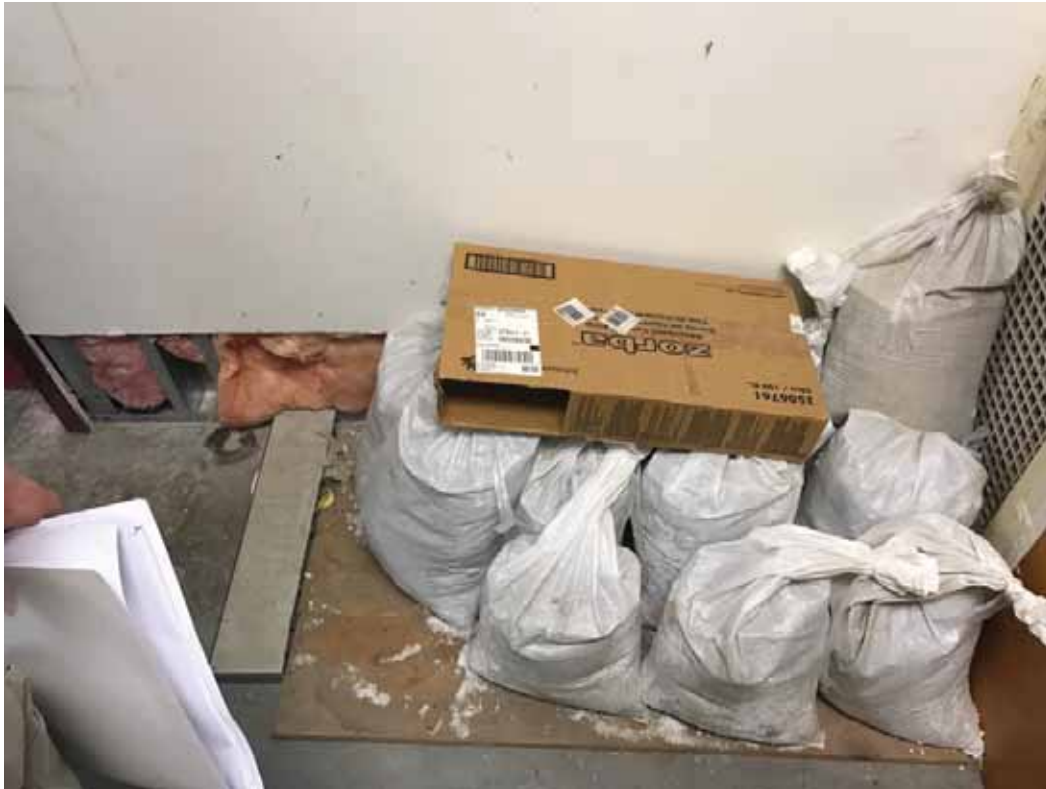
Figure 37: Pre-existing basement-level water damage observed in areas

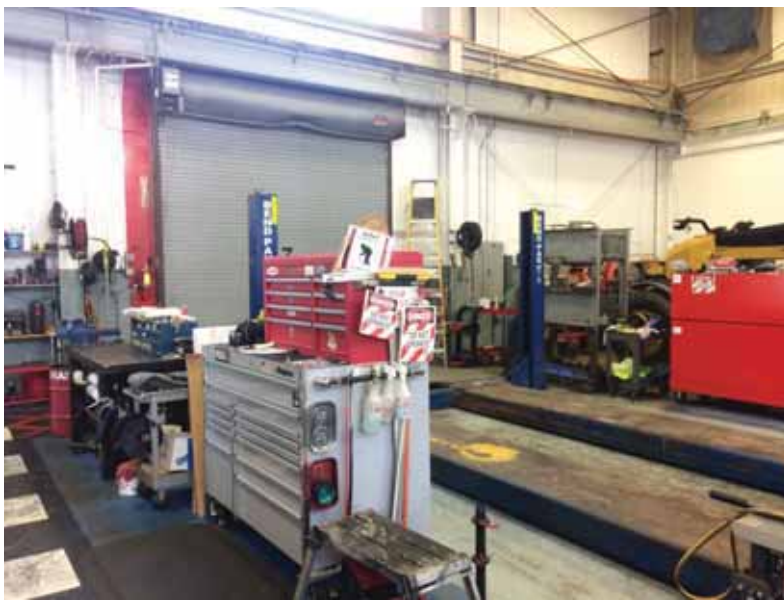
Contents could be hazardous if not addressed prior to flood event

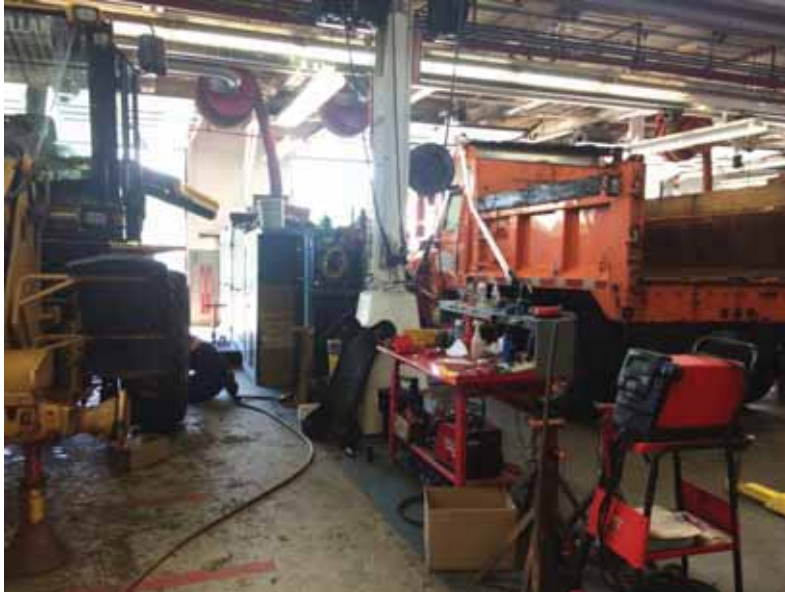
Contents could be hazardous if not addressed prior to flood event

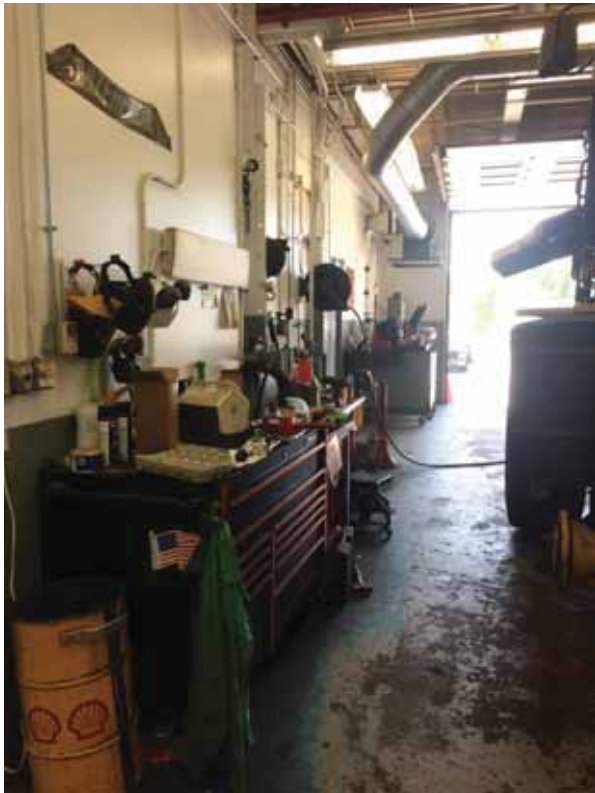
Contents could be hazardous if not addressed prior to flood event

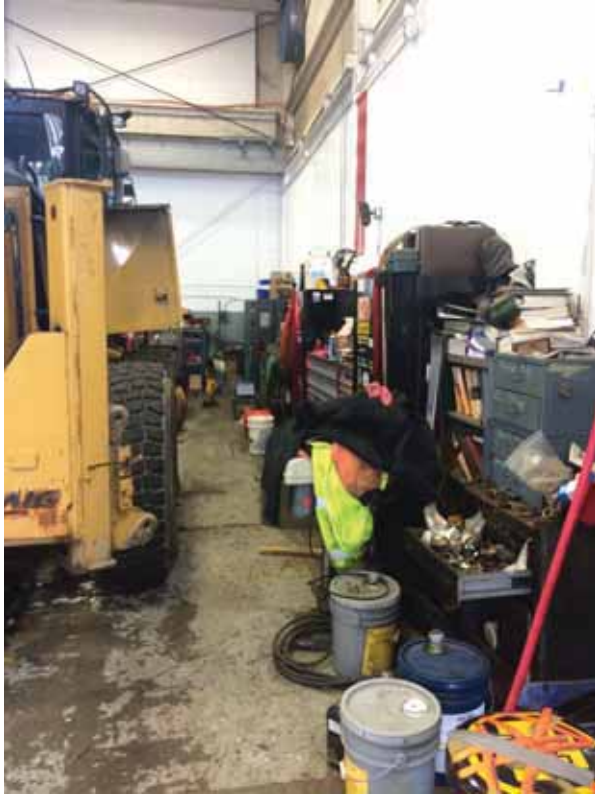
Contents could be hazardous if not addressed prior to flood event

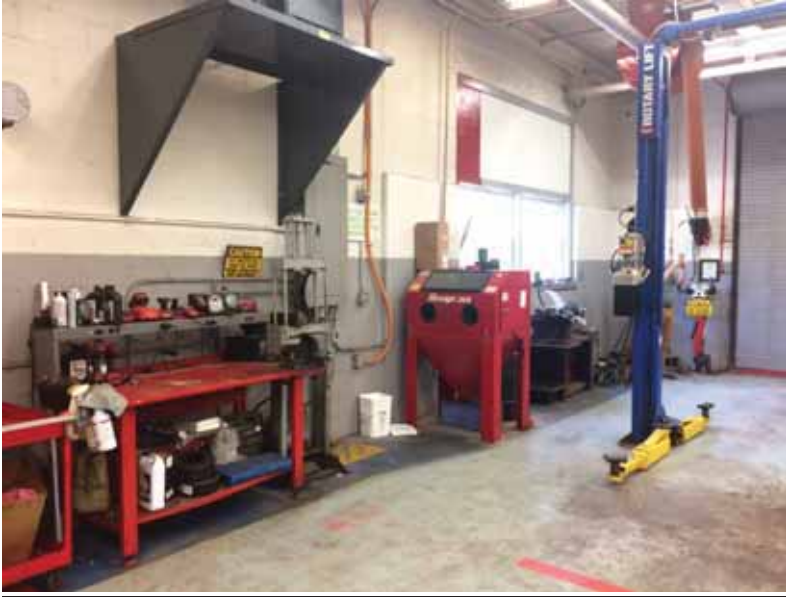
Contents could be hazardous if not addressed prior to flood event

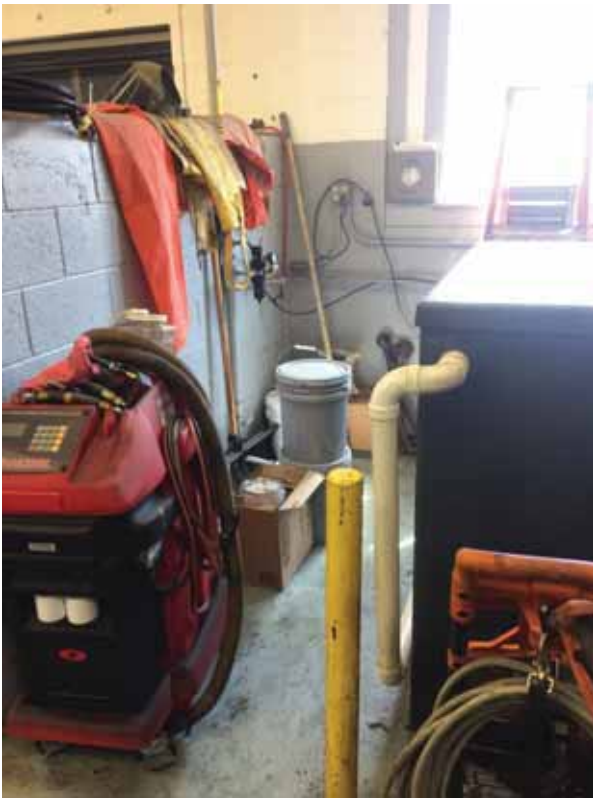
Contents could be hazardous if not addressed prior to flood event

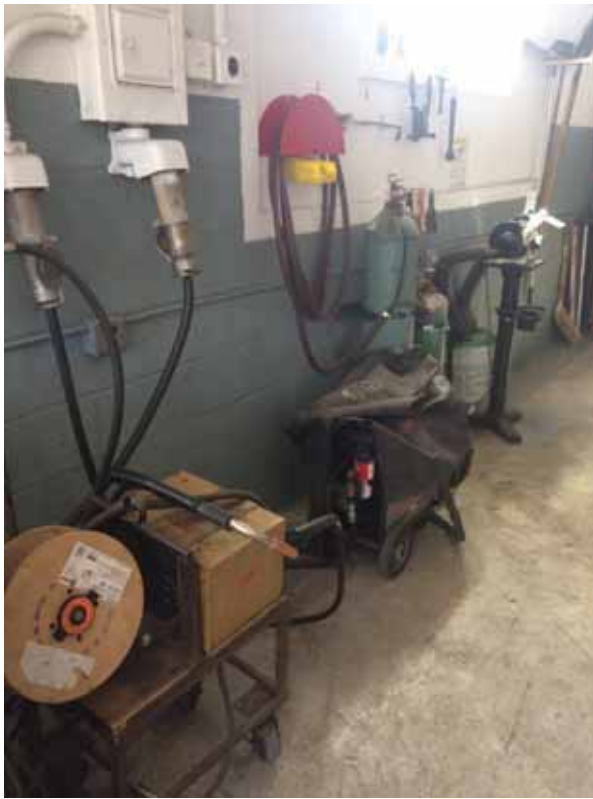
Contents could be hazardous if not addressed prior to flood event

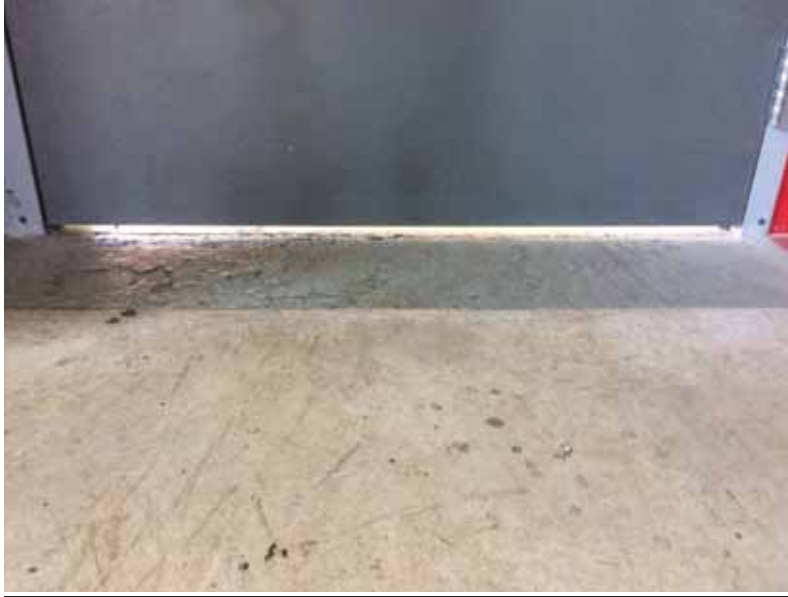
Door undercut
