4-7: Landslides

Landslides History

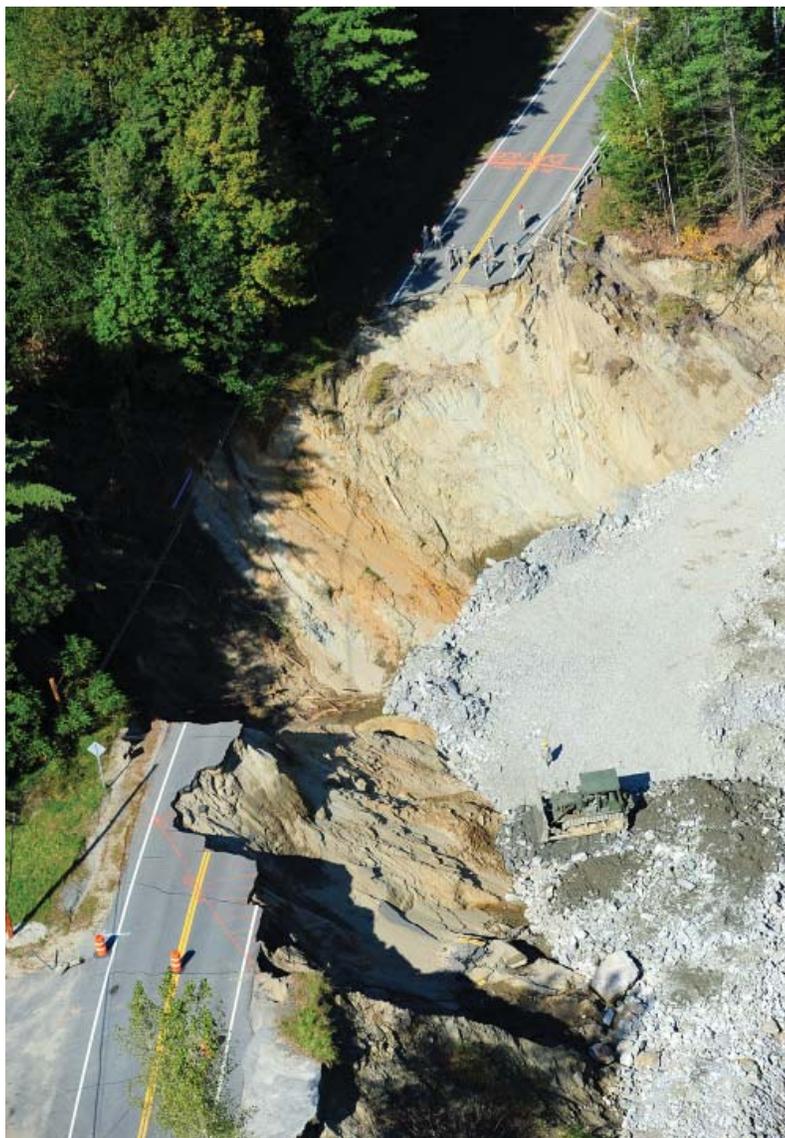
Route 131 in Cavendish devastated by slope failure.
Photo Credit: www.mansfieldheliflight.com/flood/

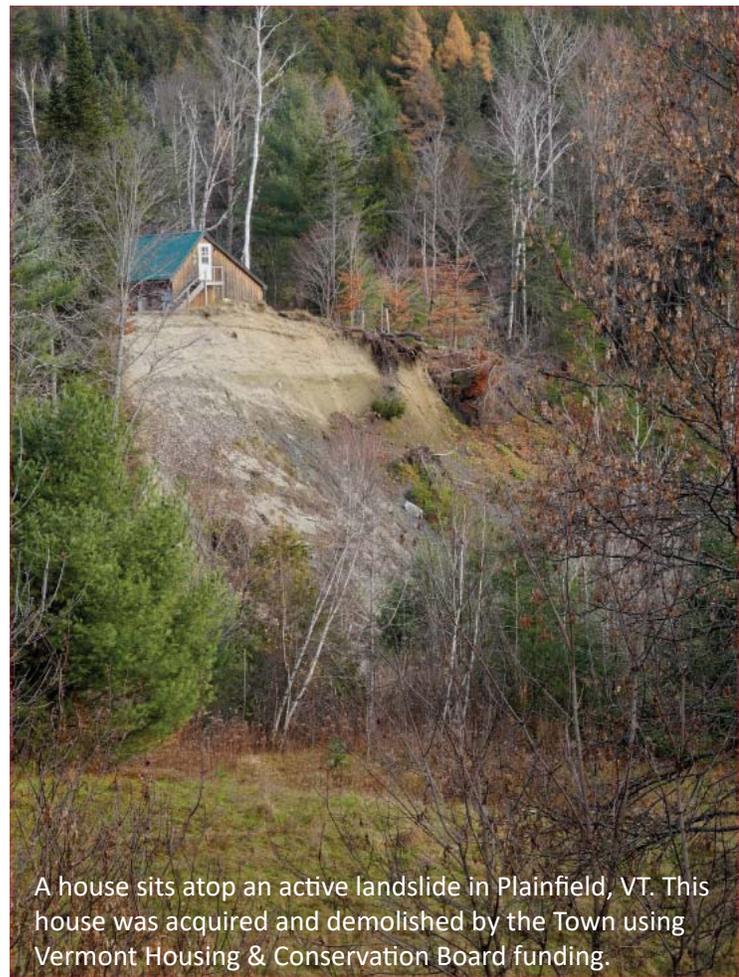
A house sits atop an active landslide in Plainfield, VT. This house was acquired and demolished by the Town using Vermont Housing & Conservation Board funding.

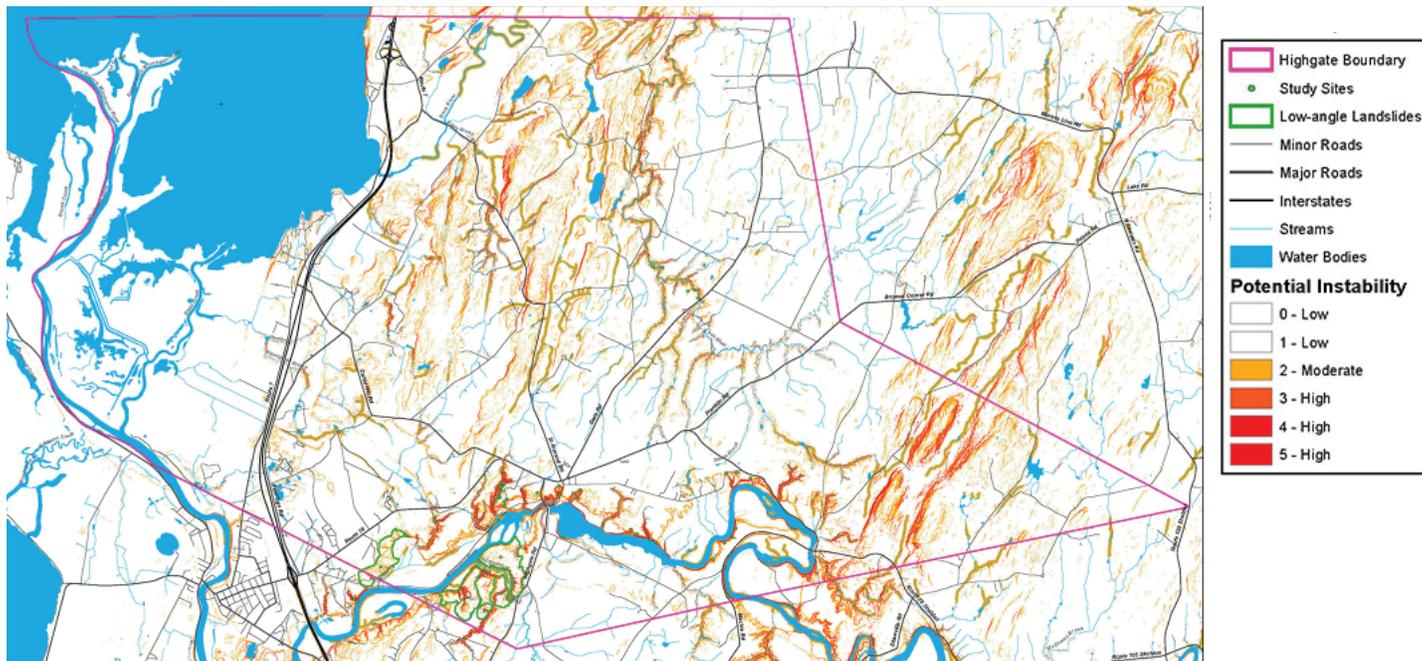
Figure 55: Town of Highgate landslide map

received via the Vermont Landslides Inventory Reporting Tool, the Vermont Geological Survey has been developing high resolution landslide hazard maps, county-by-county, as funding is available, which allows the State to better understand locations that are more vulnerable to landslides.

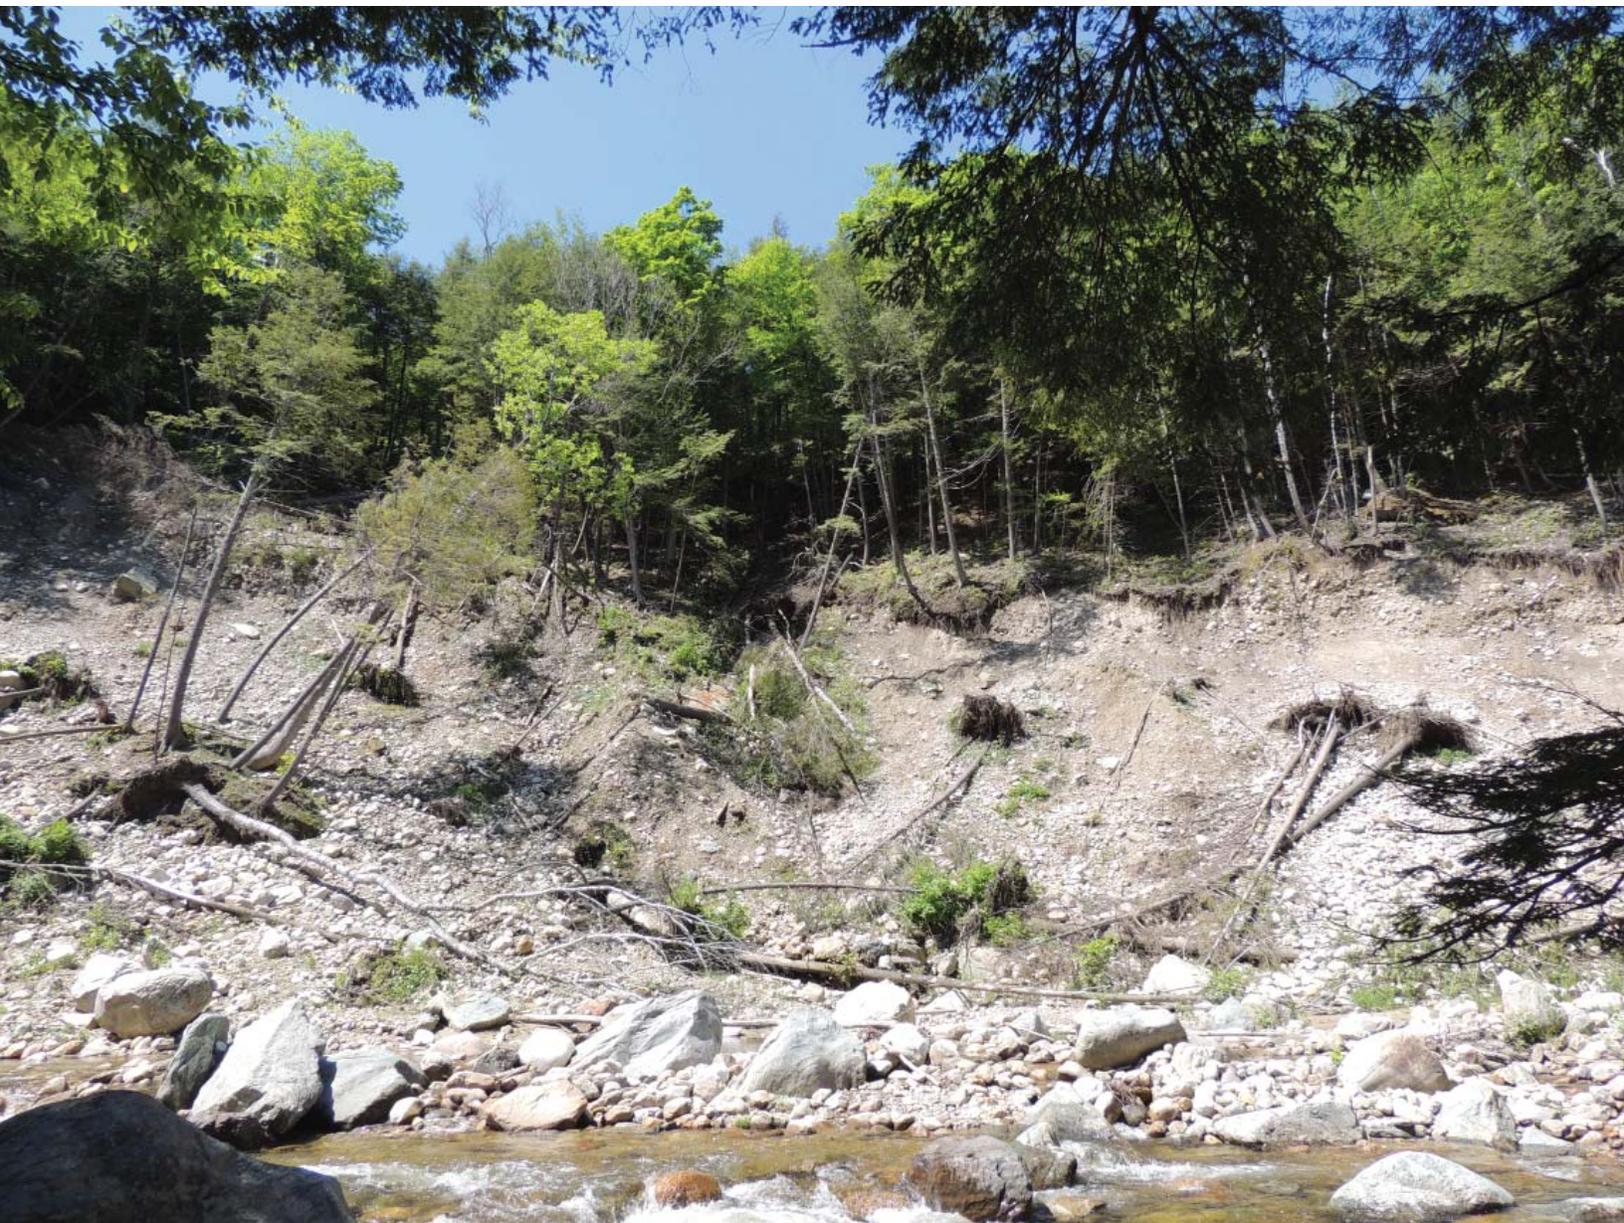
Major slope failure along the Cold River in Shrewsbury, VT. *Photo Credit: Alan Shelvey*

The Town of Shrewsbury had to have substantial work done after Tropical Storm Irene due to significant slope failures along the Cold River, including around \$887,000 in Public Assistance funds for road repair and slope stabilization. The Town, recognizing there were several landslide areas along this stretch that required immediate attention, then submitted a PDM-C application to relocate a portion of the Upper Cold River Road identified as being at imminent threat of catastrophic failure. This project, approved by FEMA in early 2018, is estimated to cost nearly \$750,000 to complete.
