4-1: Inundation Flooding & Fluvial Erosion

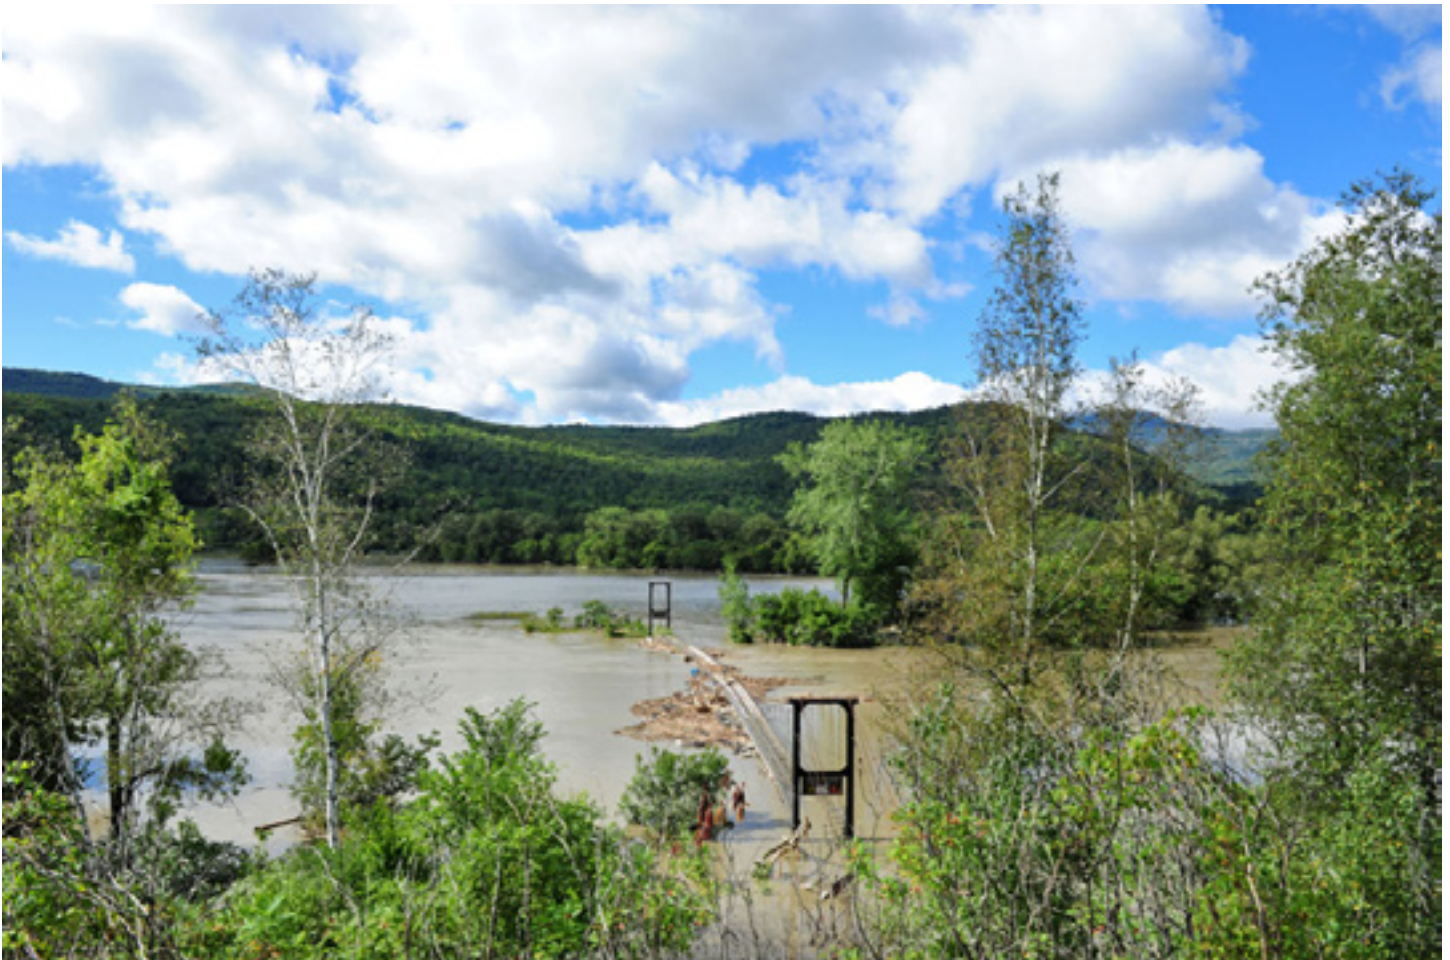
Snowmobile bridge near Waterbury, VT flexes as debris and water rush past following Tropical Storm Irene
 Photo Credit: www.mansfieldheliflight.com/flood

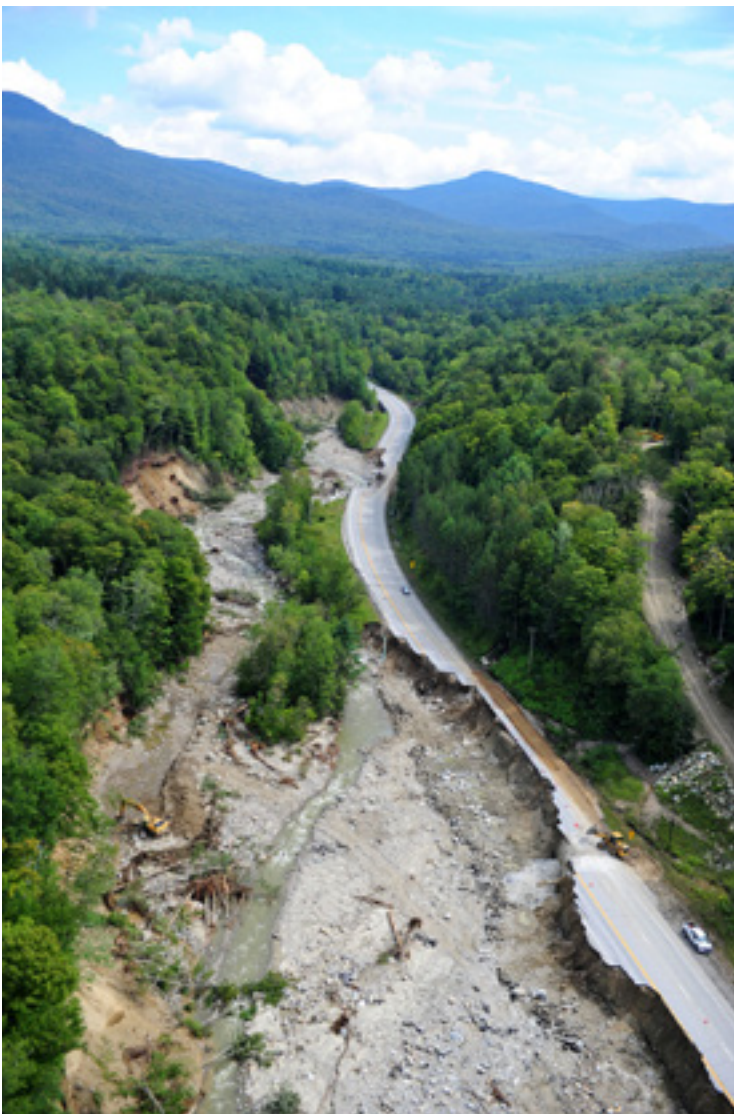
Severe damage to Vermont Route 4 in Killington, VT due to fluvial erosion during Tropical Storm Irene
Photo Credit: www.mansfieldheliflight.com/flood

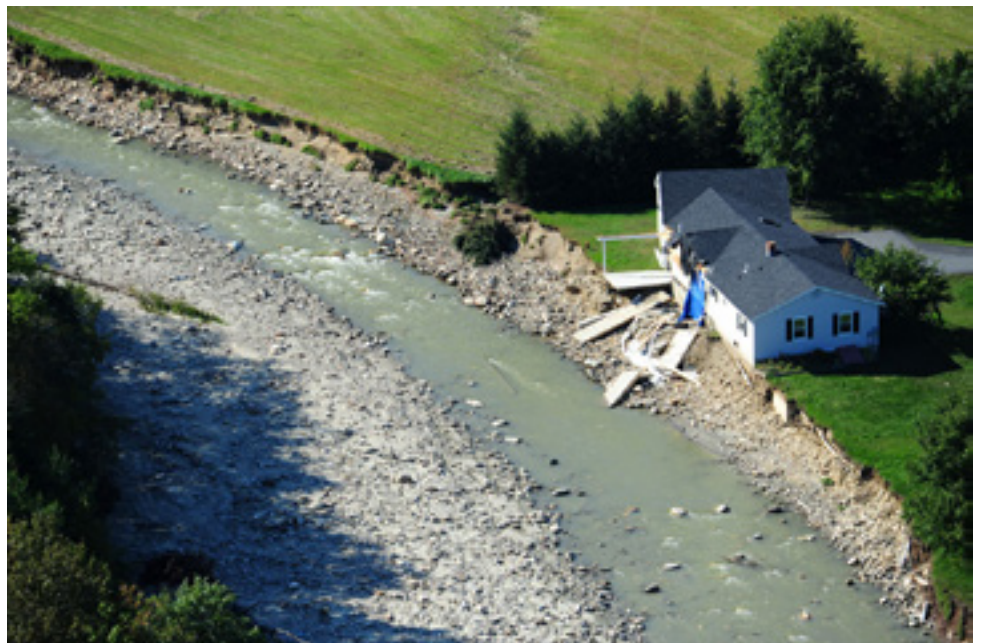
Extensive erosion damaging a home along Route 11 outside of Chester, VT.
Photo Credit: www.mansfieldheliflight.com/flood/

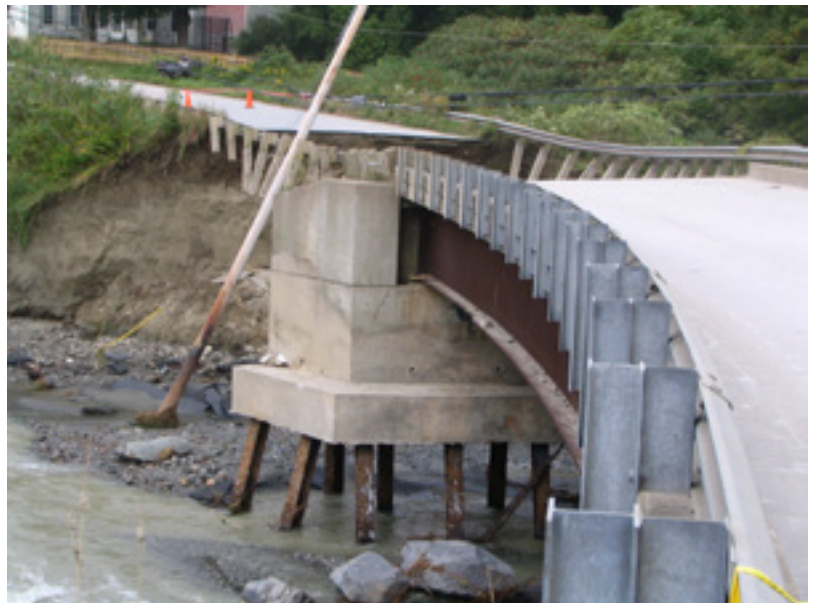
Significant scour along the Riford Brook in Braintree caused severe damage to Riford Brook Road during Tropical Storm Irene.

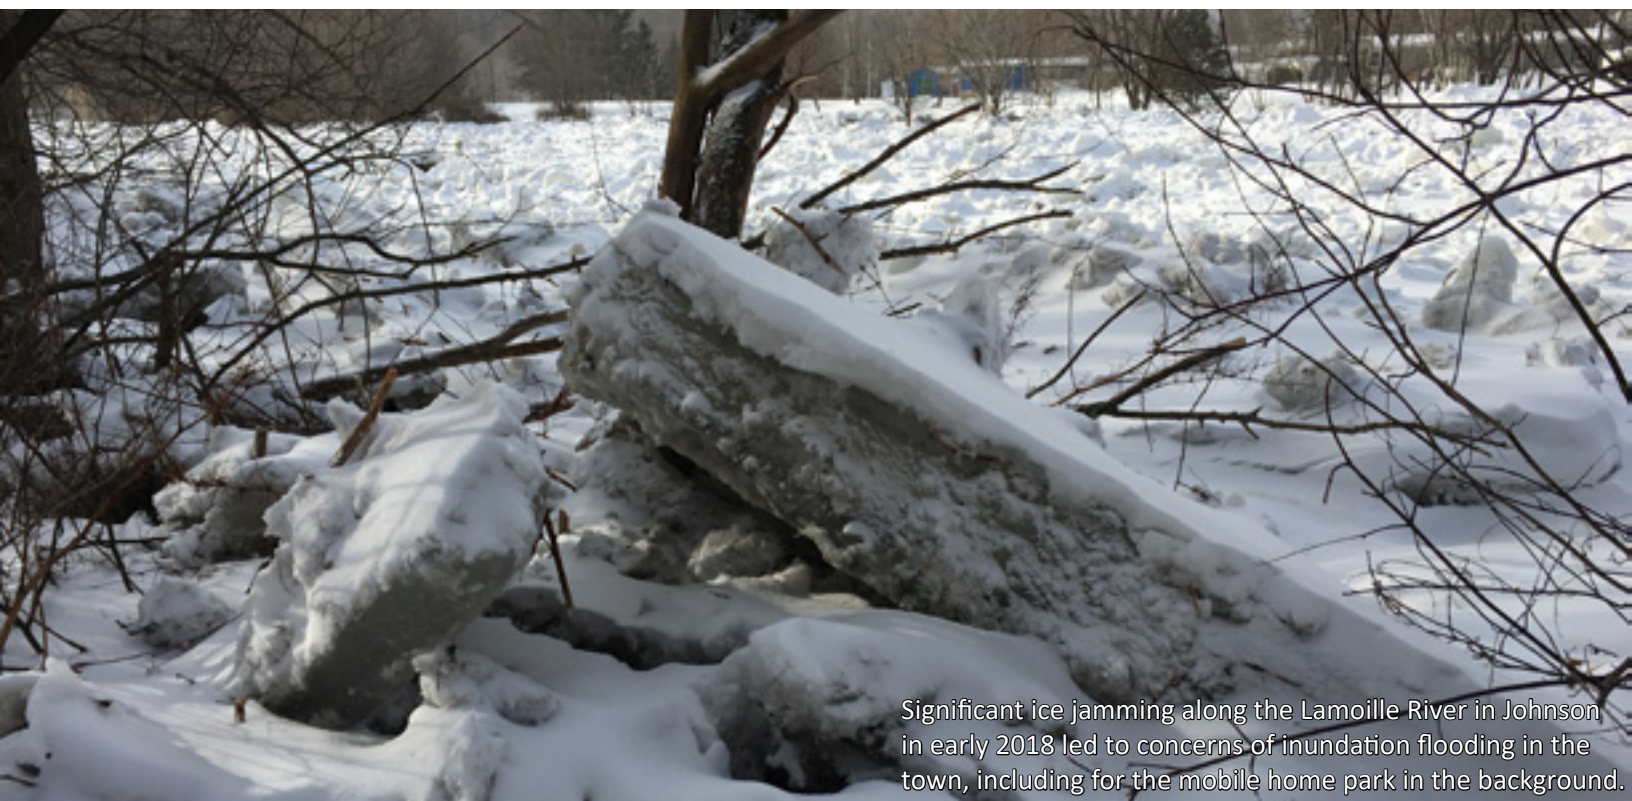
Significant ice jamming along the Lamoille River in Johnson in early 2018 led to concerns of inundation flooding in the town, including for the mobile home park in the background.
