4-7: Landslides

Landslides History

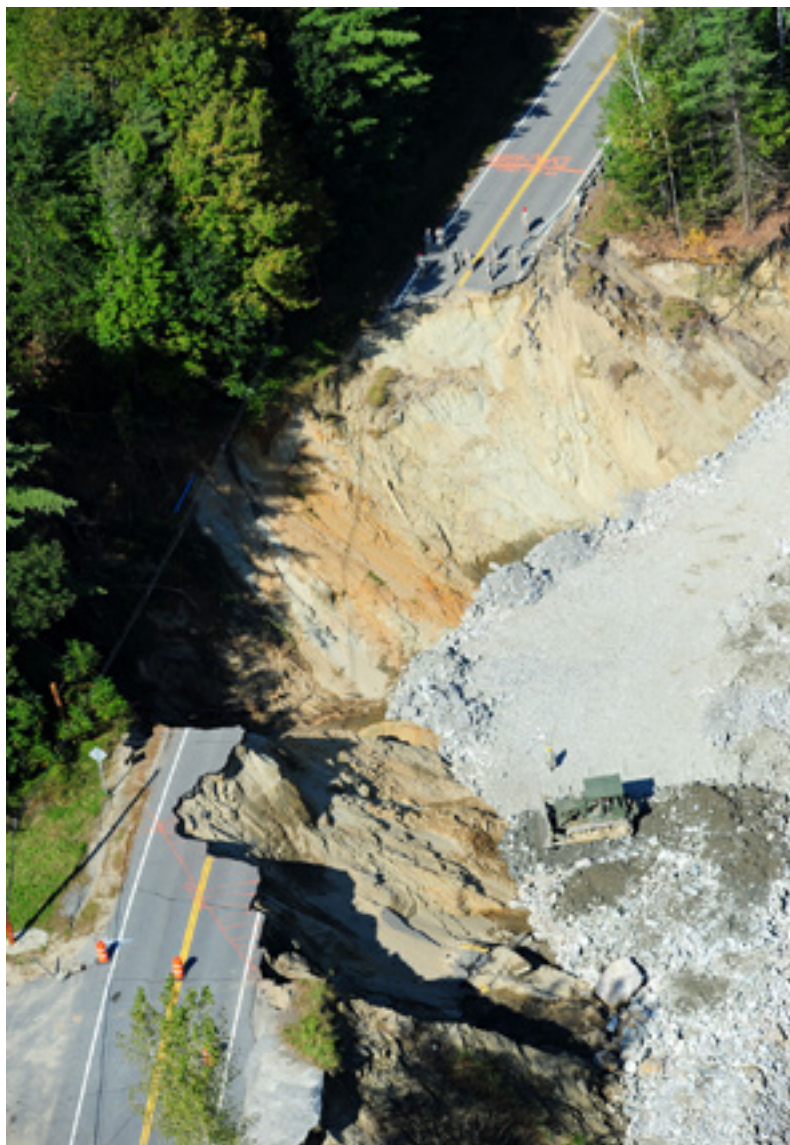
Route 131 in Cavendish devastated by slope failure.
Photo Credit: www.mansfieldheliflight.com/flood/

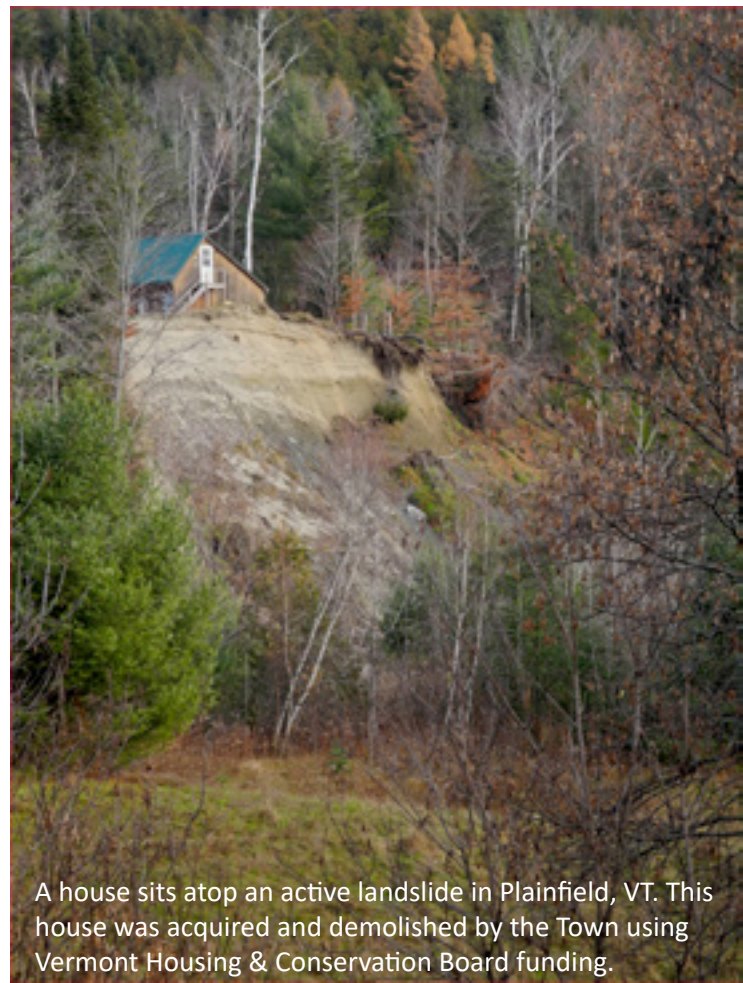
A house sits atop an active landslide in Plainfield, VT. This house was acquired and demolished by the Town using Vermont Housing & Conservation Board funding.

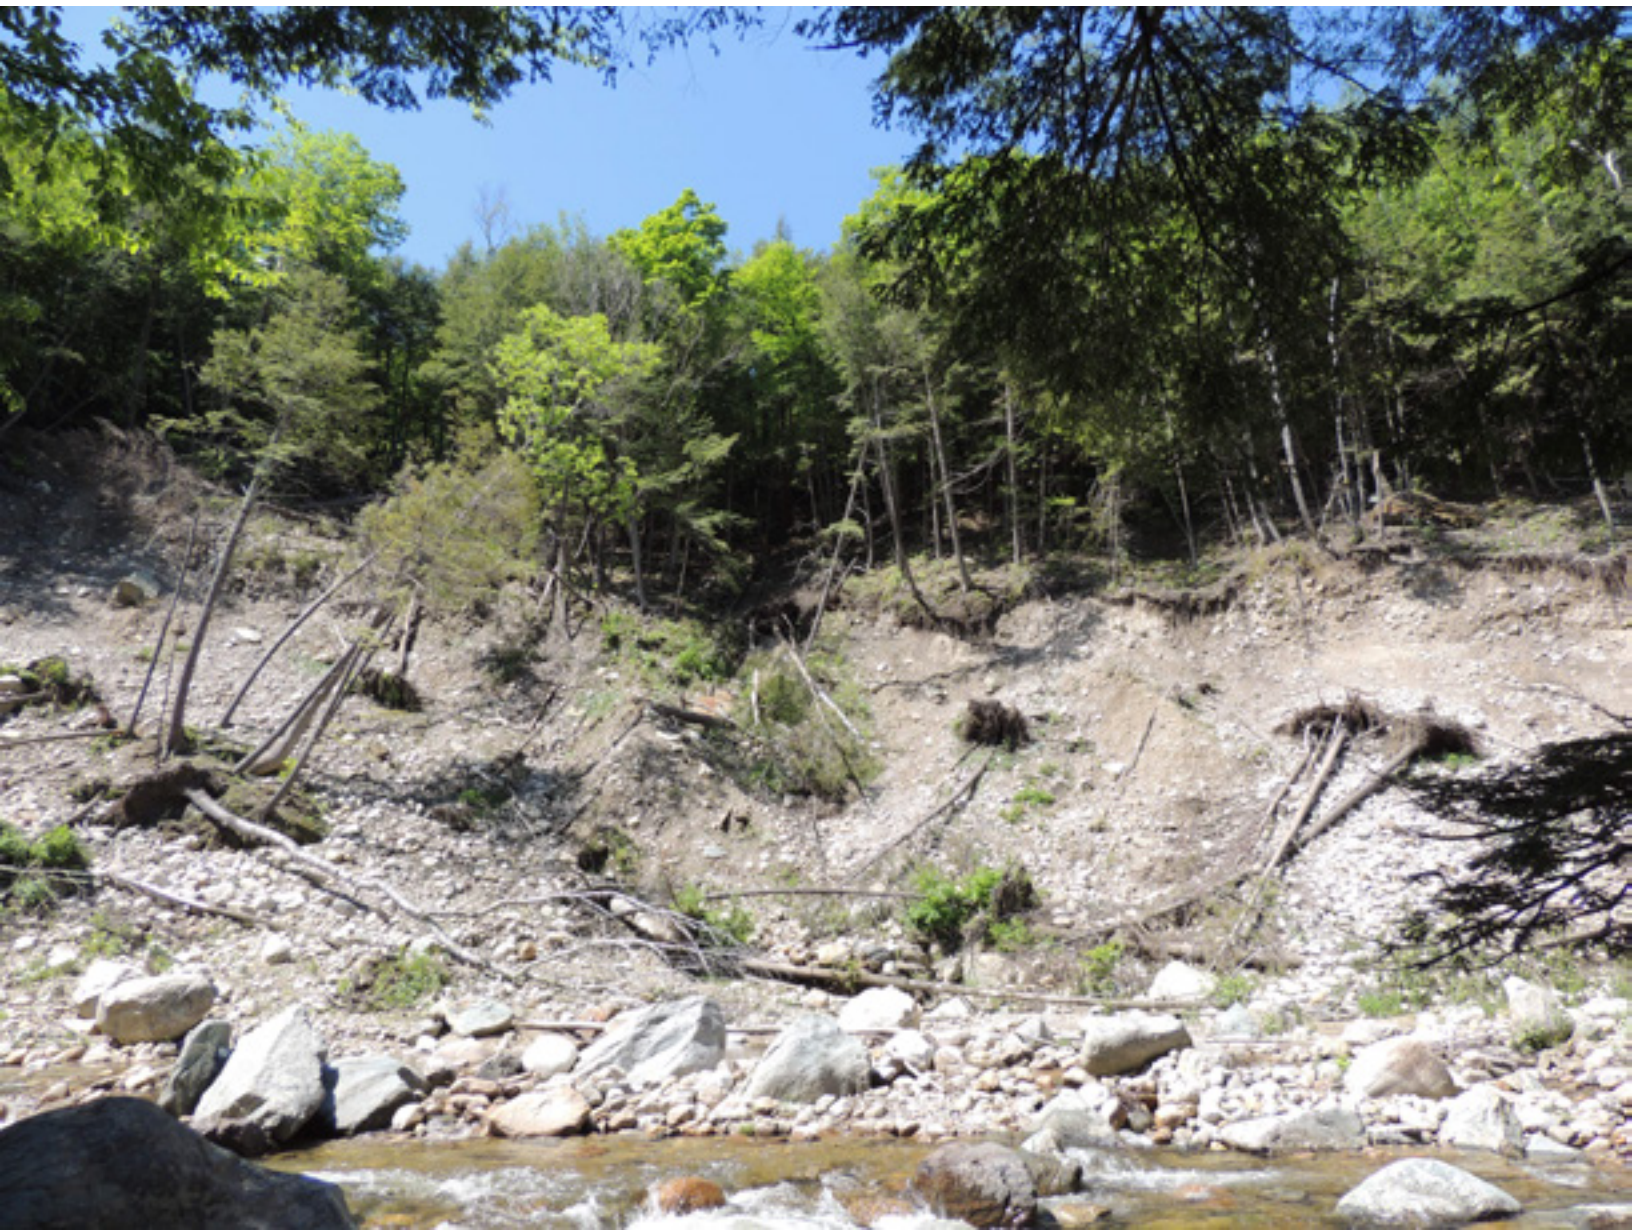
Major slope failure along the Cold River in Shrewsbury, VT. *Photo Credit: Alan Shelvey*

The Town of Shrewsbury had to have substantial work done after Tropical Storm Irene due to significant slope failures along the Cold River, including approximately \$887,000 in Public Assistance funds for road repair and slope stabilization. The Town, recognizing there were several landslide areas along this stretch that required immediate attention, then submitted a PDM application to relocate a portion of the Upper Cold River Road identified as being an imminent threat of catastrophic failure. This project, approved by FEMA in early 2018, is estimated to cost nearly \$750,000 to complete.
