Appendix - Section 3 - State & Local Capabilities Supplemental

Building Prioritization: Methodology

BGS Subgrant Project - Priority Building Assessment

BUILDING ASSESSMENT FORM

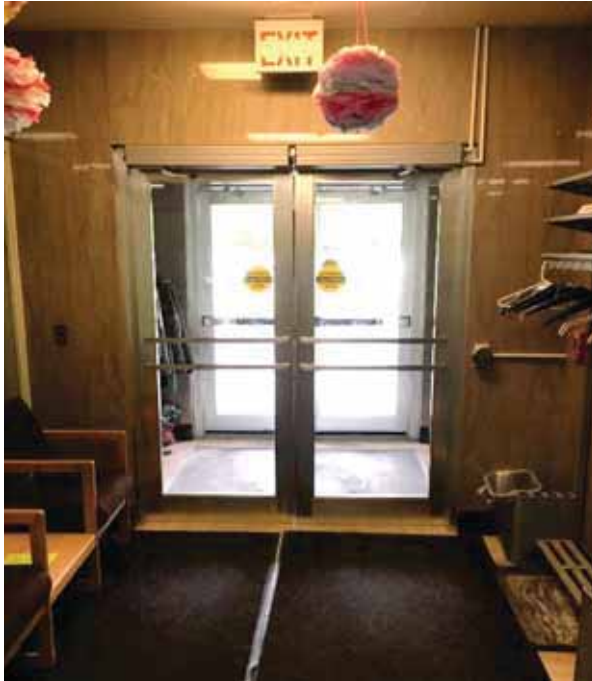
Figure 6: Basement exit door west

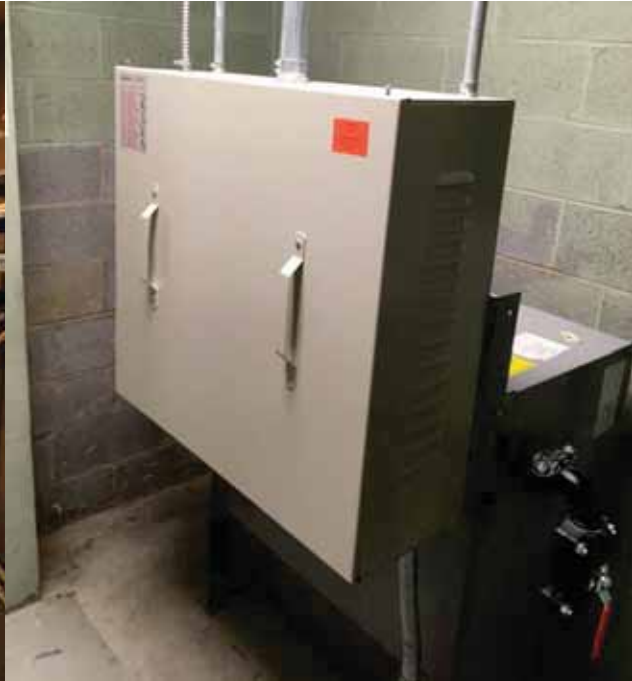
Figure 7: Elevator machine room equip

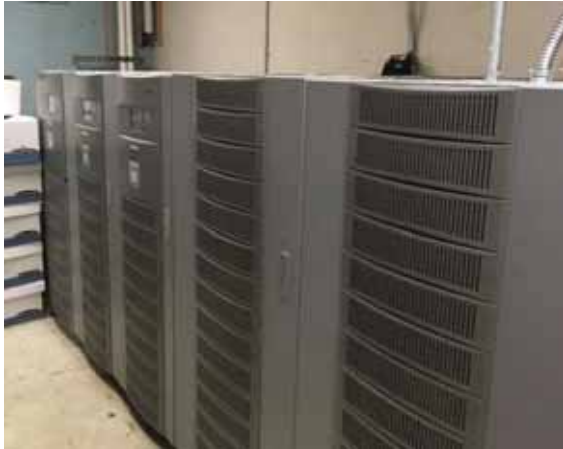
Figure 10: Liebert network power units

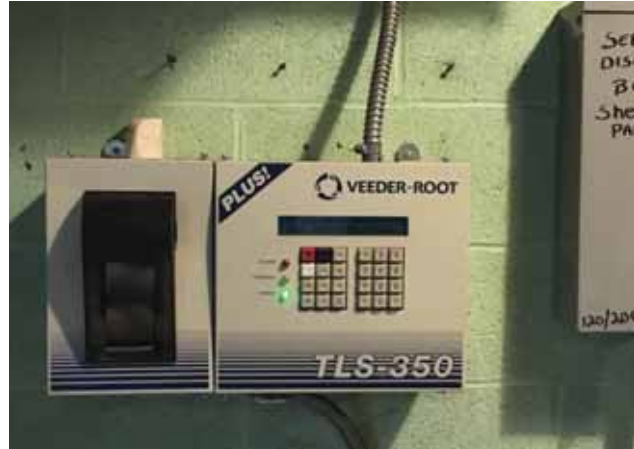
Figure 11: Emergency Generator Tank Monitor

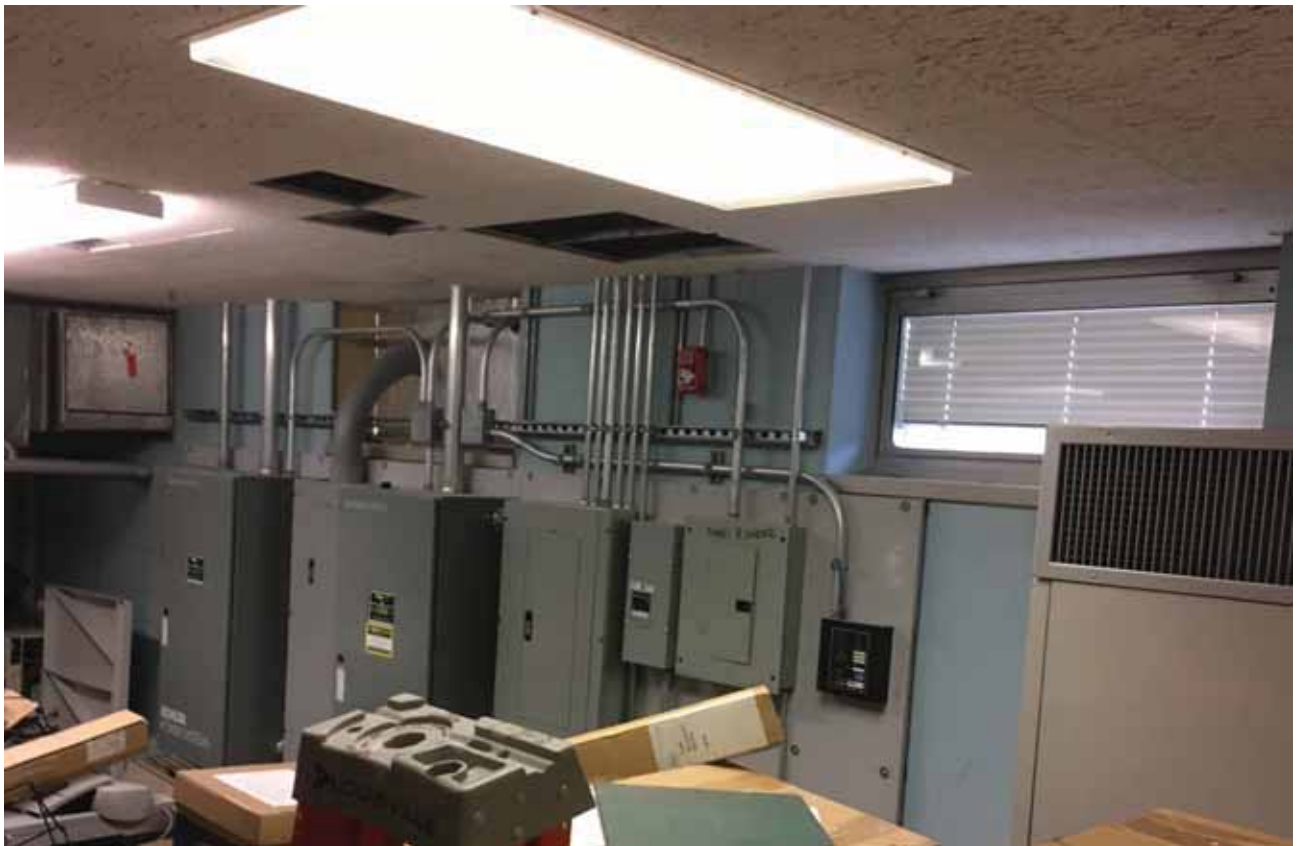
Figure 12: Basement electrical and mechanical equipment.

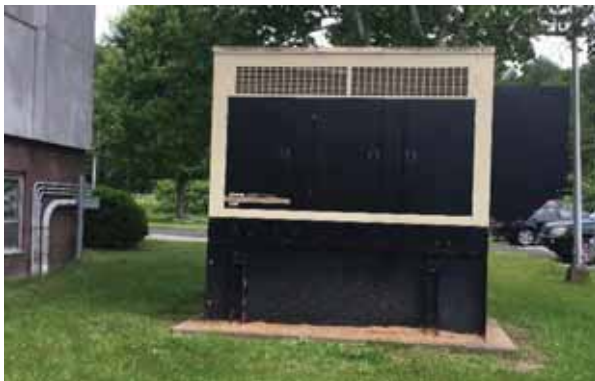
Figure 15: Pad mounted Generator (SE corner)

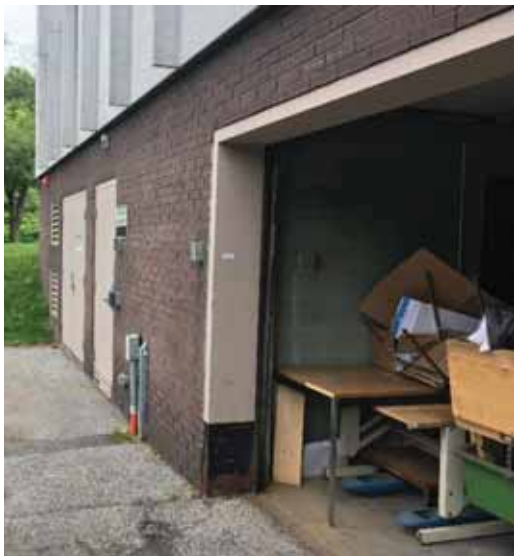
Figure 17: Openings in south façade

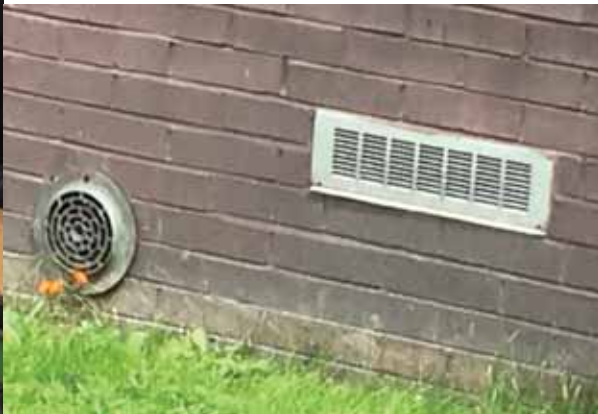
Figure 18: Vents and openings in west façade

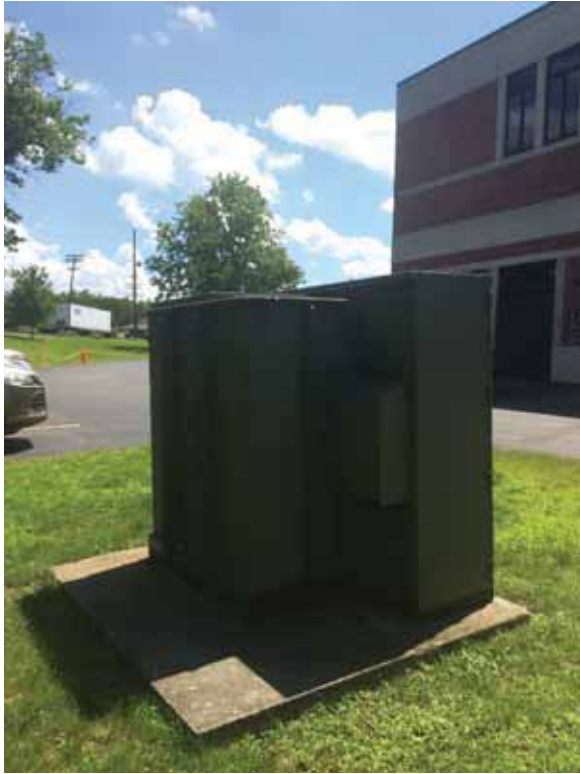
Figure 5: Exterior pad mount transformer.

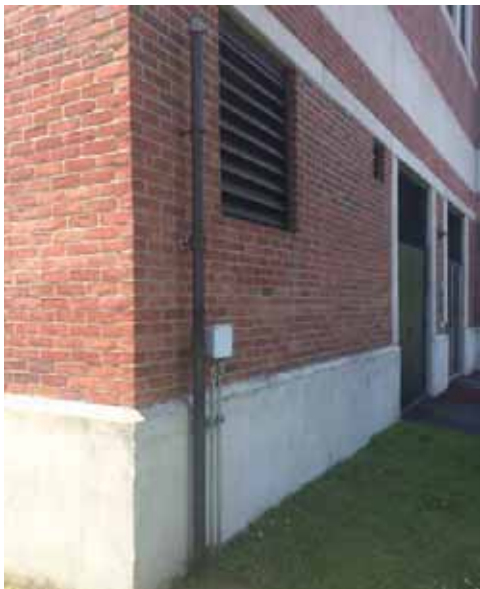
Figure 7: Vent pipe
(underground fuel tank?).

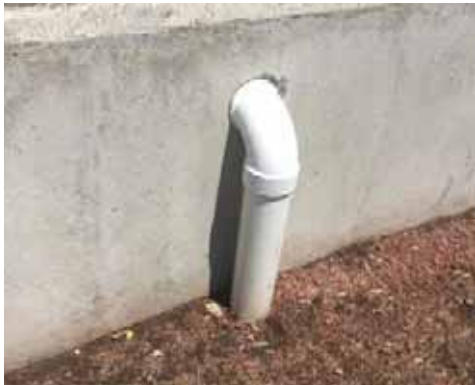
Figure 12: Unsealed exterior wall penetration(s).

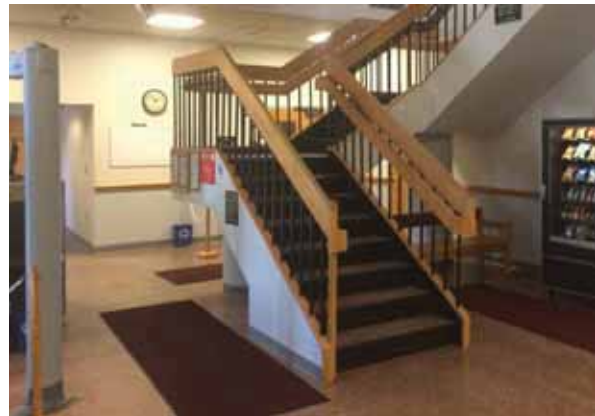
Figure 17: Entry Stair and Metal Detector.

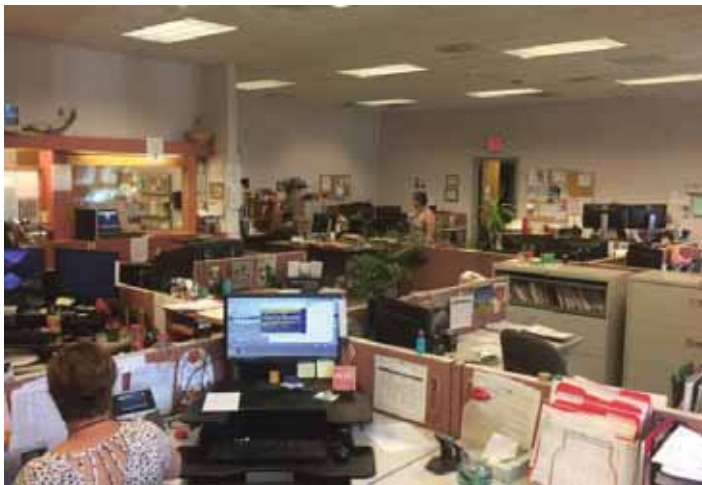
Figure 24: Open office space.

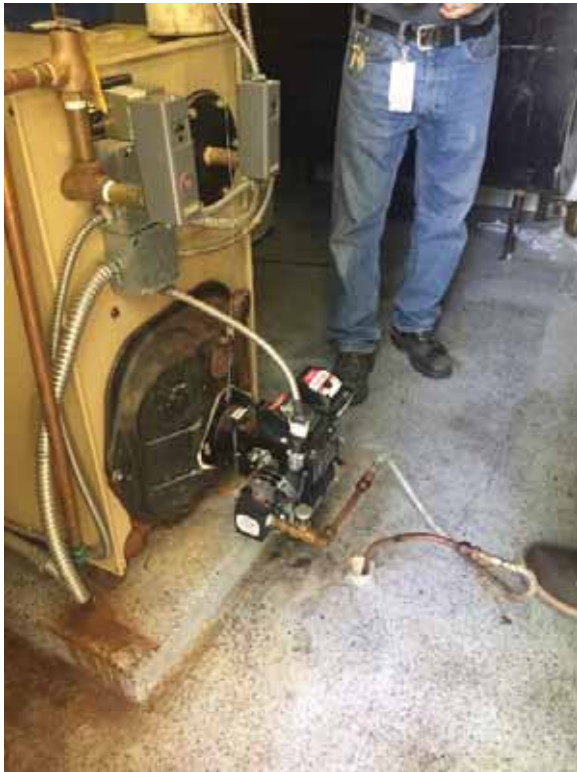
Figure 5: Boiler in Mechanical Room (Source: MSK)

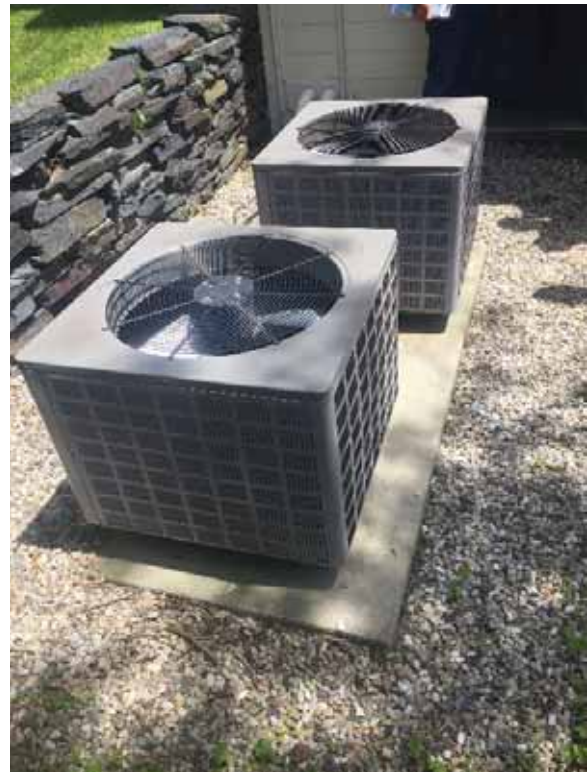
Figure 6: Exterior A/C Units (Source: MSK)

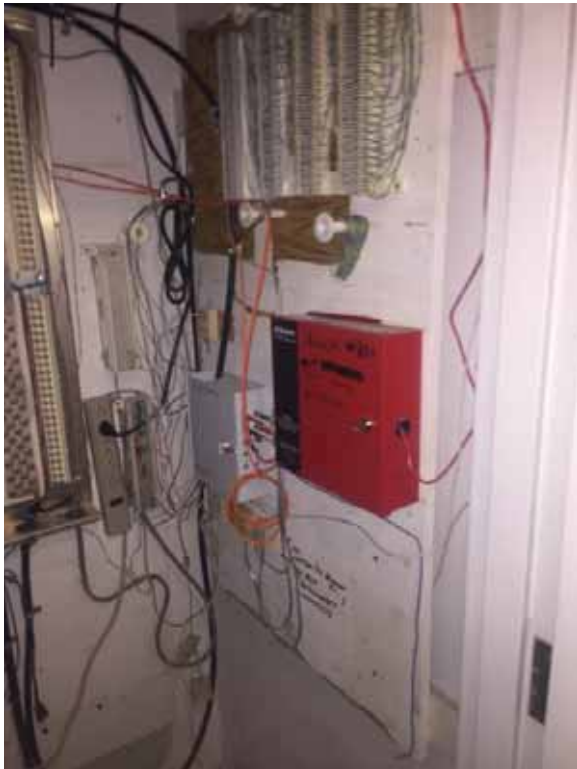
Figure 7: Telcom / Security Panels (Source: MSK)

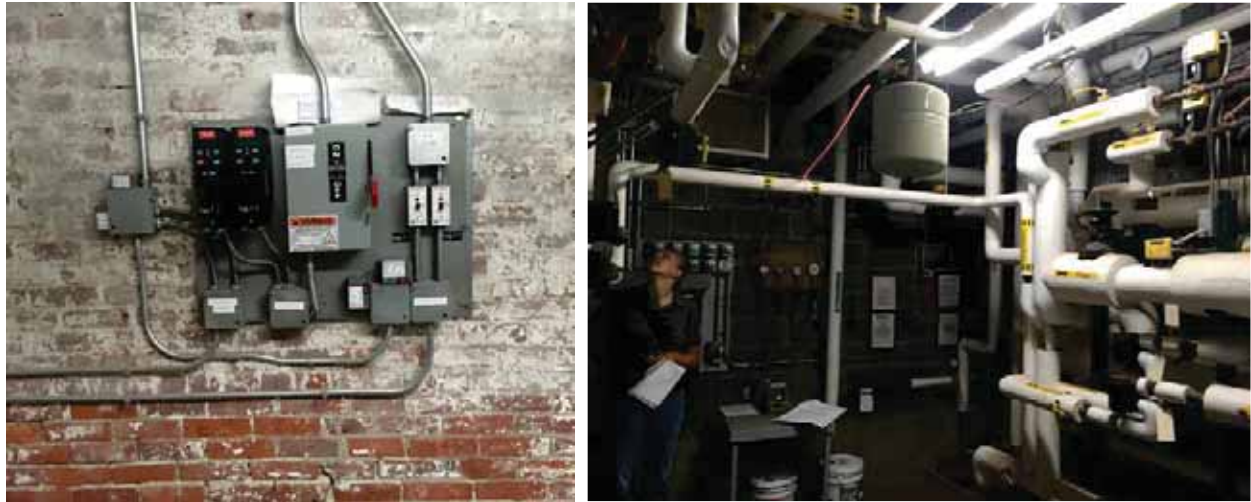
Figure 6 & 7: Basement Electrical and mechanical

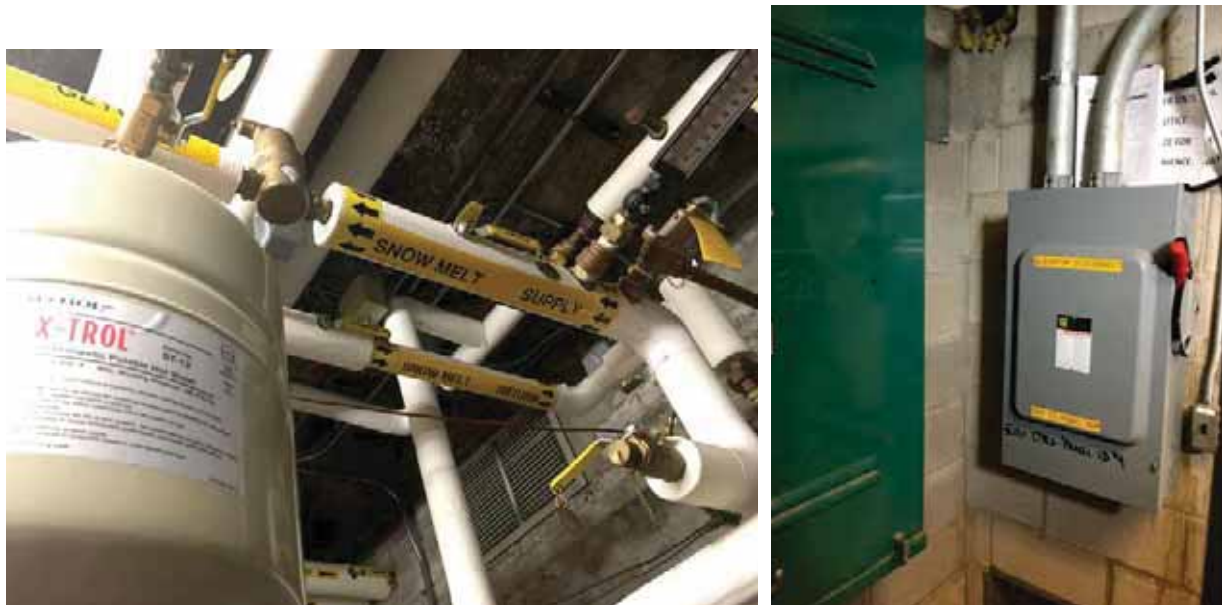
Figure 8 & 9: Basement mechanical and electrical

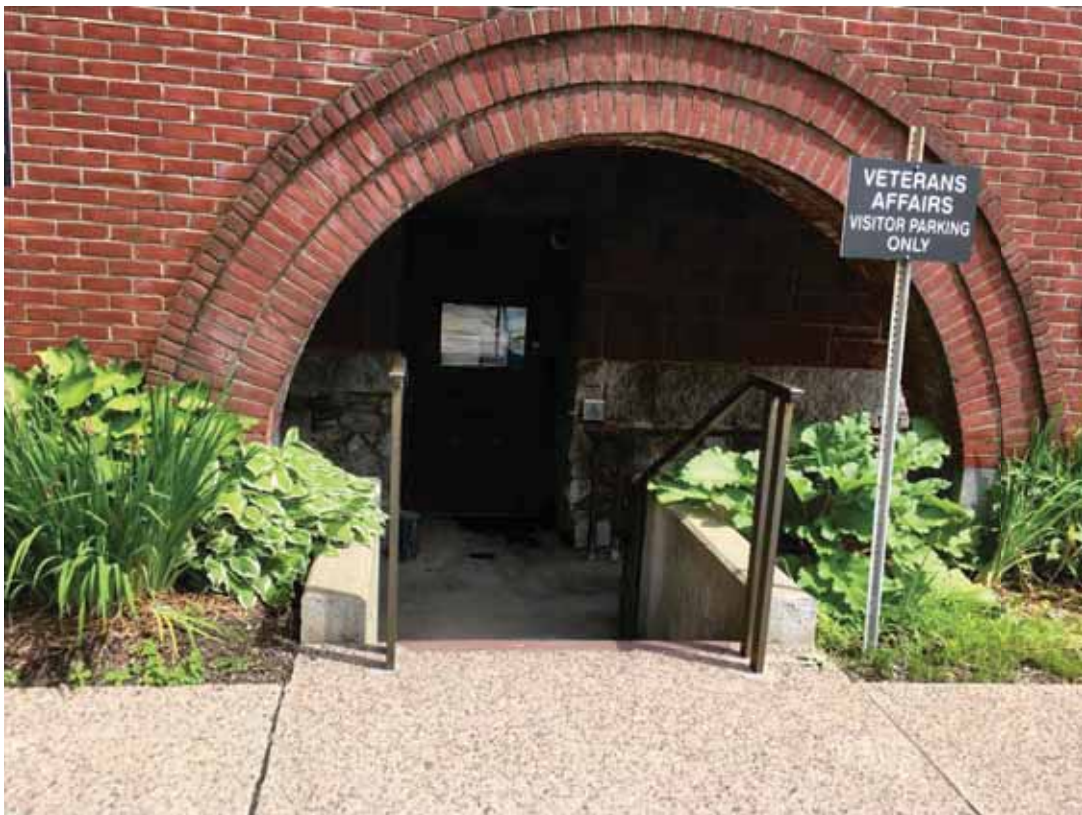
Figure 19: Basement recessed entry

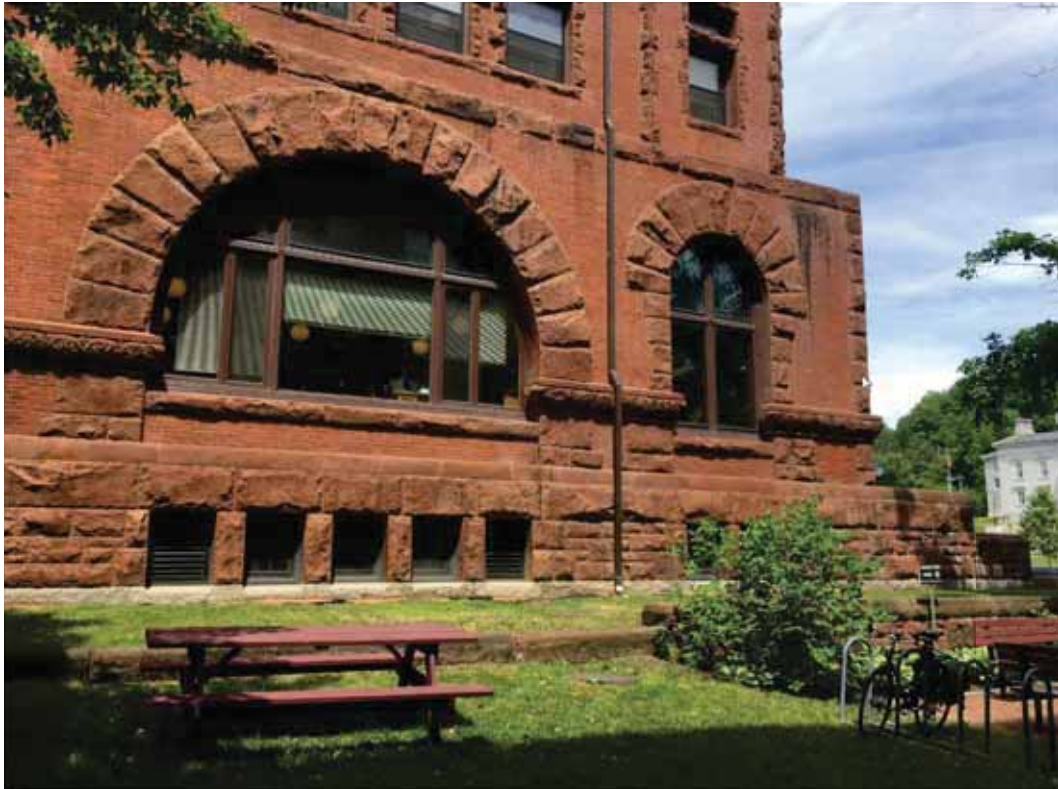
Figure 20: East façade and openings

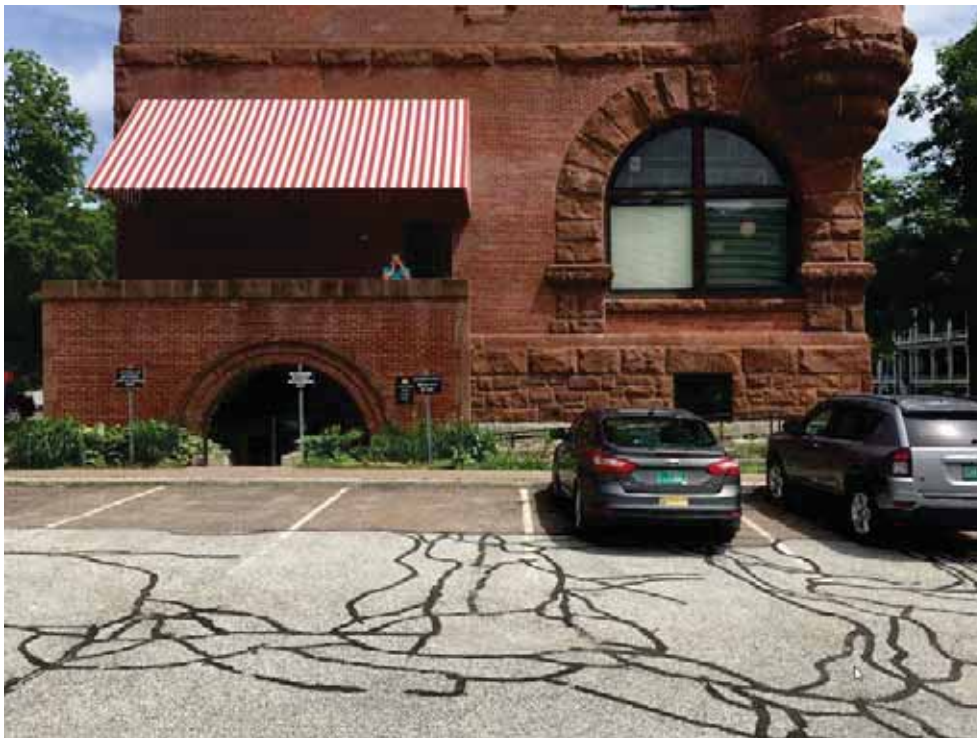
Figure 21: South façade and recessed basement entry

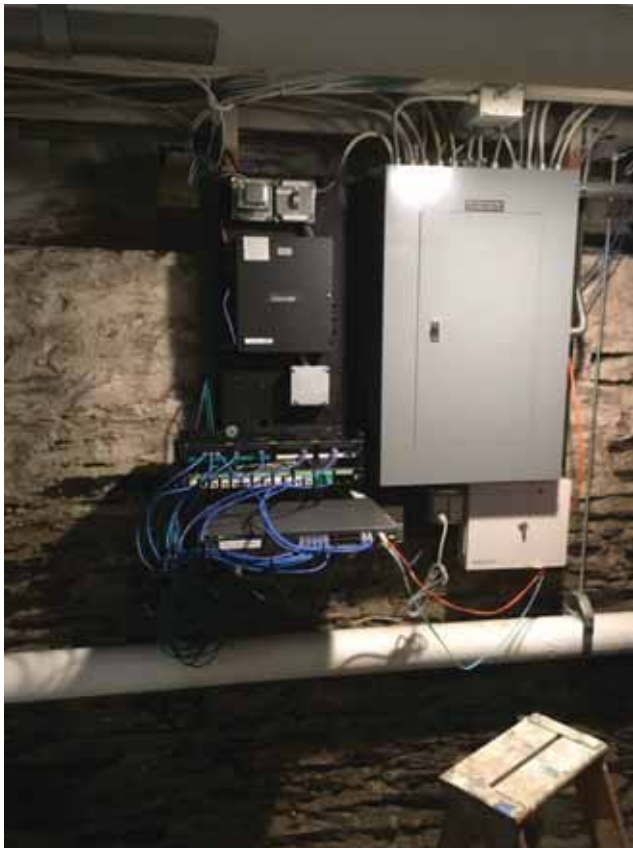
Figure 13: IT, Electrical, Security

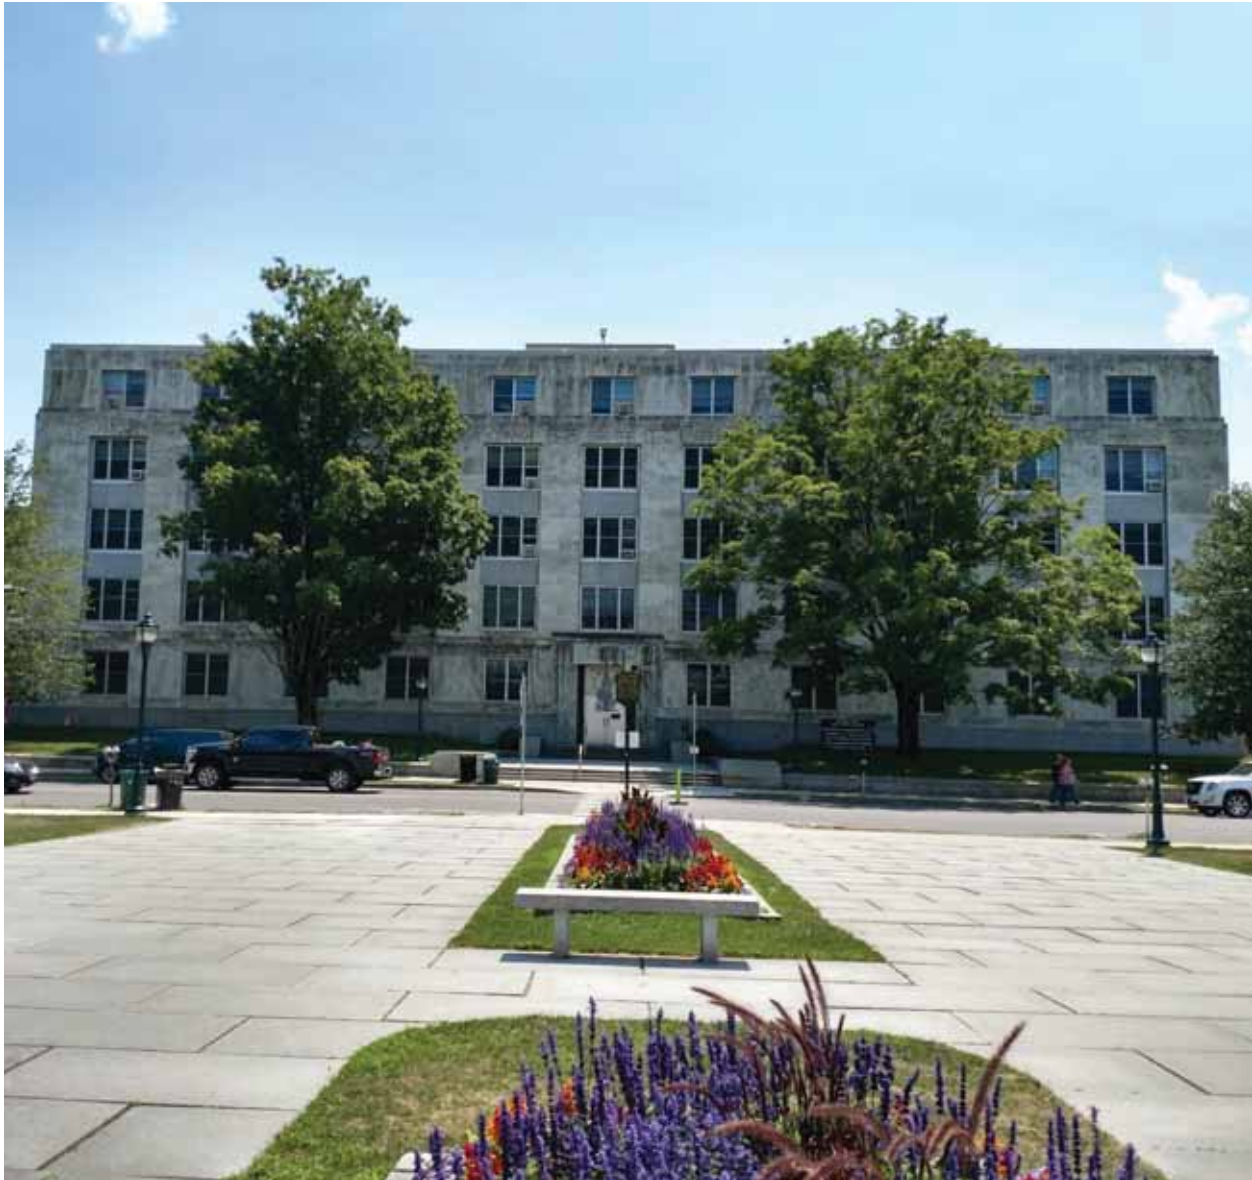
Figure 1: Front Entrance looking South (photo credit: Grenier Engineering, PC)

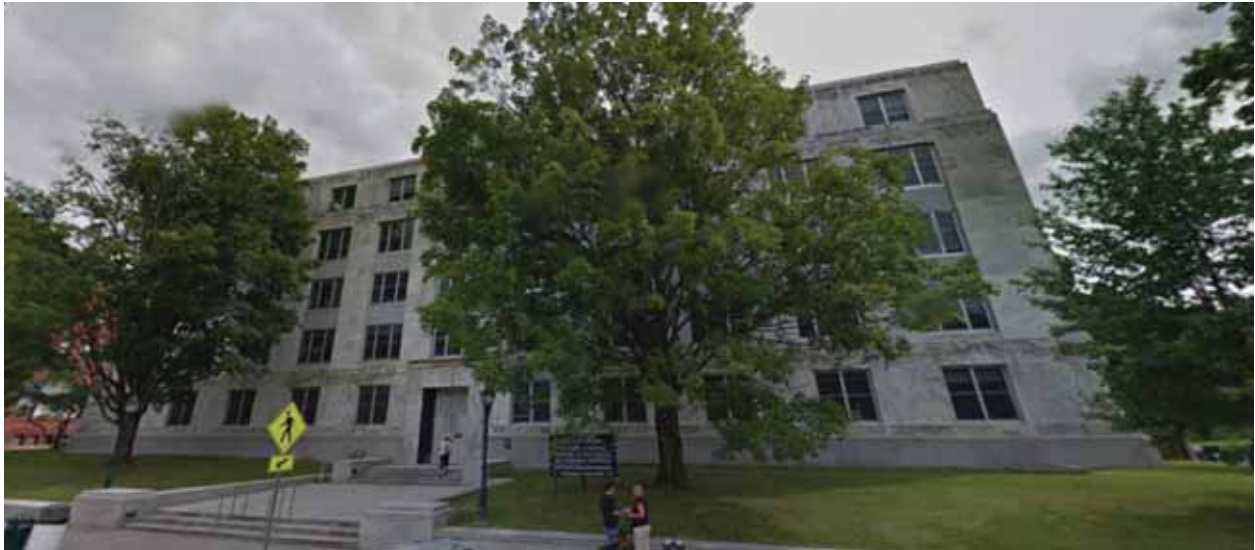
Figure 2: North Façade (photo credit: Freeman French Freeman)

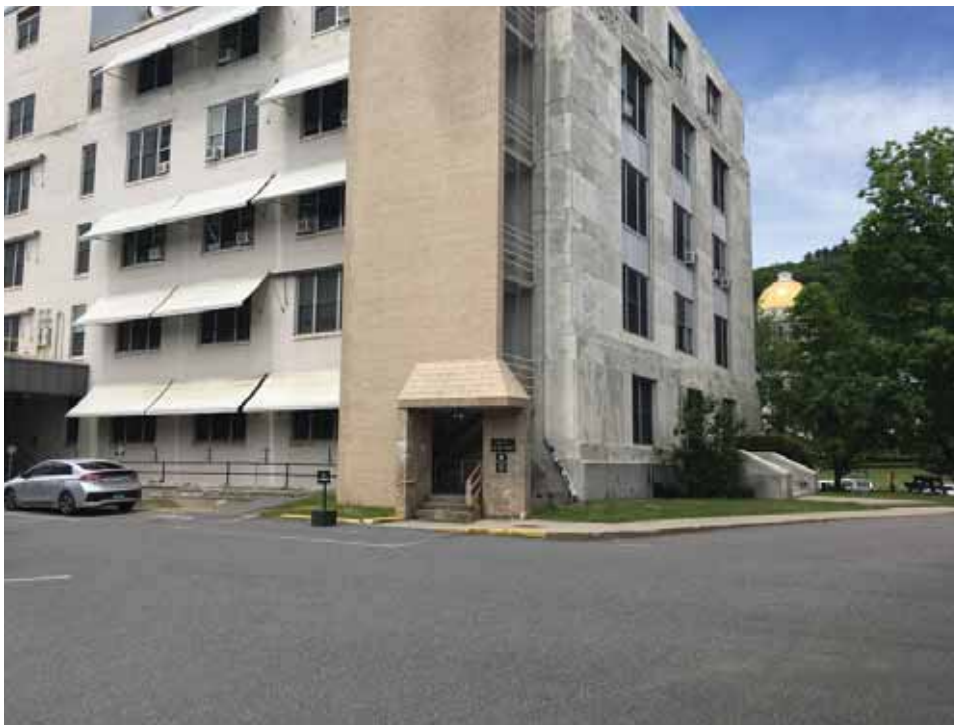
Figure 7: East and south façades

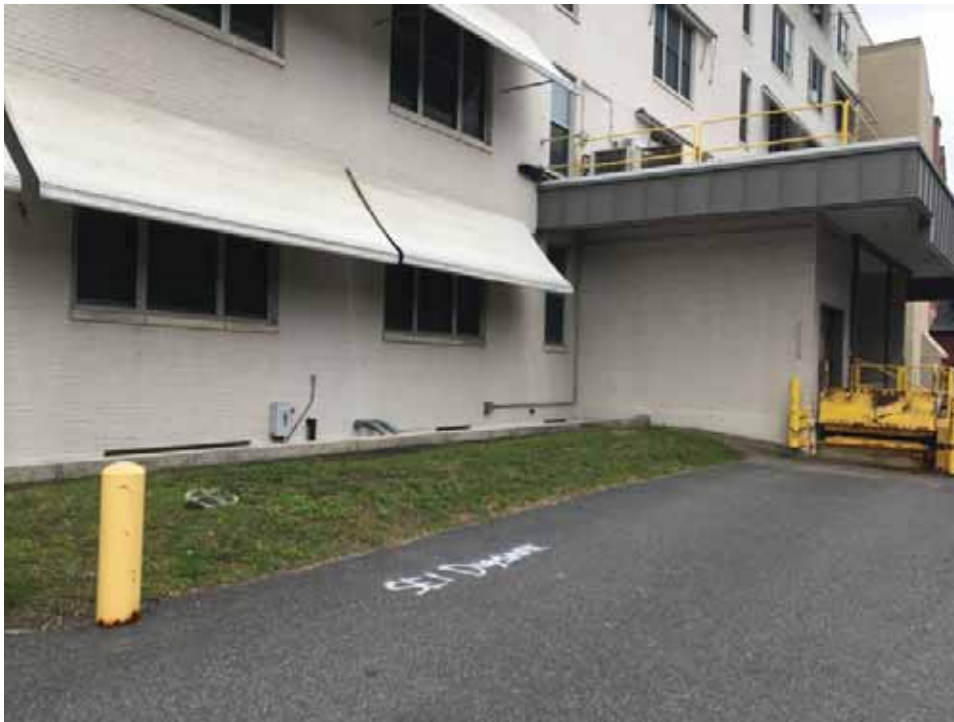
Figure 10: South areaway and loading dock

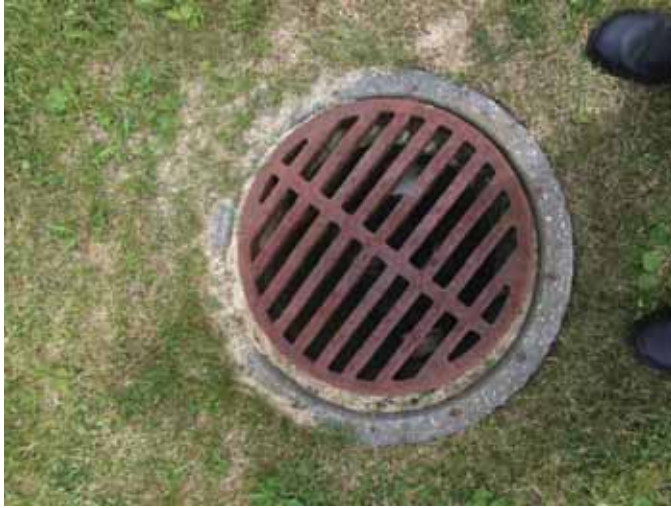
Figure 11: Exterior drainage structure

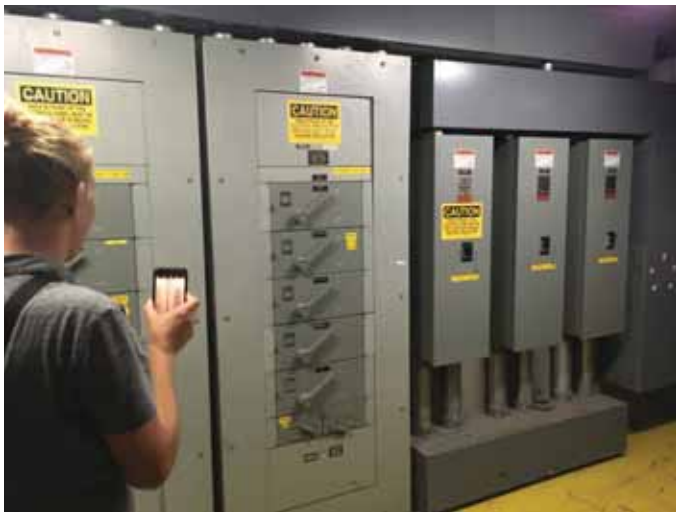
Figure 12: Basement electrical equipment

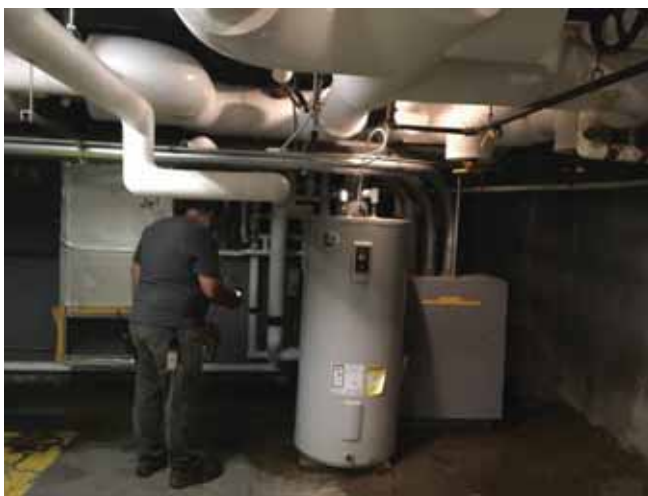
Figure 13: Basement mechanical equipment

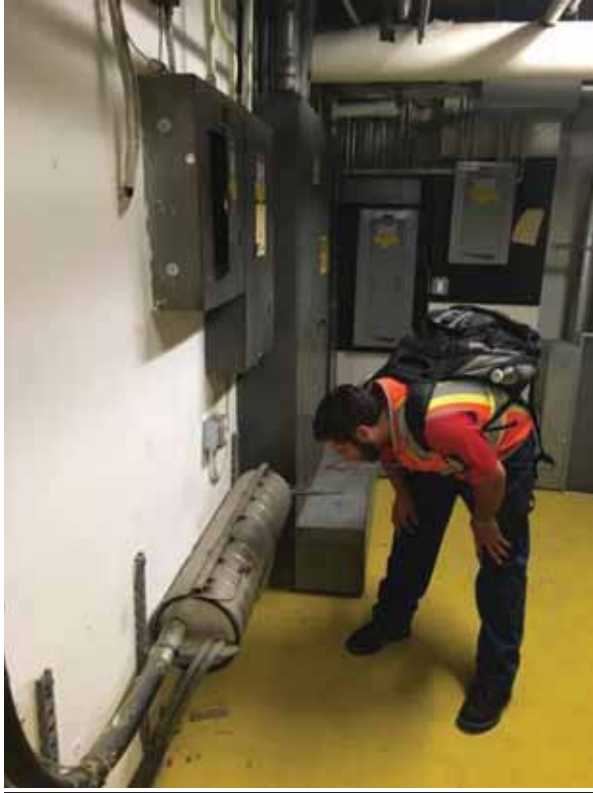
Figure 14: Basement electrical equipment

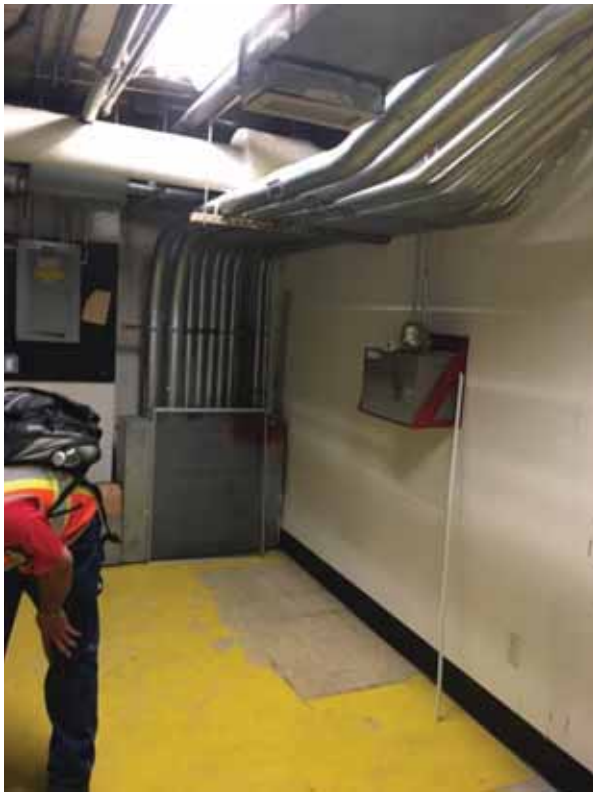
Figure 15: Basement electrical equipment

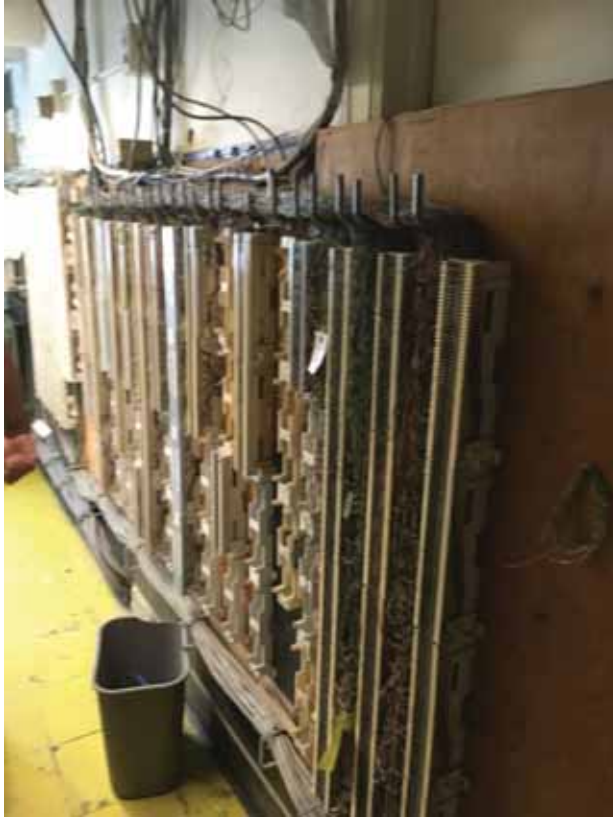
Figure 16: Basement Tel-com equipment

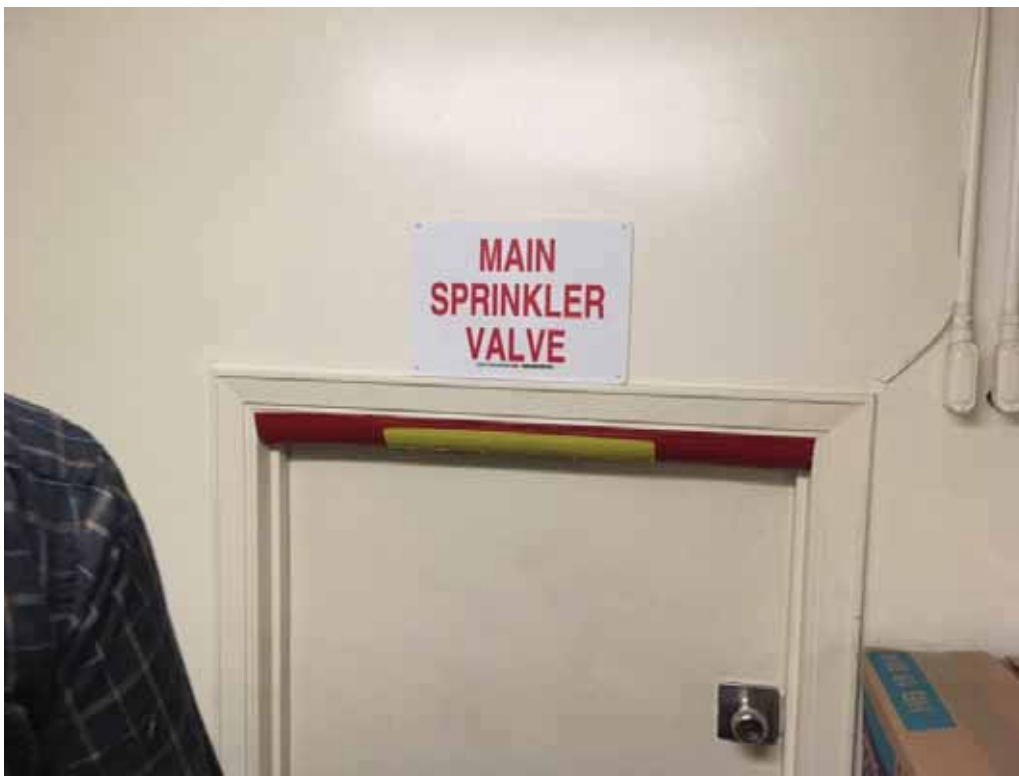
Figure 17: Basement sprinkler room

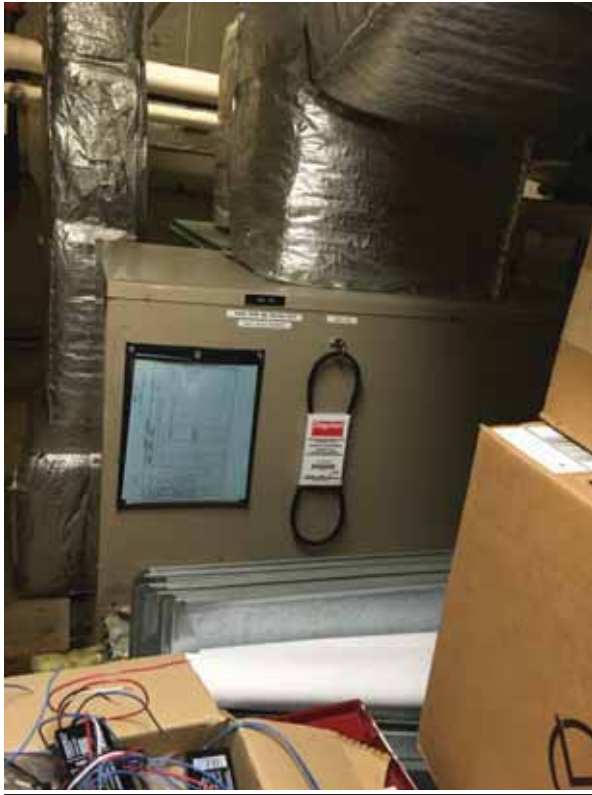
Figure 18: Basement mechanical equipment

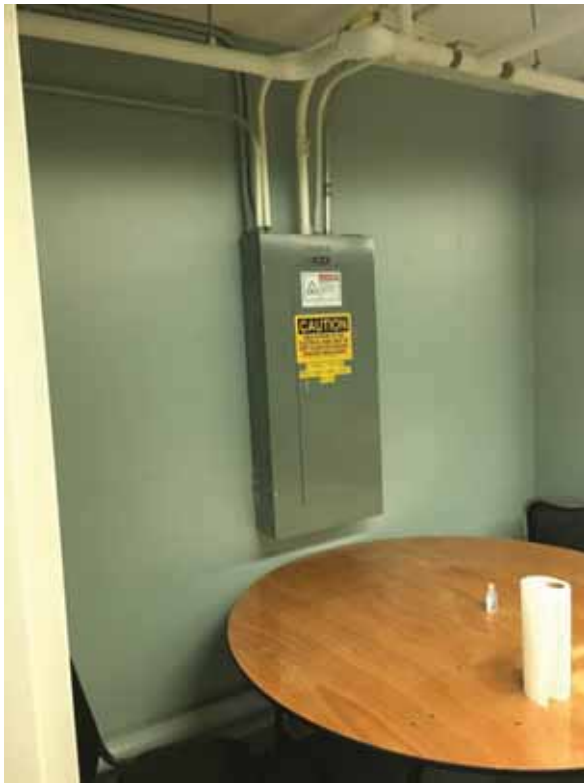
Figure 19: Basement electrical equipment

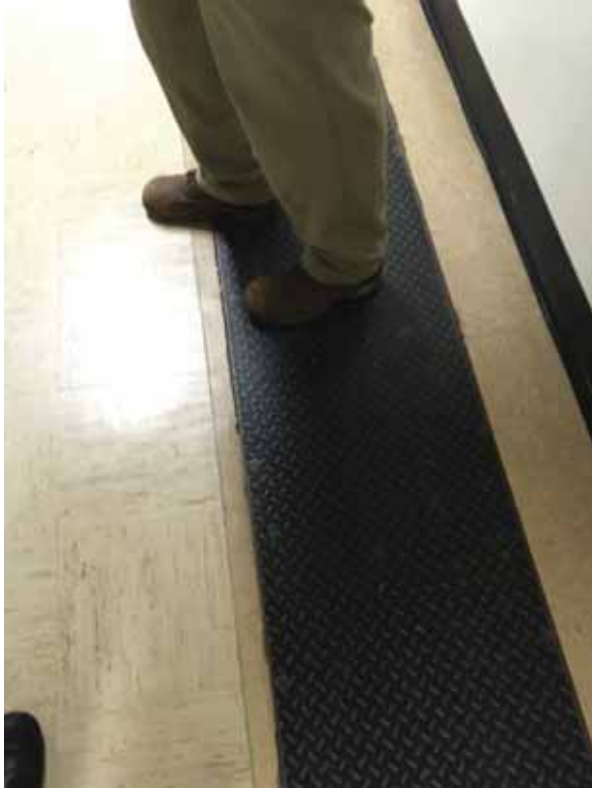
Figure 20: Basement floor trench with cover plate

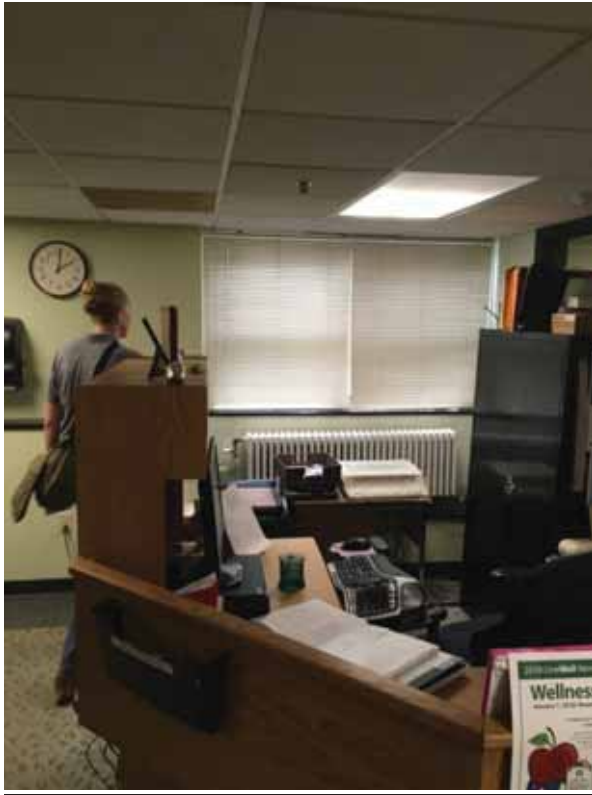
Figure 22: Basement office space

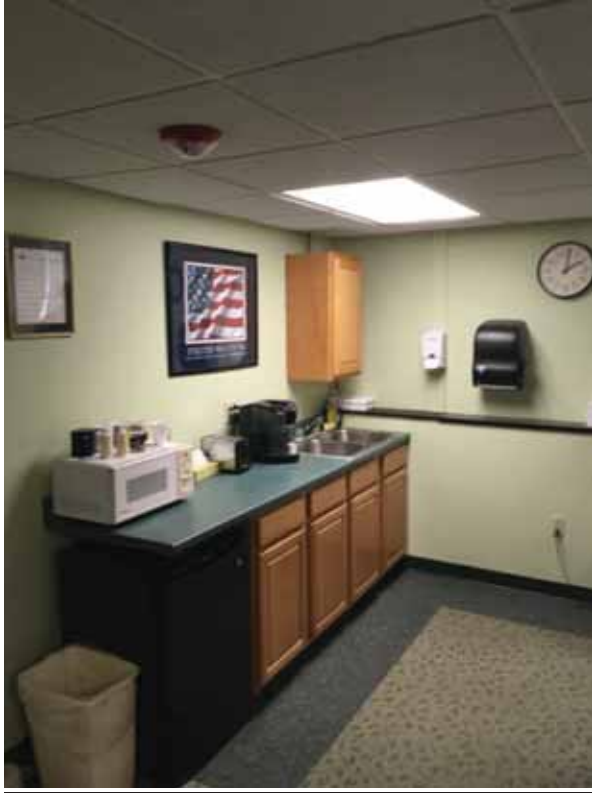
Figure 24: Basement breakroom space

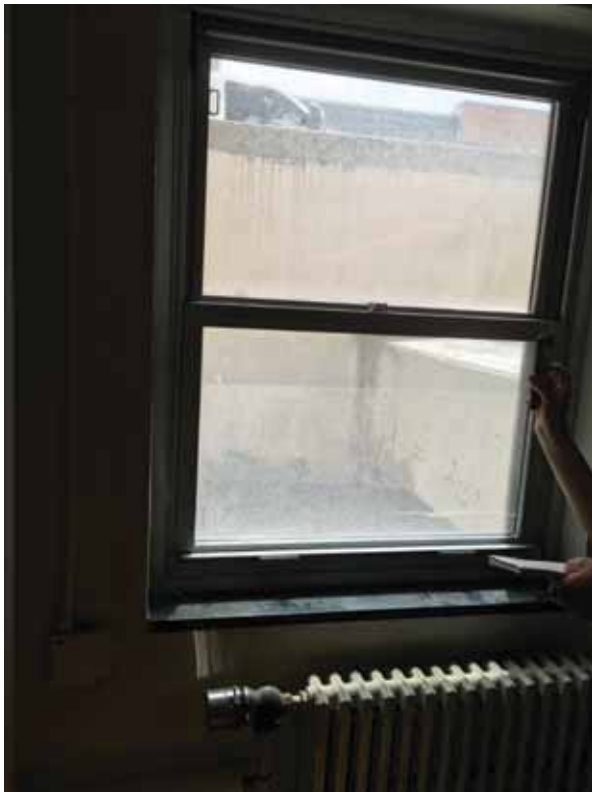
Figure 25: Basement window into areaway

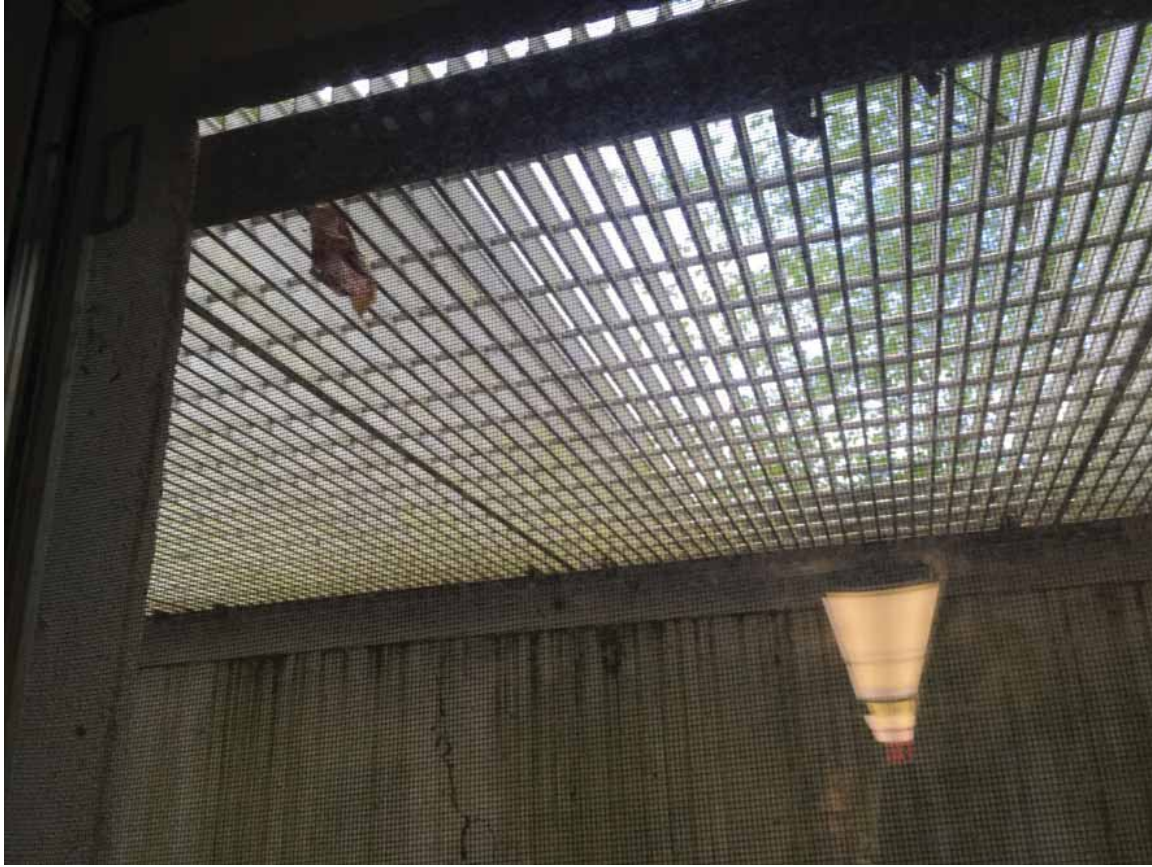
Figure 26: Areaway with grate cover

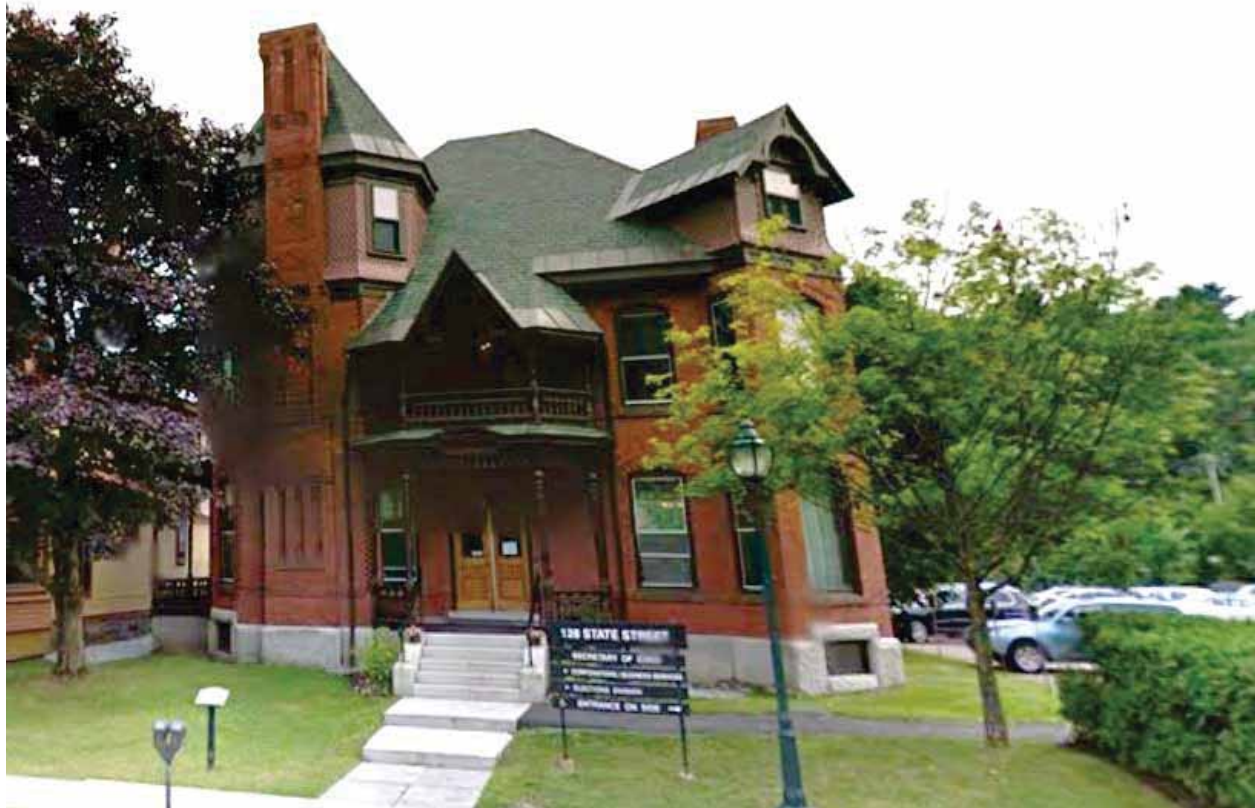
Figure 1: Front Entrance looking South (photo credit: Freeman French Freeman)

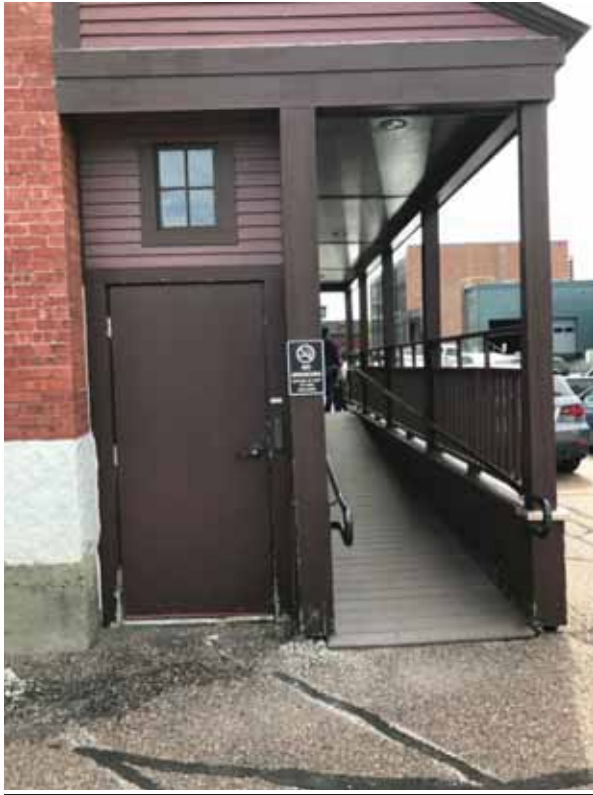
Figure 10: Basement access door
