Appendix - Section 3 - State & Local Capabilities Supplemental

Building Prioritization: Methodology

BGS Subgrant Project - Priority Building Assessment

BUILDING ASSESSMENT FORM

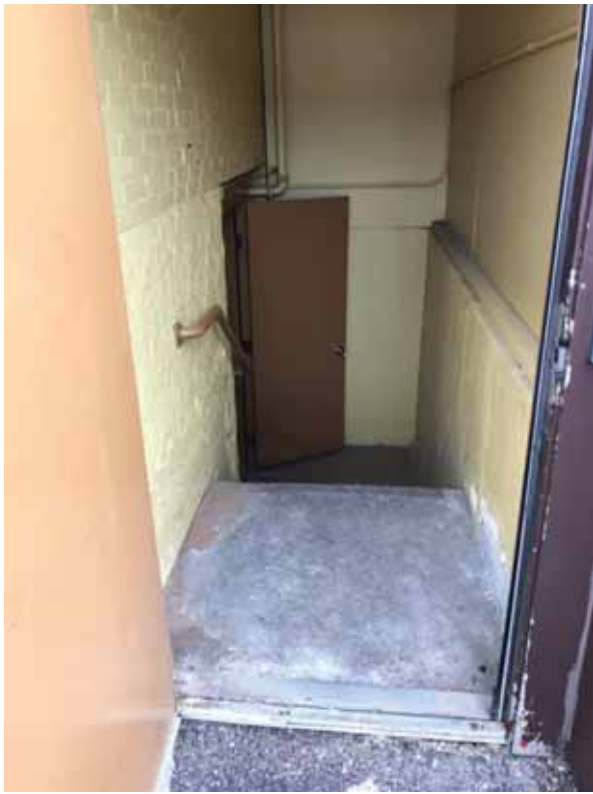
Figure 11: Basement access door open and stairs to basement

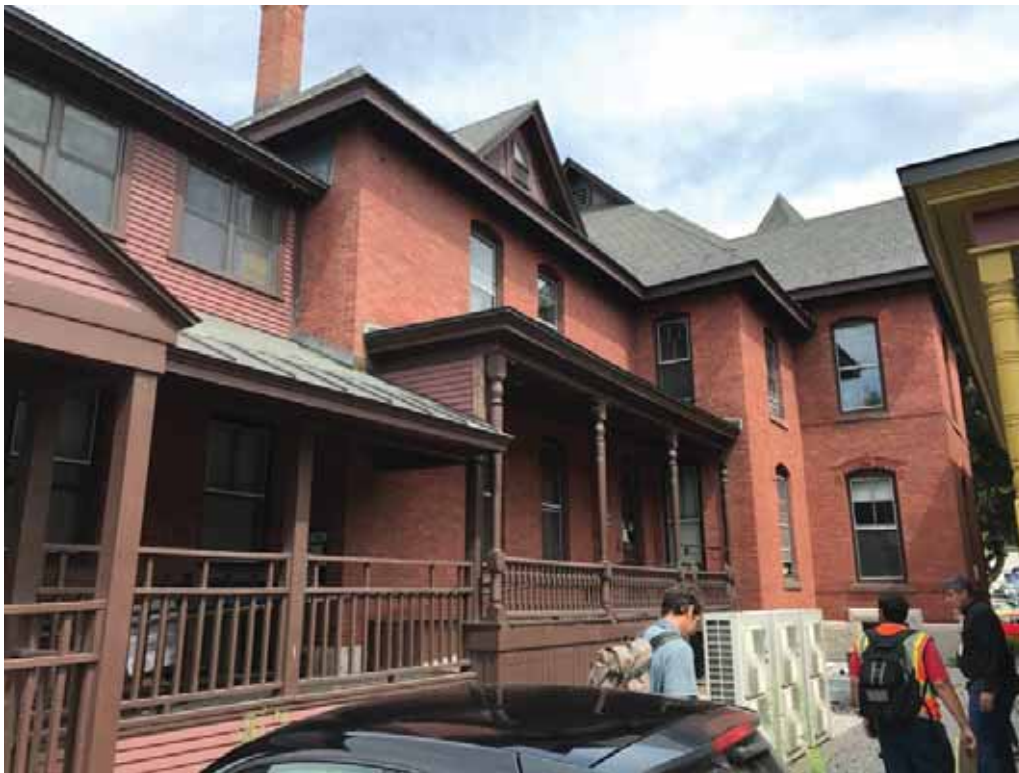
Figure 13: Site mounted split system AC units

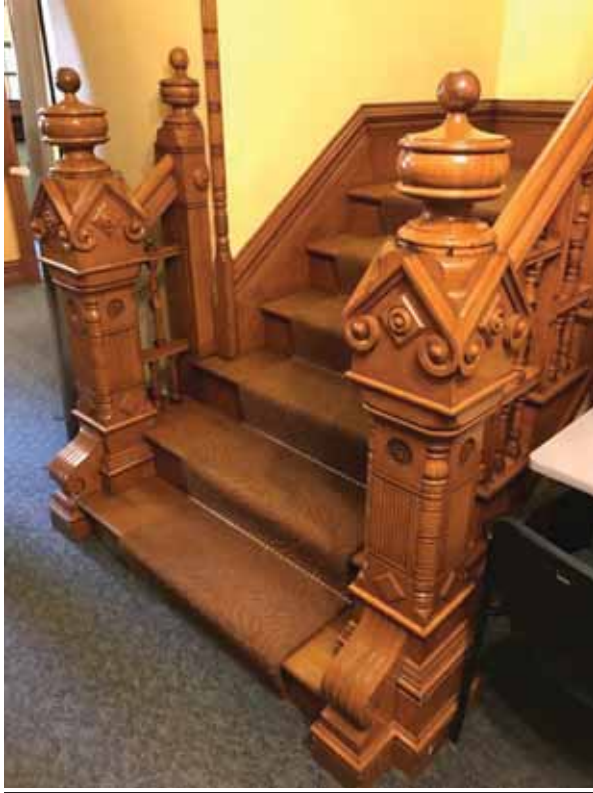
Figure 16: First floor woodwork (understood to be above predicted flood elevations)

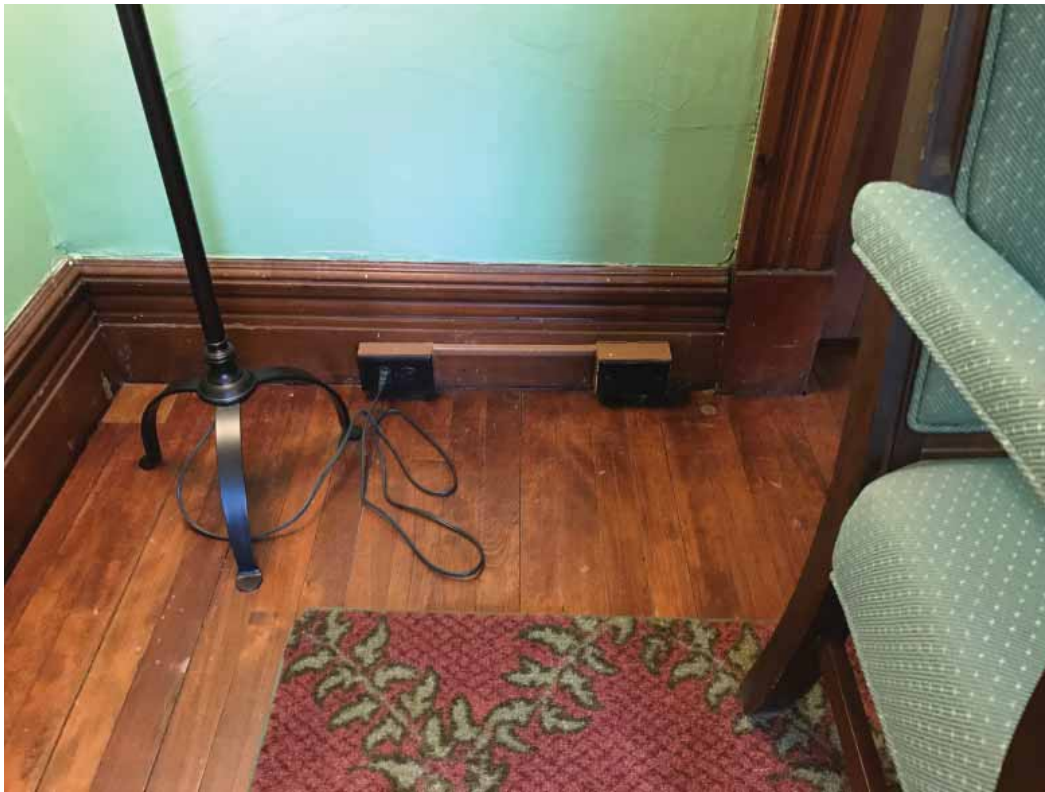
Figure 17: First floor woodwork (understood to be above predicted flood elevations)

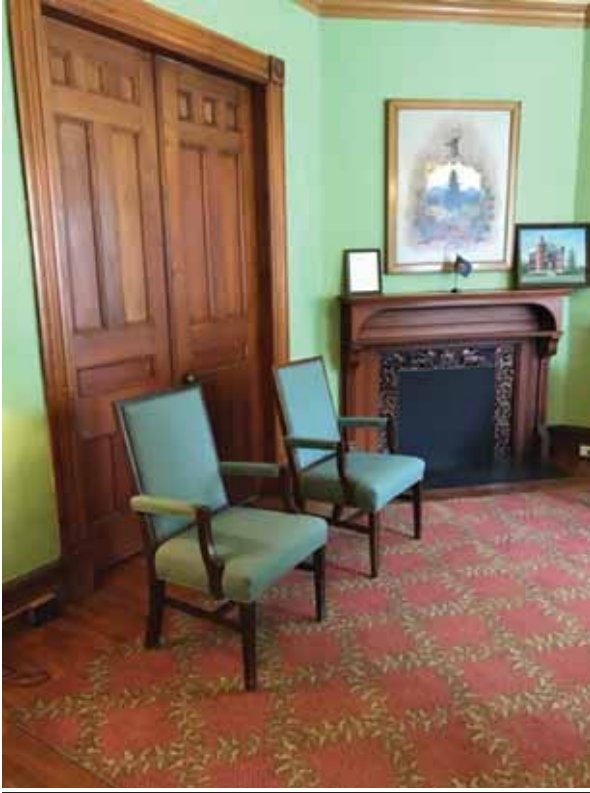
Figure 18: First floor woodwork (understood to be above predicted flood elevations)

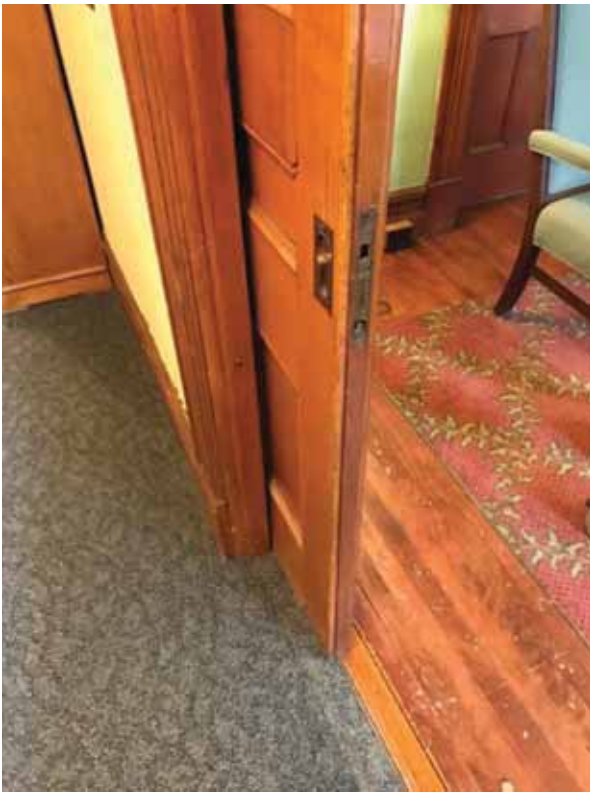
Figure 19: First floor woodwork (understood to be above predicted flood elevations)

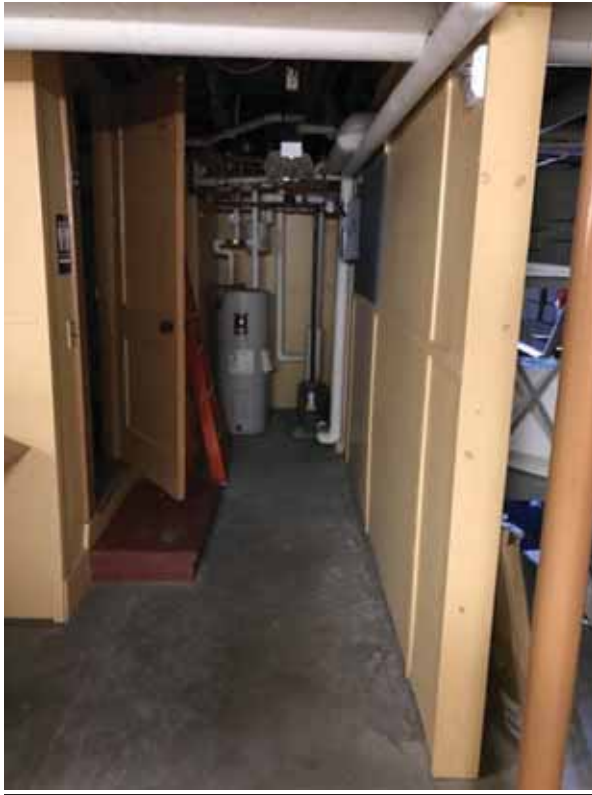
Figure 20: Basement mechanical / hot water heater

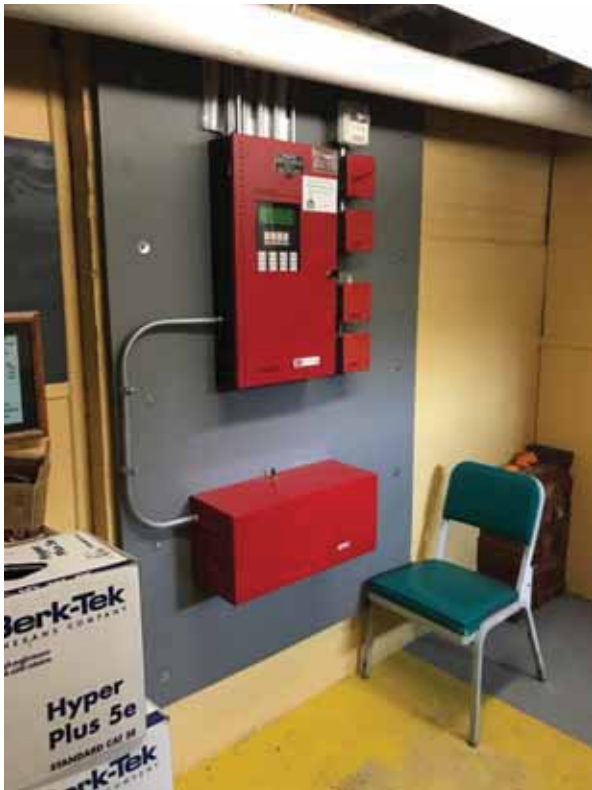
Figure 21: Basement fire alarm panel

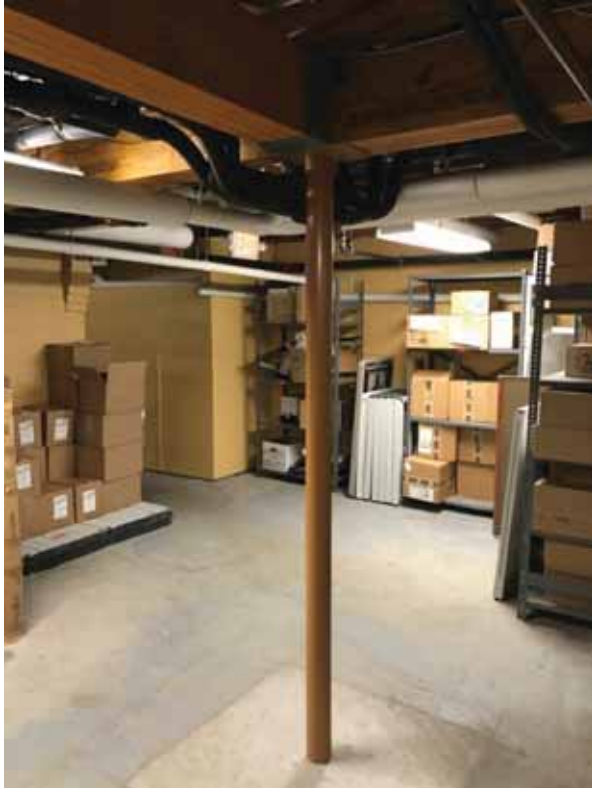
Figure 22: Basement column and stored supplies

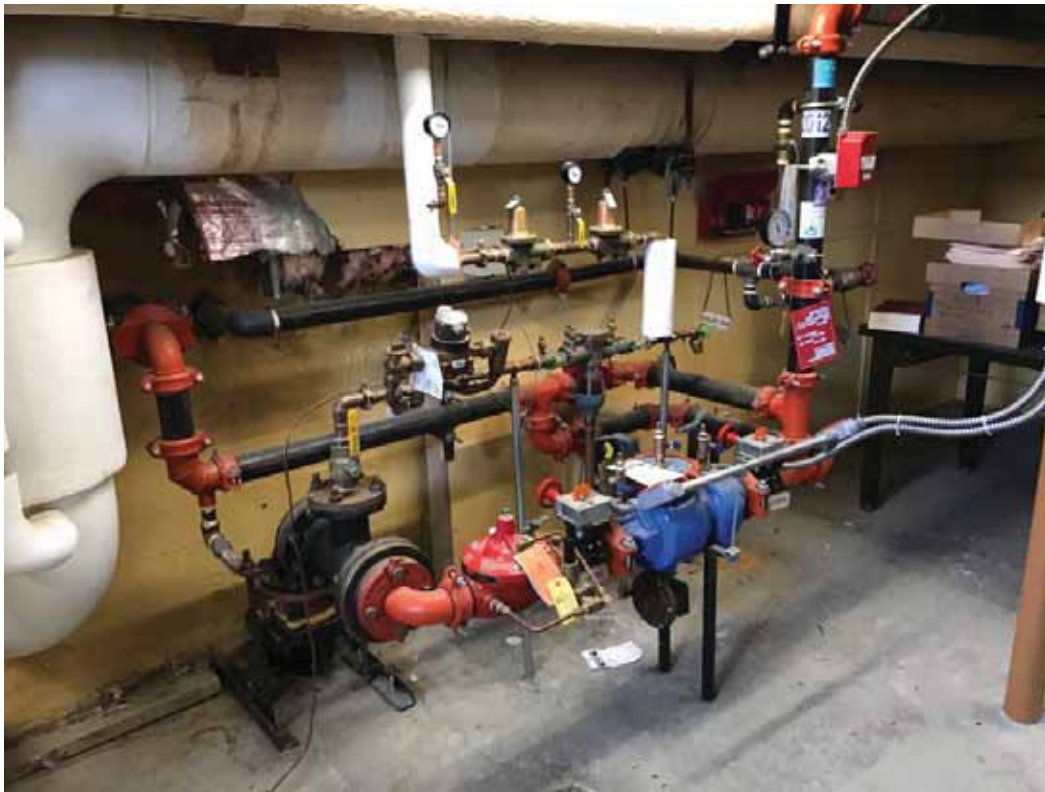
Figure 25: Basement sprinkler riser

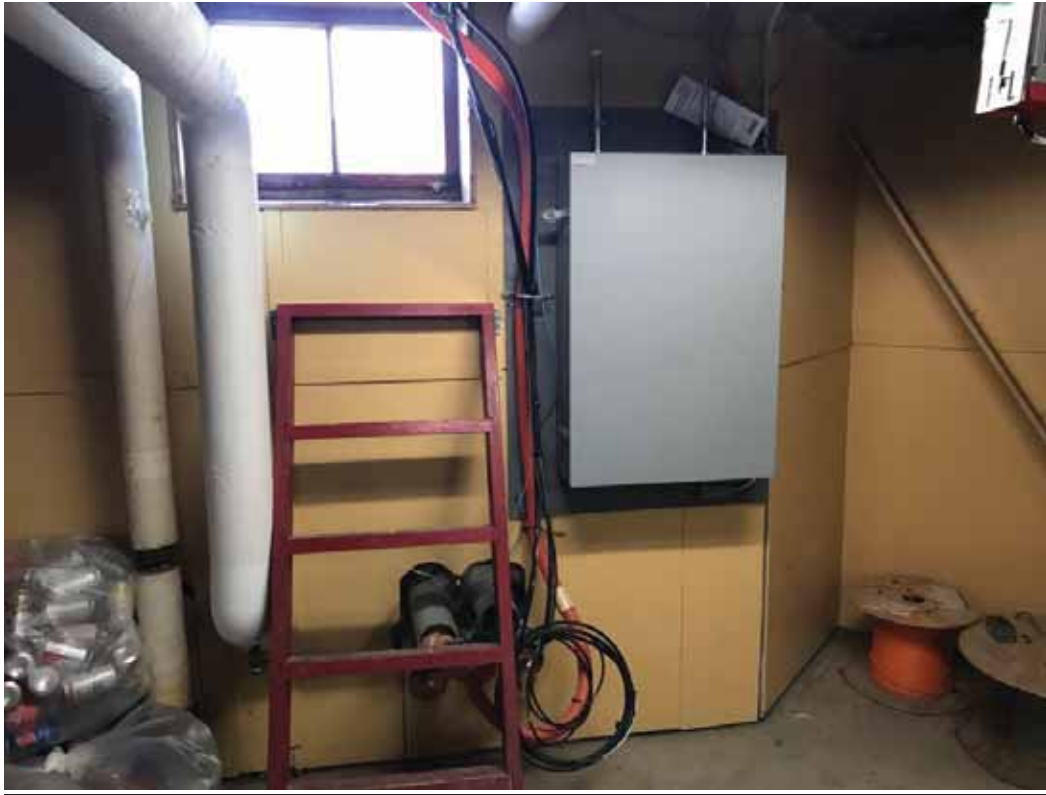
Figure 26: Basement fiber-optic and electrical panel

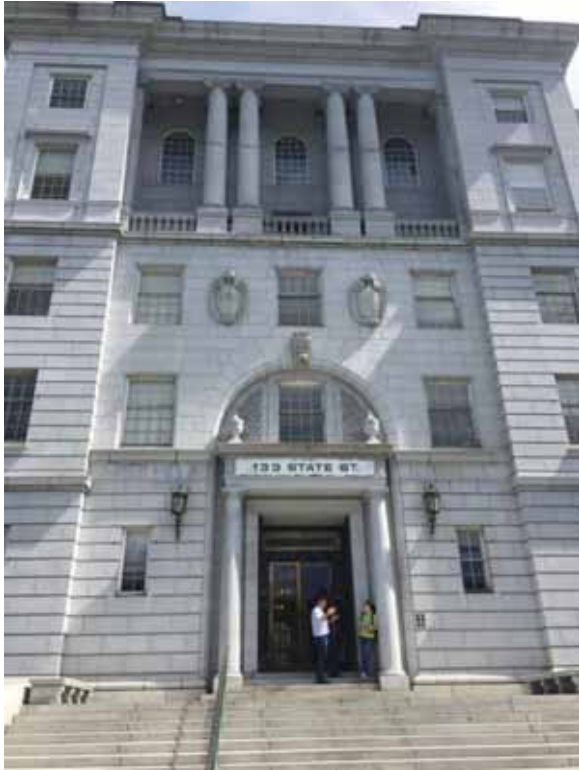
Figure 5: South façade and main entrance

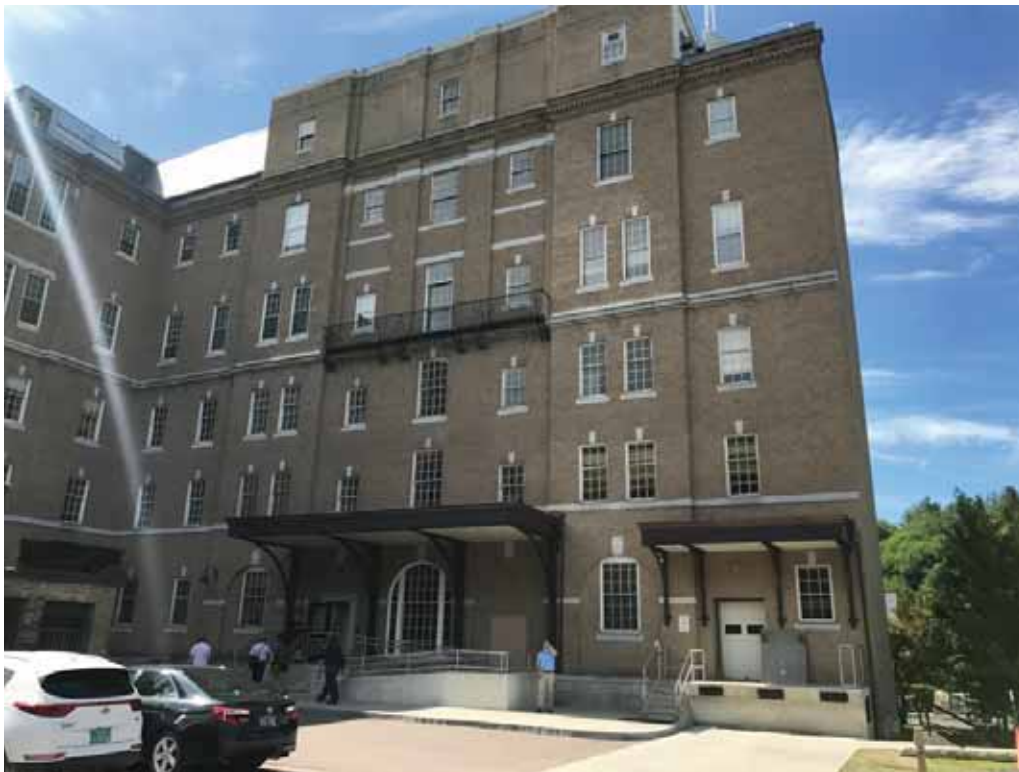
Figure 6: North façade and rear entrance

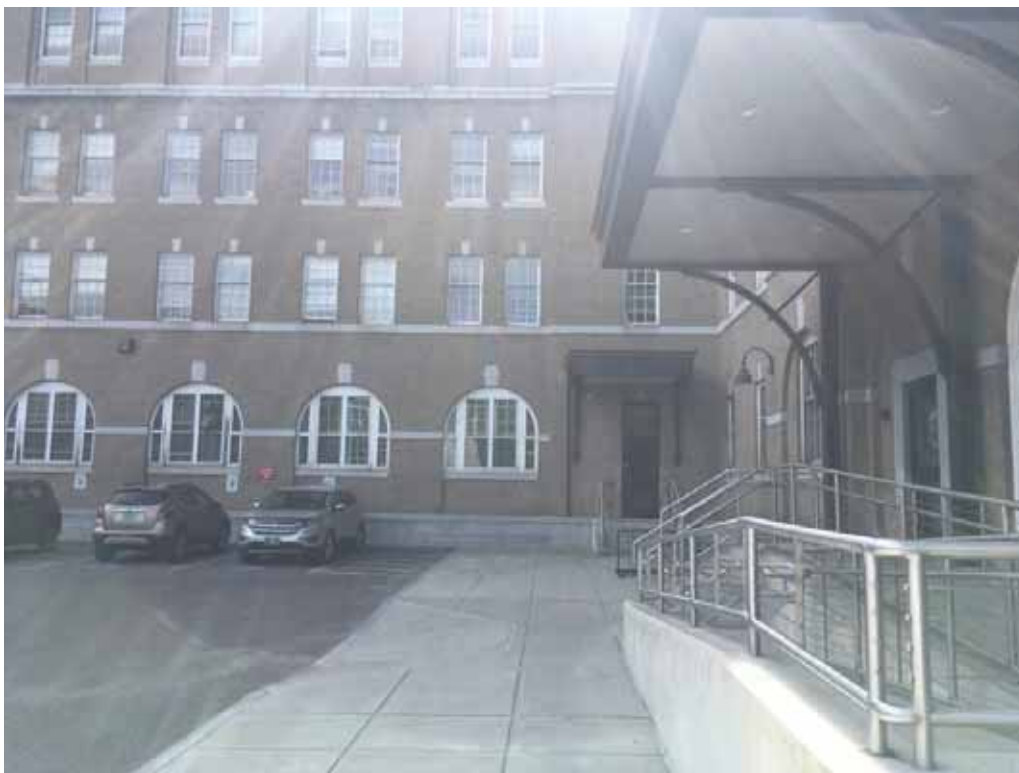
Figure 8: North and west façades

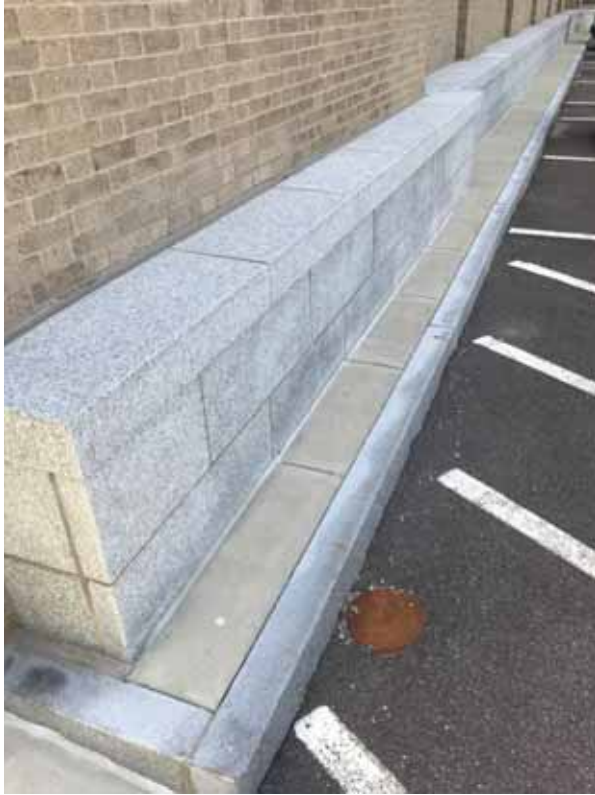
Figure 9: West exterior wall granite base course (appears to be of newer construction)

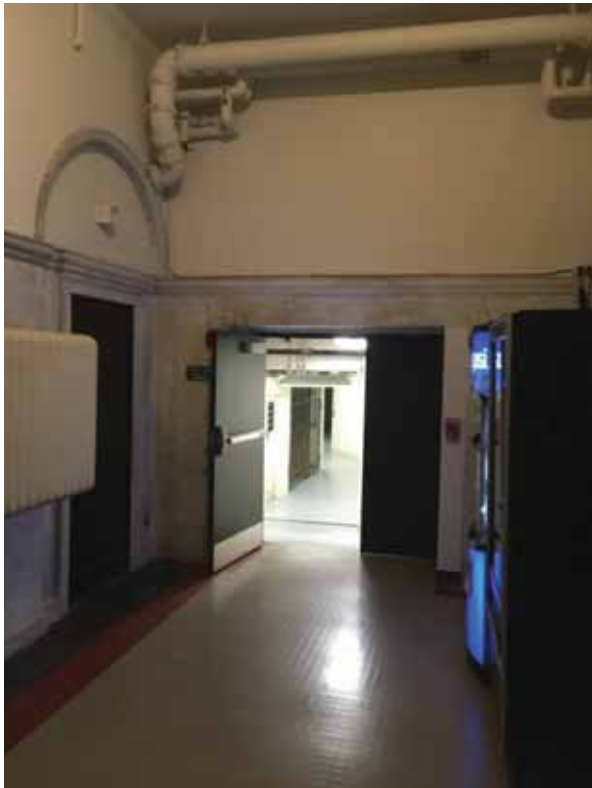
Figure 10: Basement floor looking towards tunnel and access to sub-basement

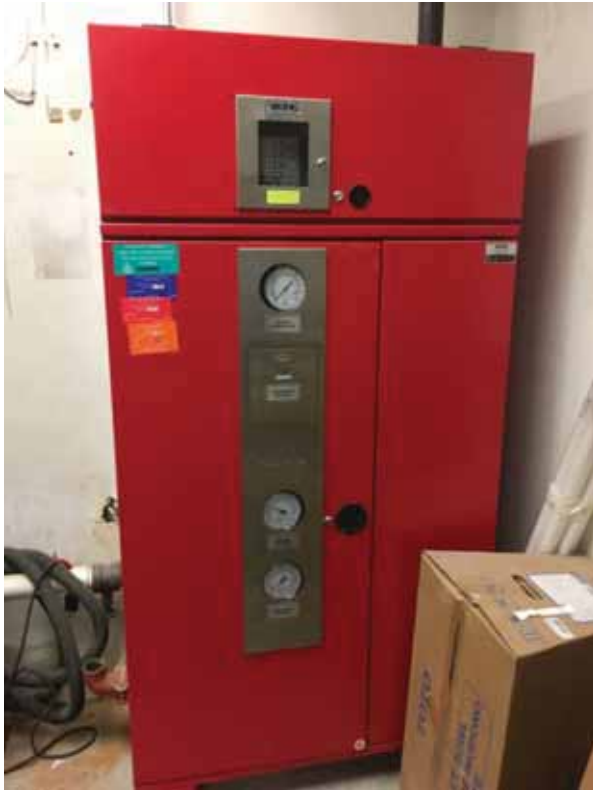
Figure 11: Basement level fire safety equipment

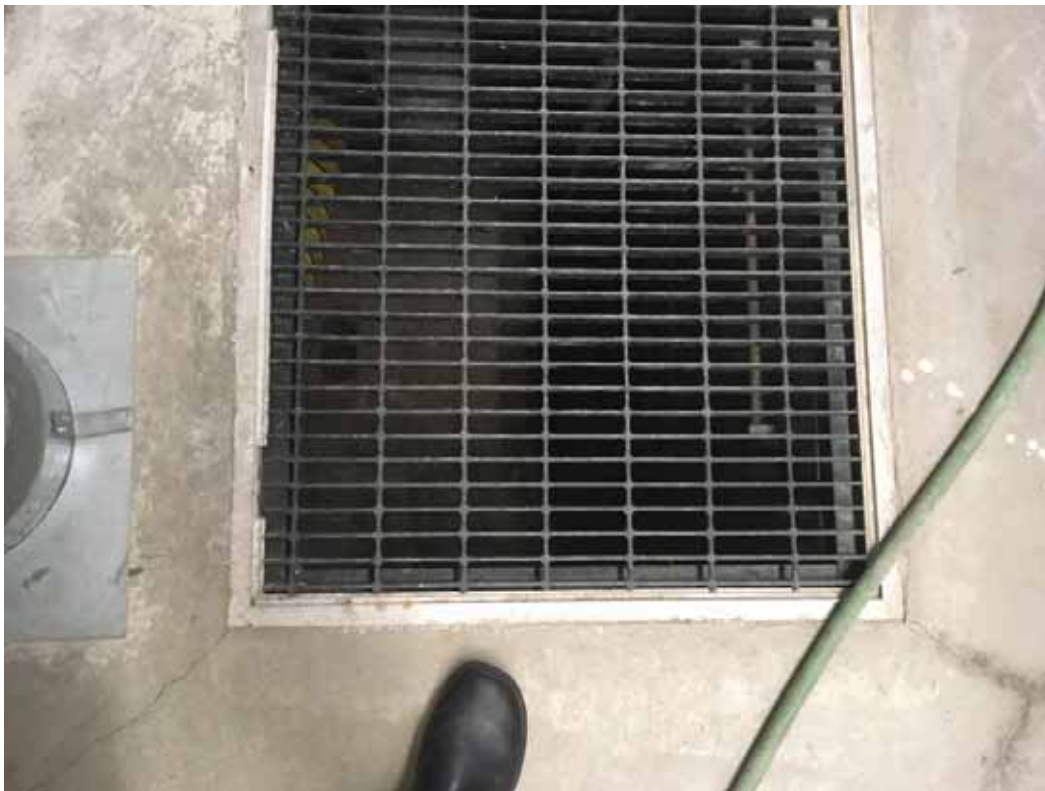
Figure 12: Sub-basement floor access grate to lower areaway(s)

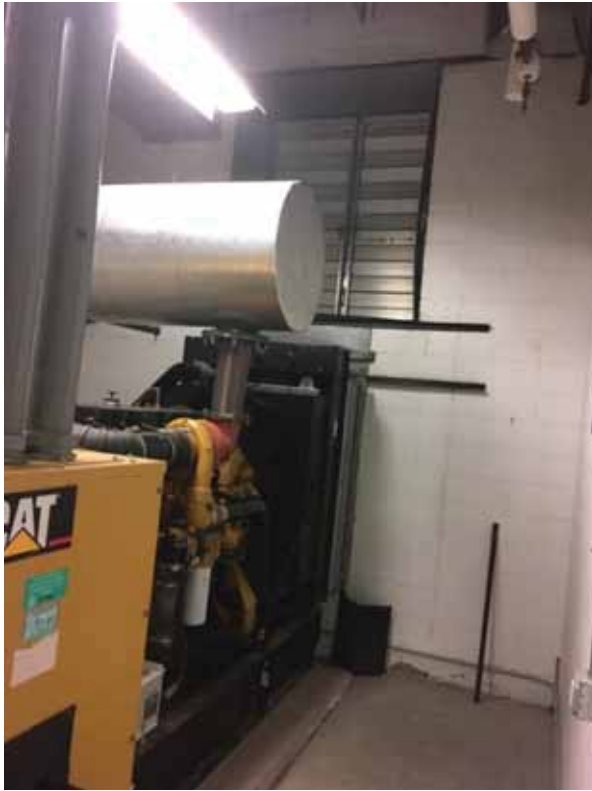
Figure 13: Sub-basement emergency generator

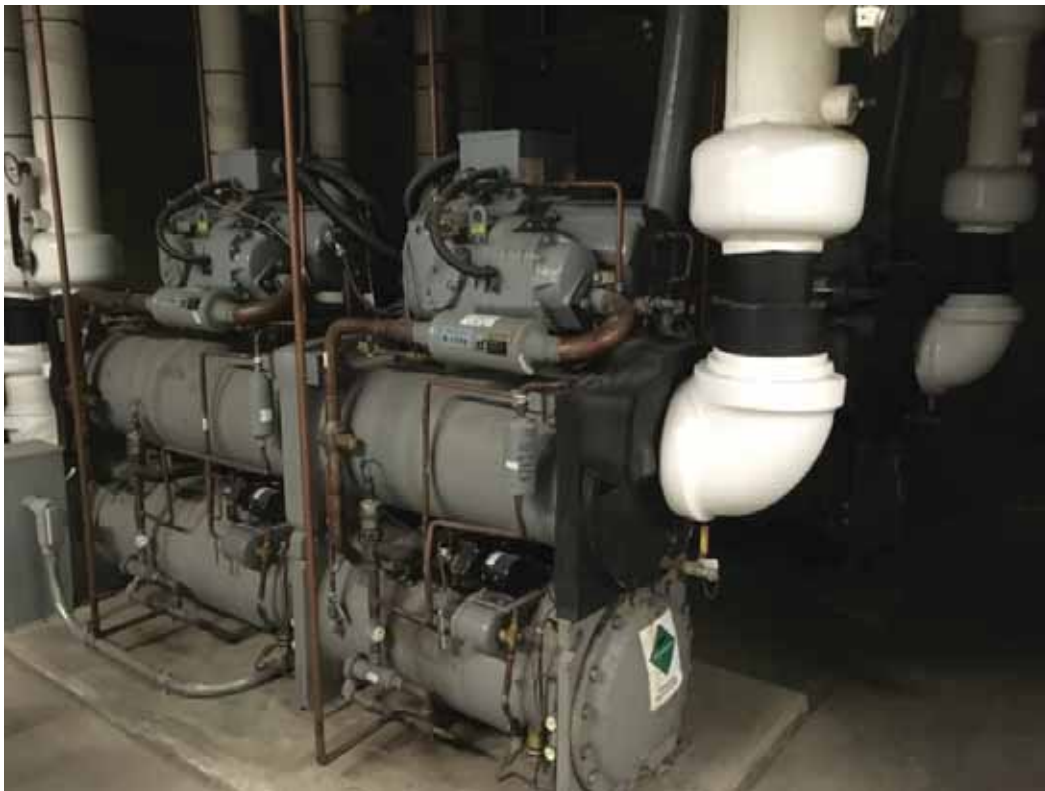
Figure 14: Sub-basement steam piping

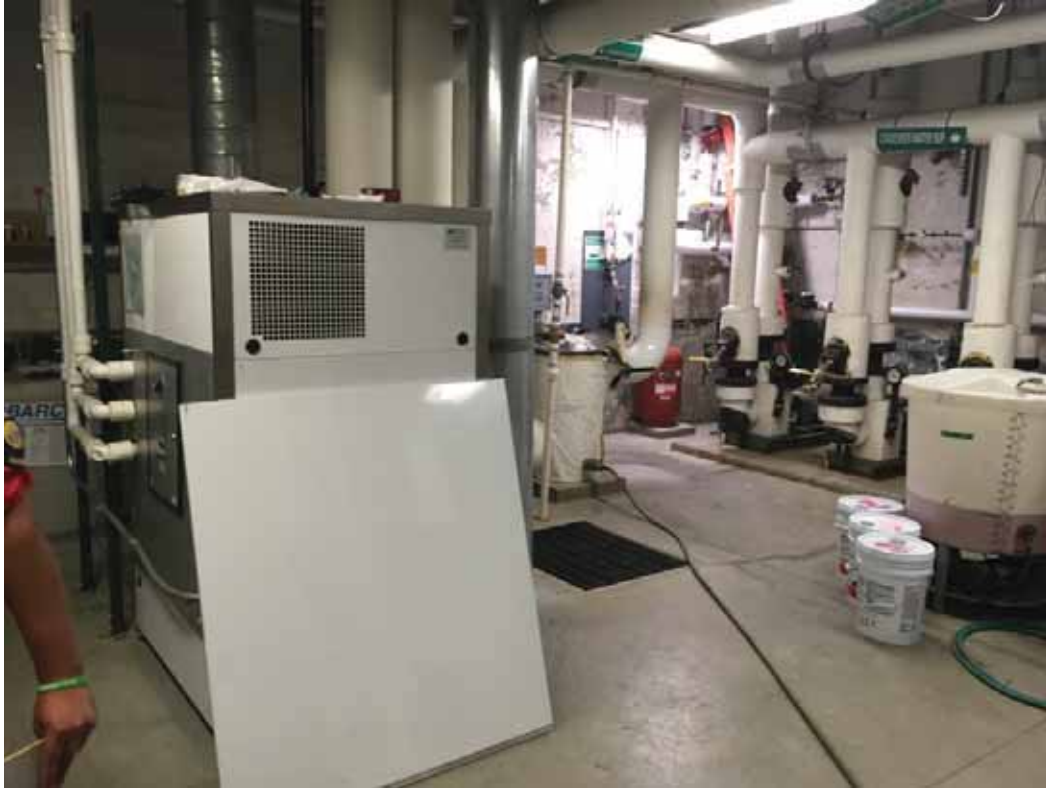
Figure 15: Sub-basement mechanicals and steam

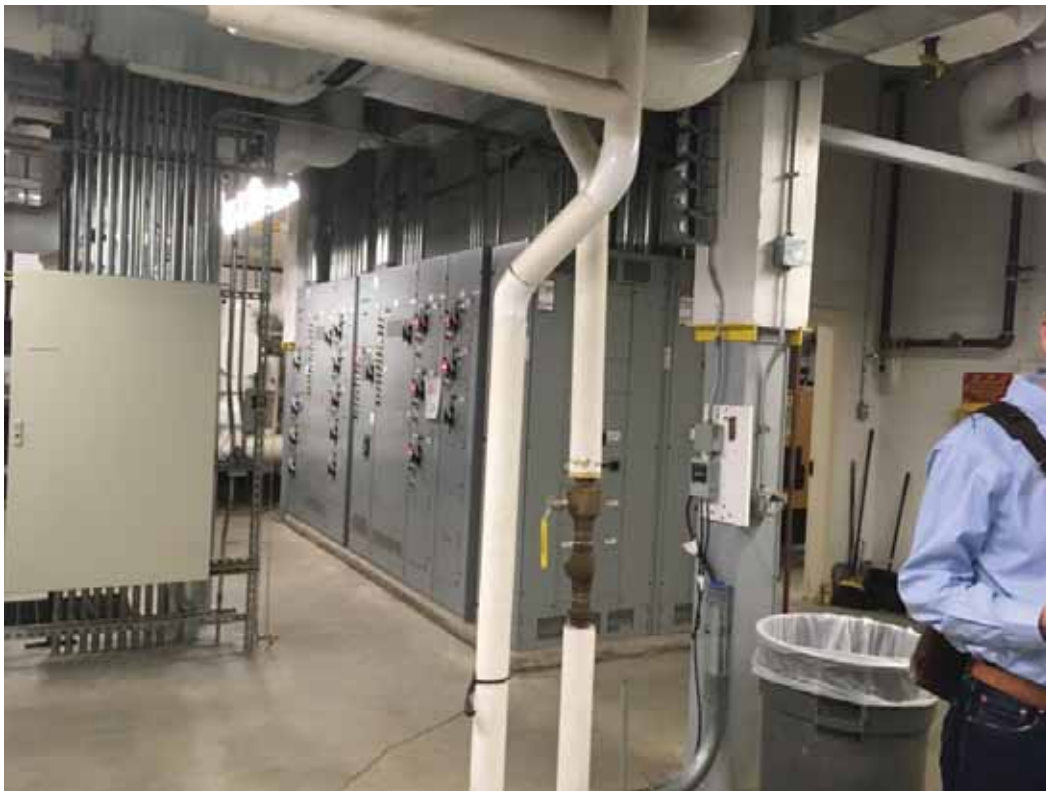
Figure 16: Sub-basement electrical panels

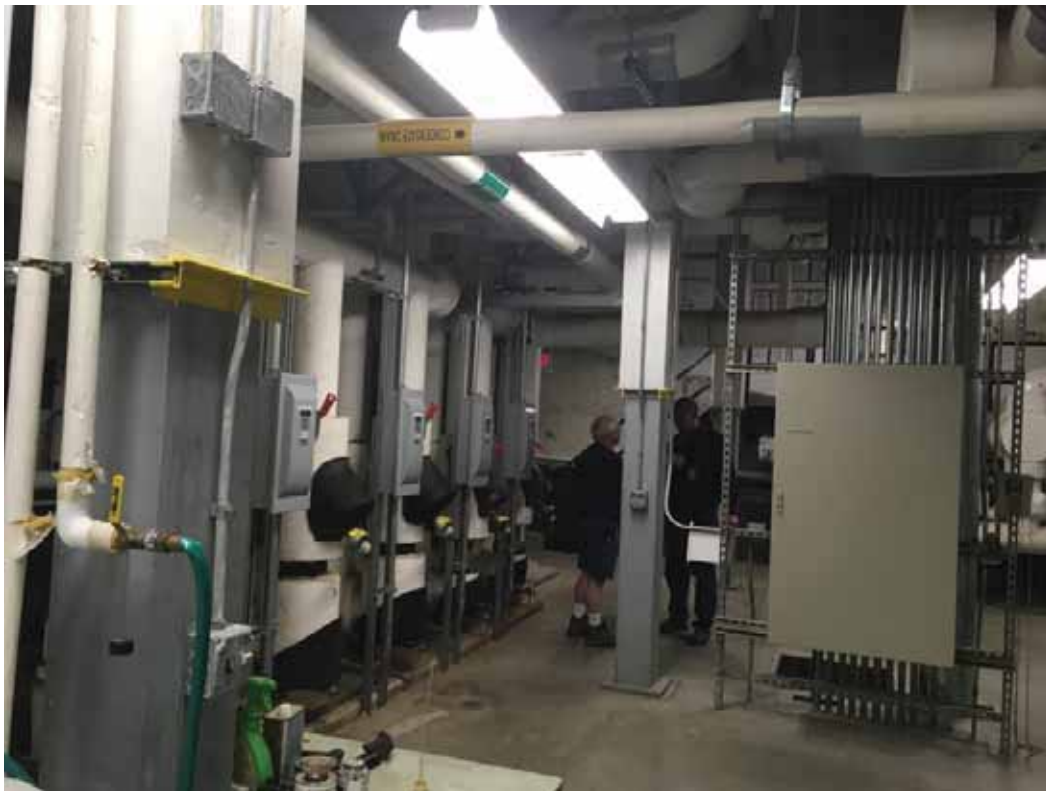
Figure 17: Sub-basement electrical panels

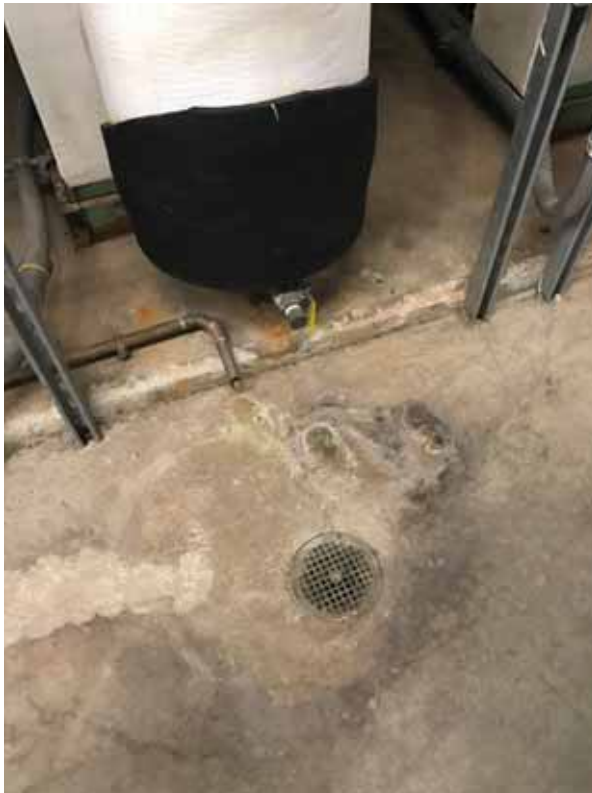
Figure 19: Sub-basement sump

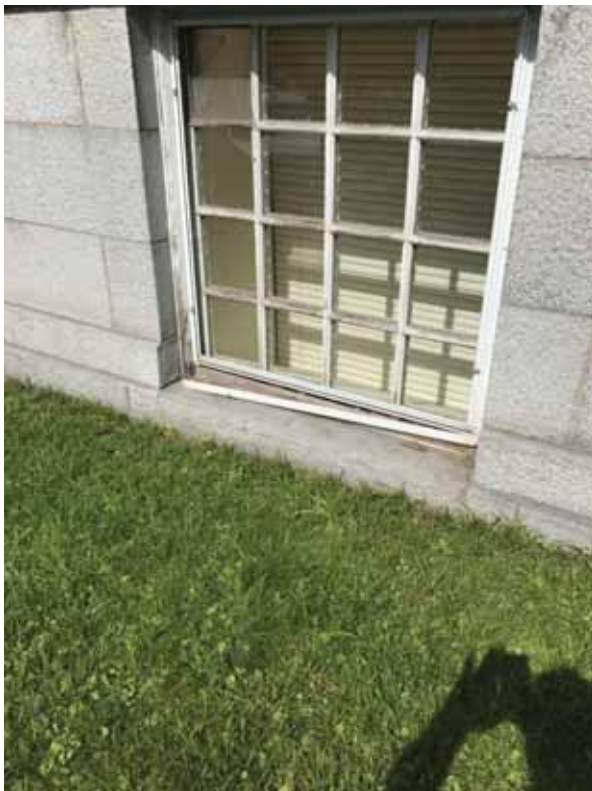
Figure 25: Basement windows at building perimeter (east façade)

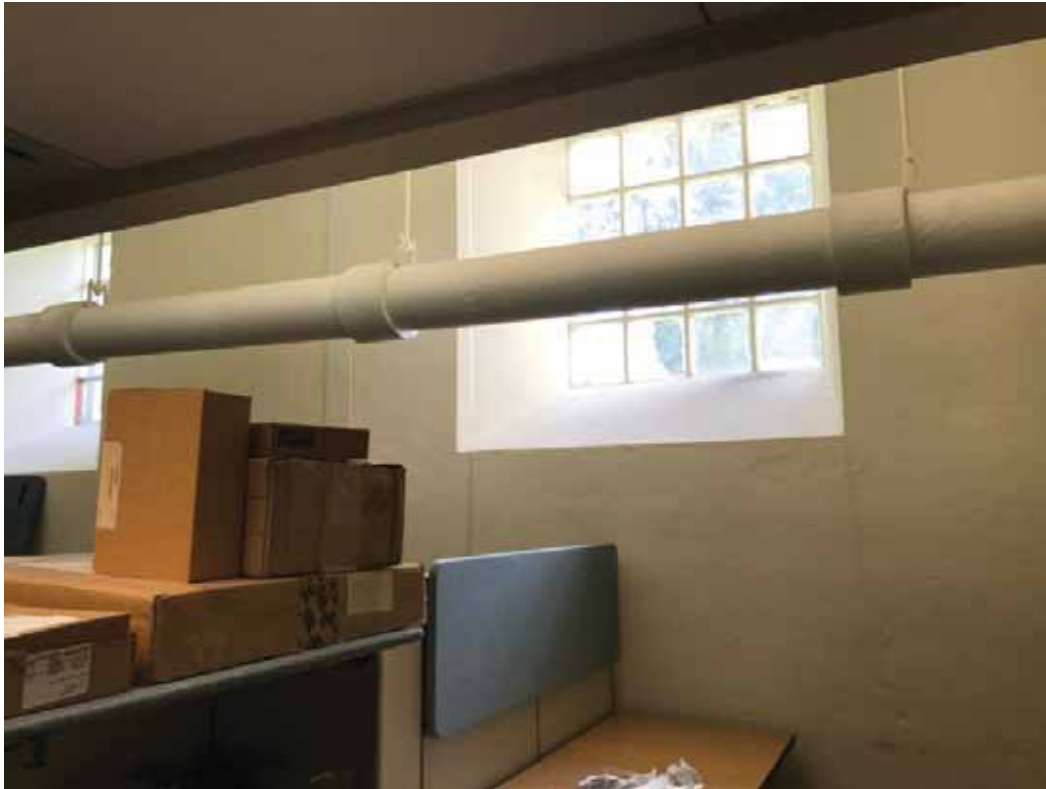
Figure 32: Basement-level office space adjacent to perimeter basement windows

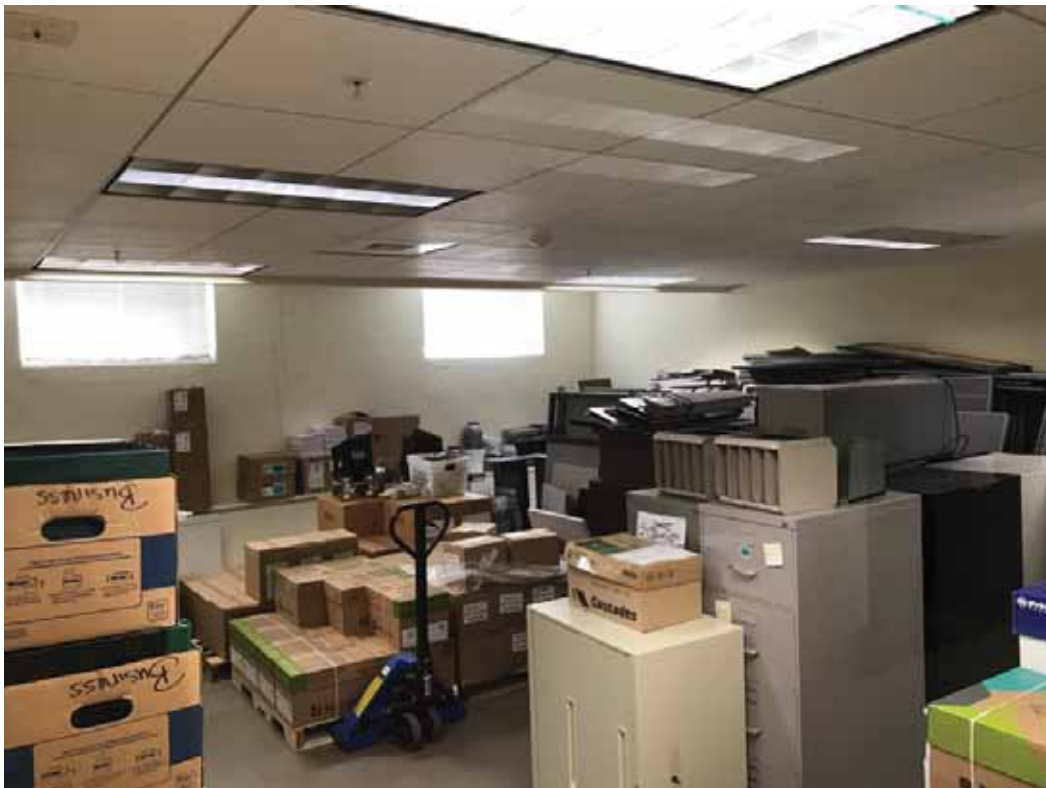
Figure 33: Basement-level office space and storage adjacent to perimeter basement windows

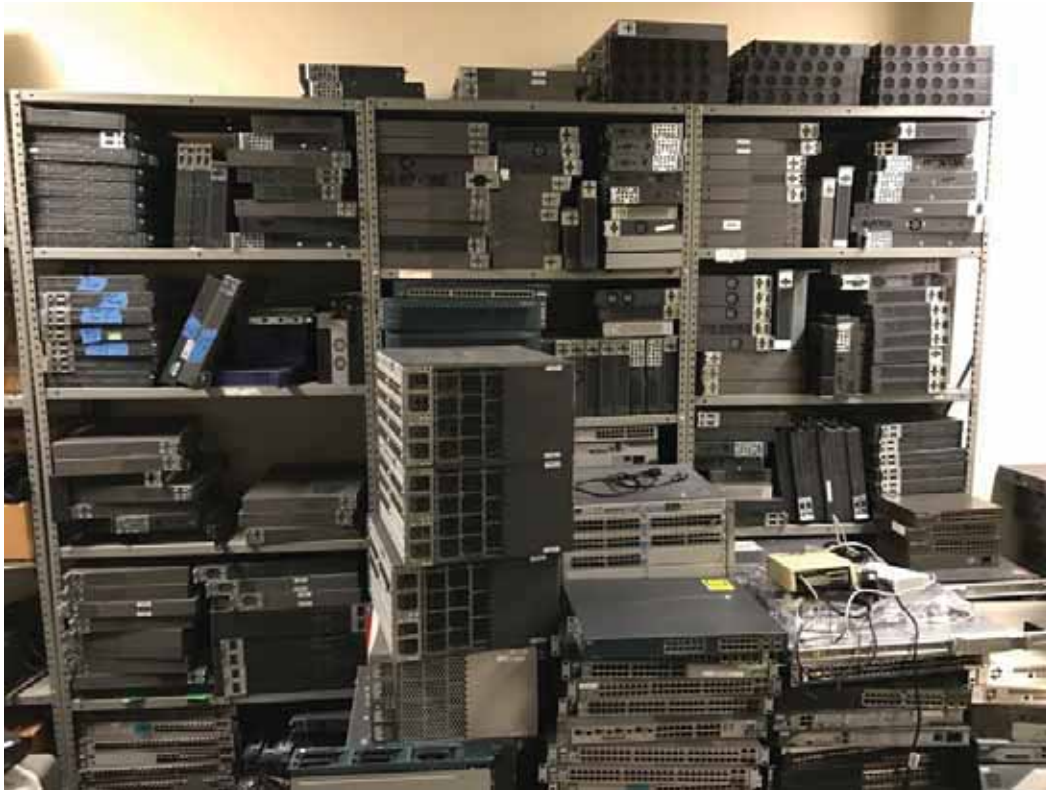
Figure 34: Basement-level office supply storage adjacent to perimeter basement windows

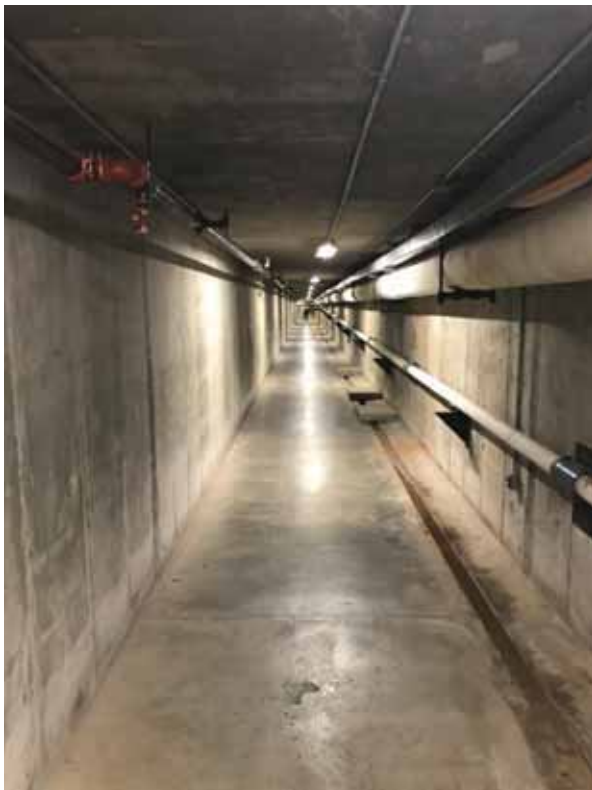
Figure 37: Pre-existing basement-level water damage observed in areas

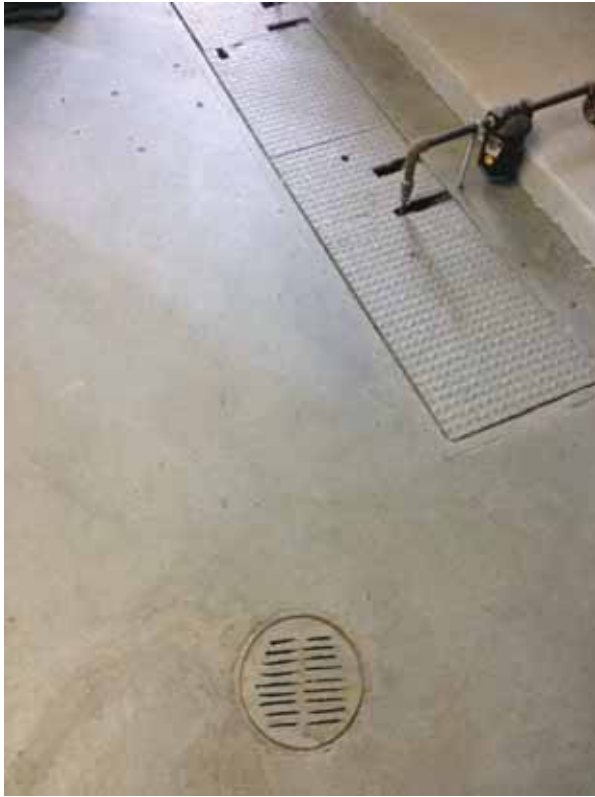
Plumbing assembly

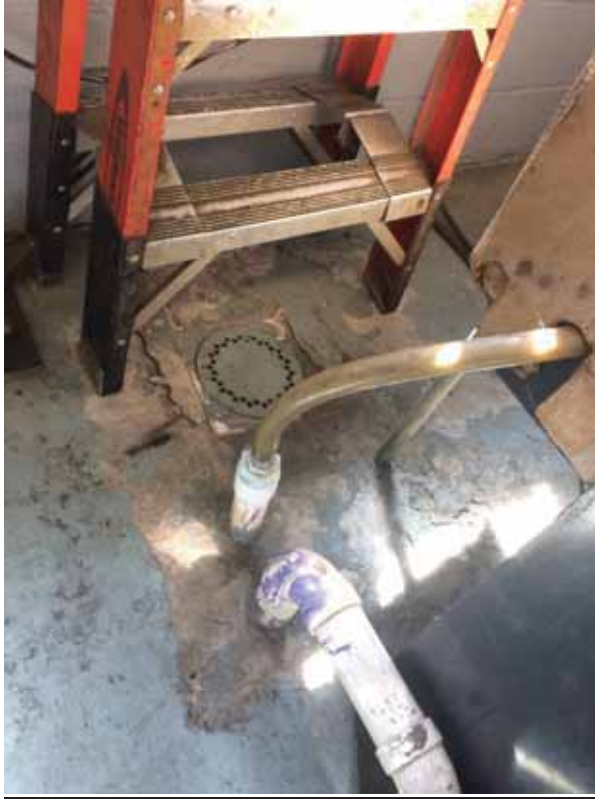
Floor drain and piping

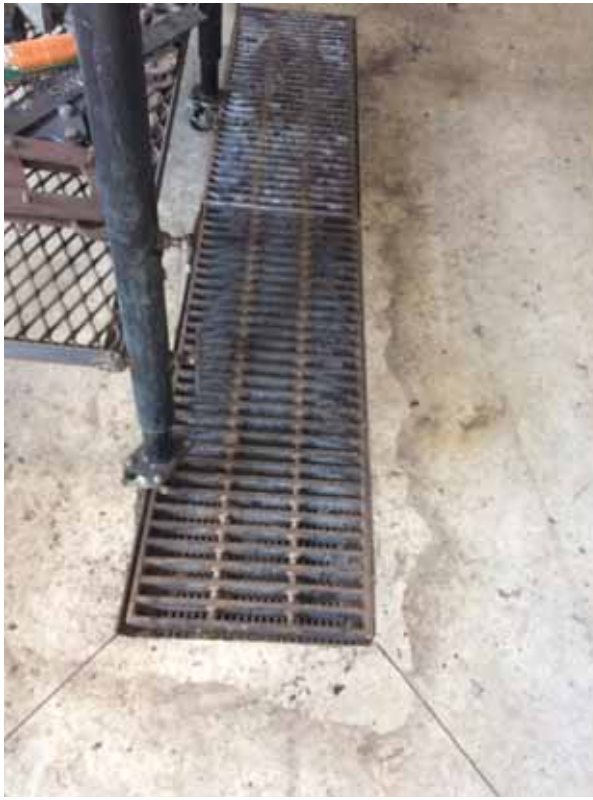
Floor trench drain
