Appendix - Section 3 - State & Local Capabilities Supplemental

Building Prioritization: Methodology

BGS Subgrant Project - Priority Building Assessment

BUILDING ASSESSMENT FORM

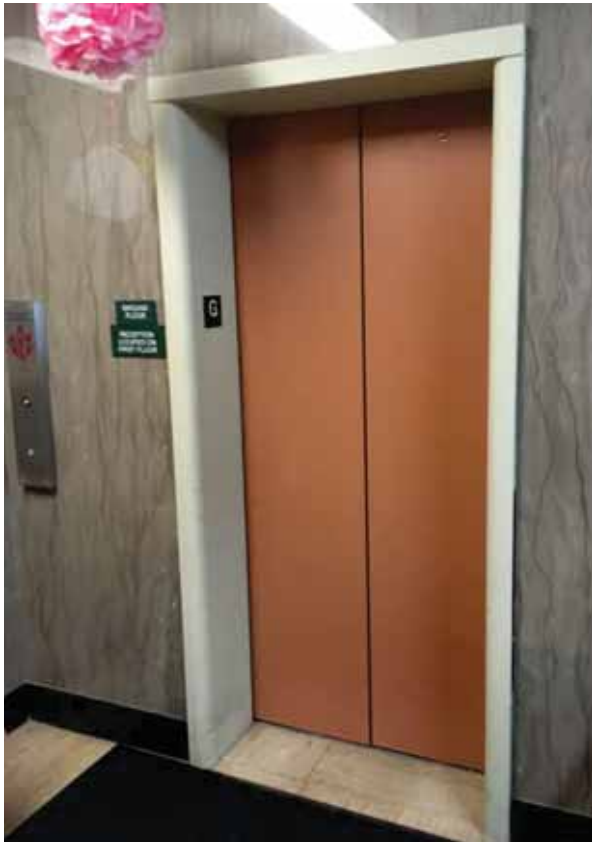
Figure 8: Elevator

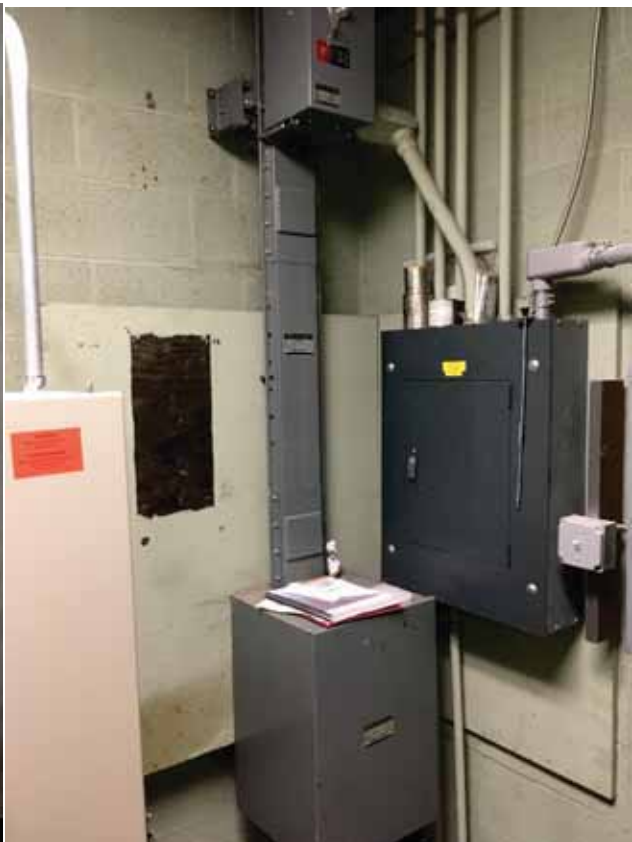
Figure 9: EMR equipment

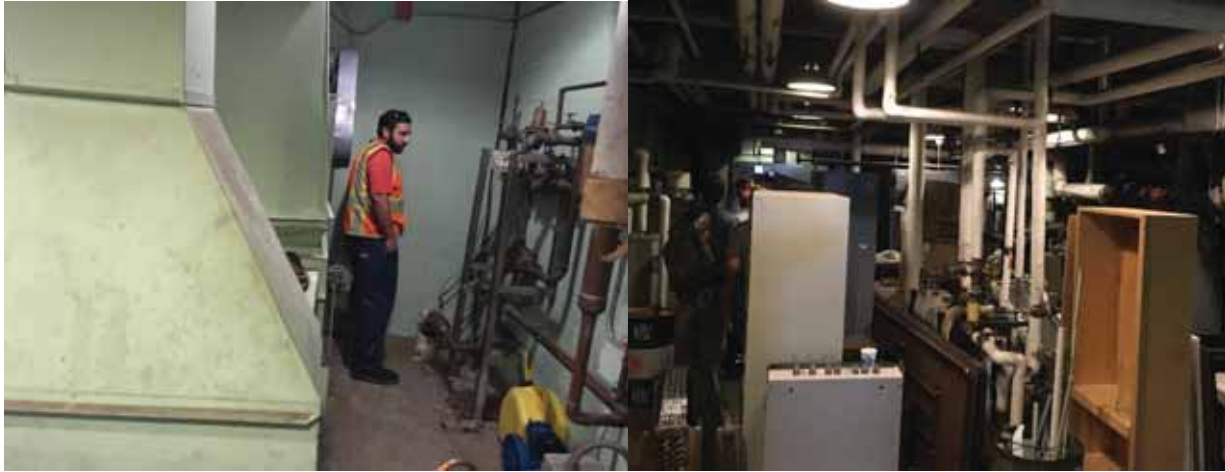
Figure 13 & 14: Mechanical rooms

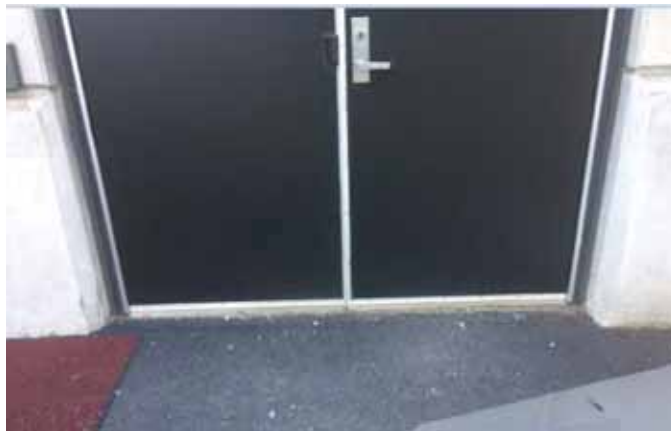
Figure 8: Exterior doors.

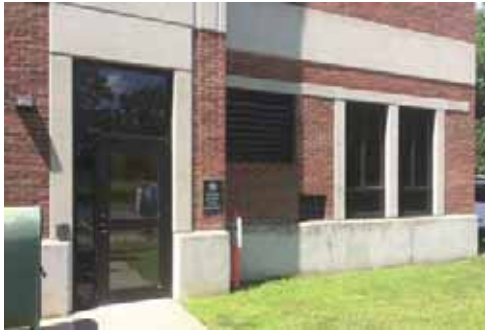
Figure 9: Exterior doors/ windows/ vents.

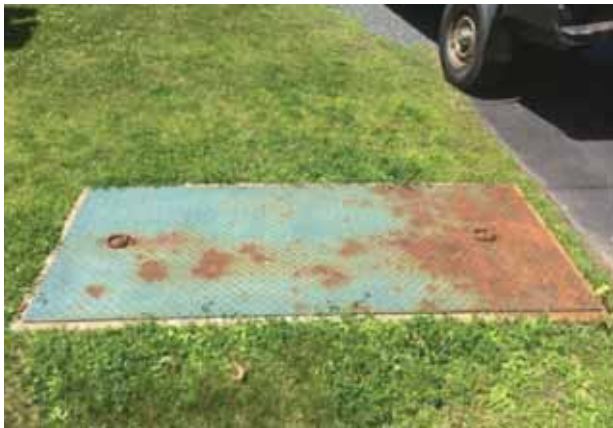
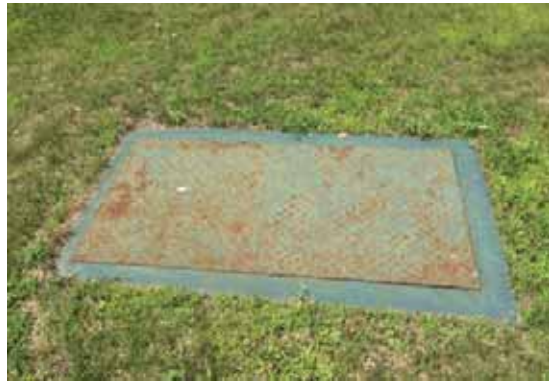
Figure 10 & 11: At-grade access panels on site, contents unknown.

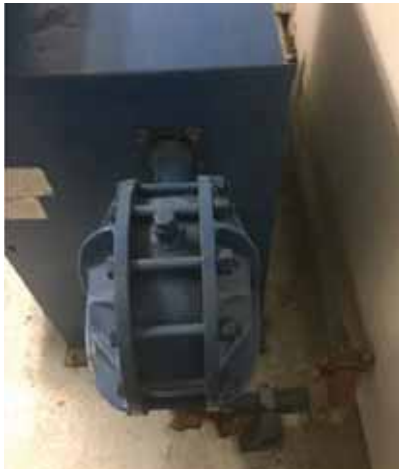
Figure 16: Emergency Generator

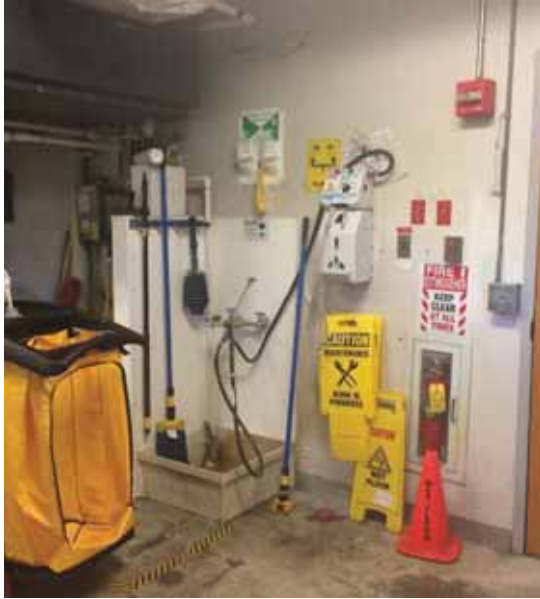
Figure 18: Custodial room.

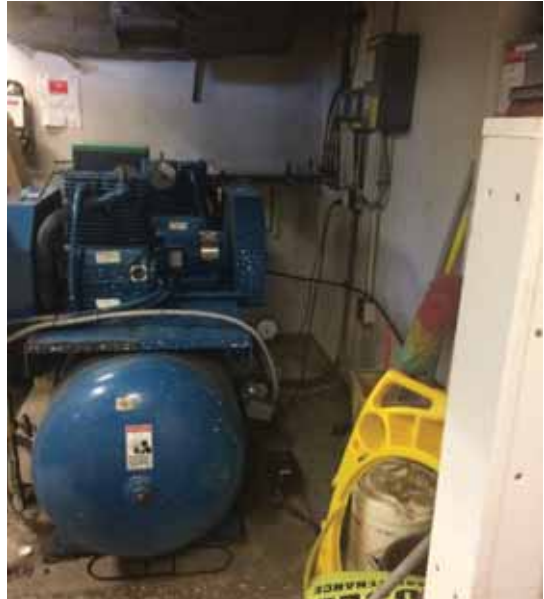
Figure 19: Compressor.

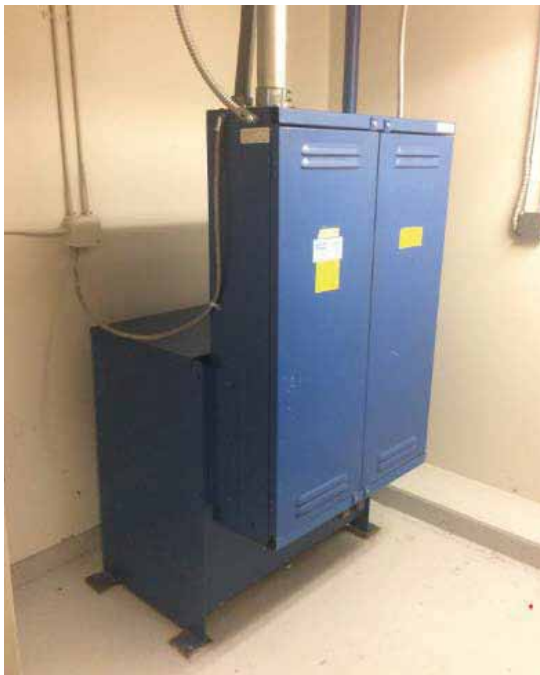
Figure 20: Elevator equipment.

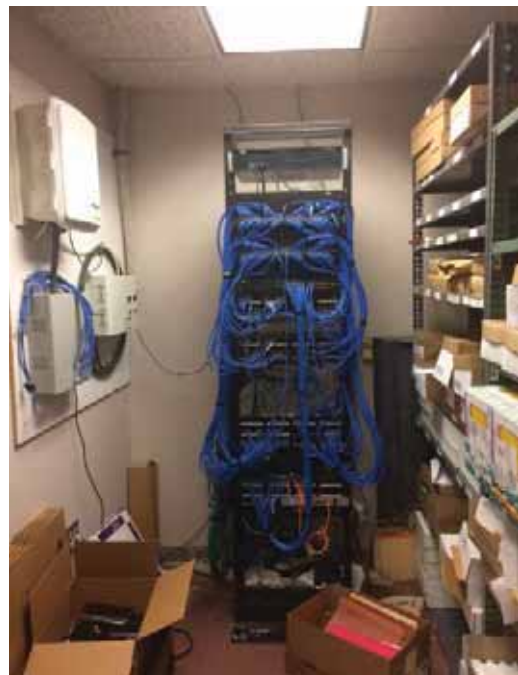
Figure 21: Network Server Room

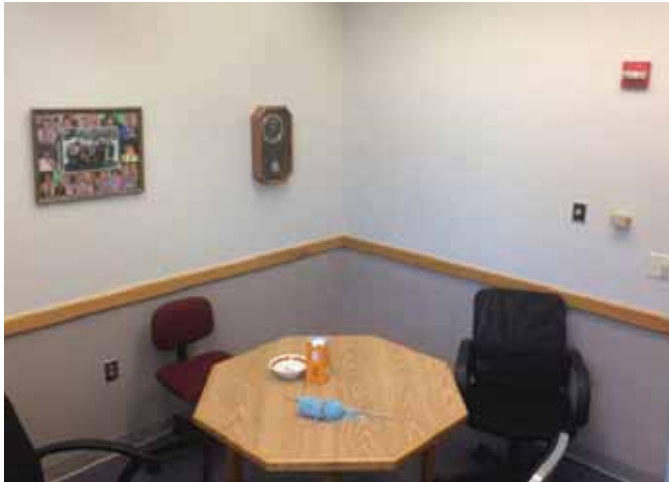
Figure 22: Conference Room Finishes

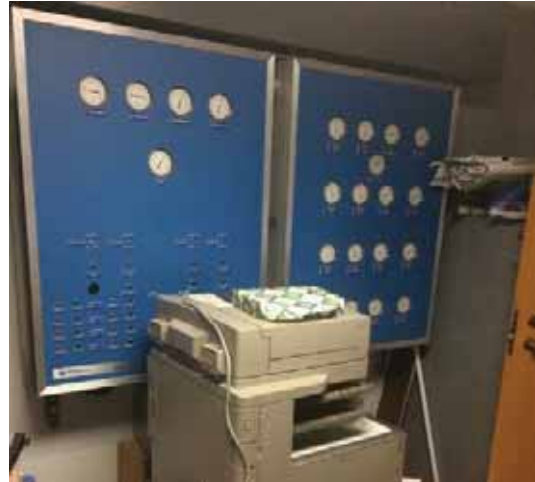
Figure 23: Control Panels

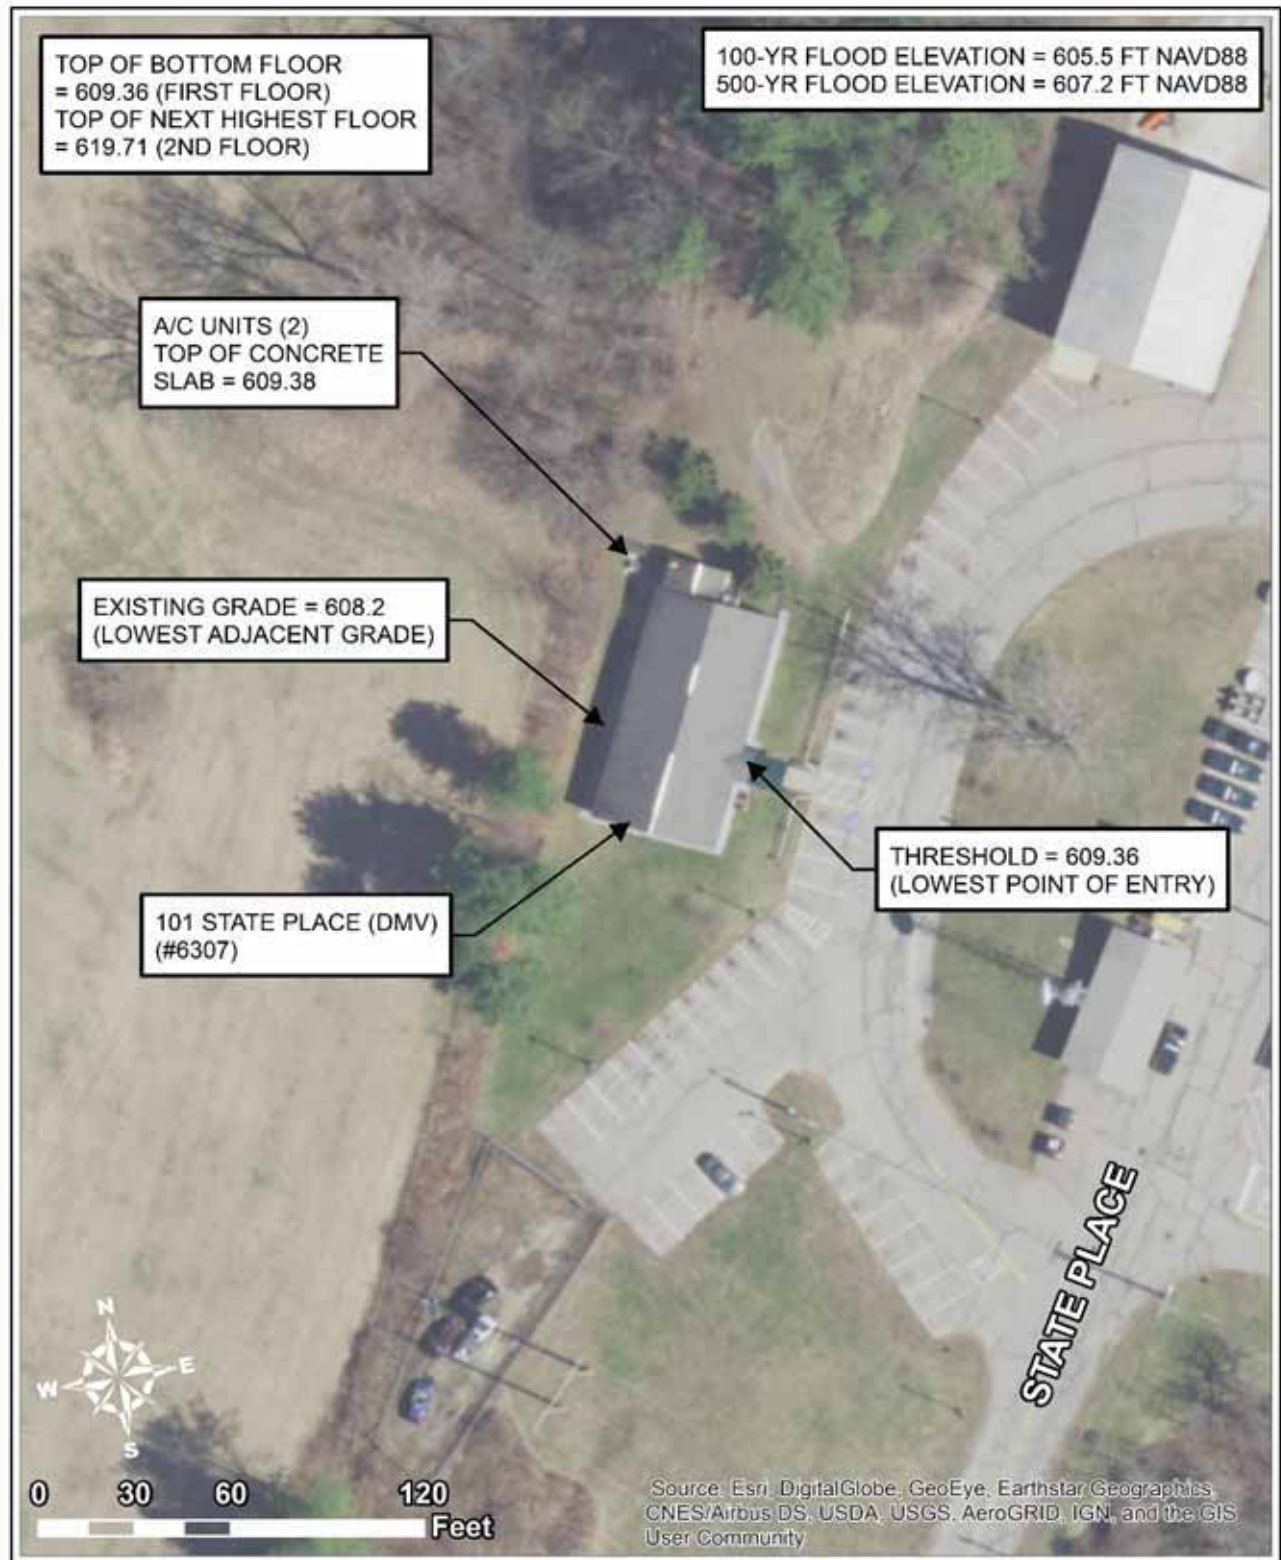
Figure 3: Lowest Point of Entry (1in = 60 ft, elevations reference NAVD 88 vertical datum)

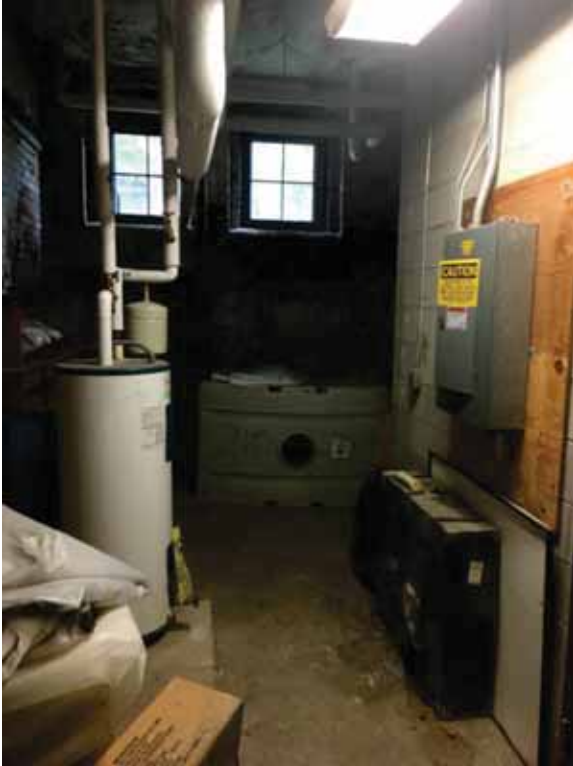
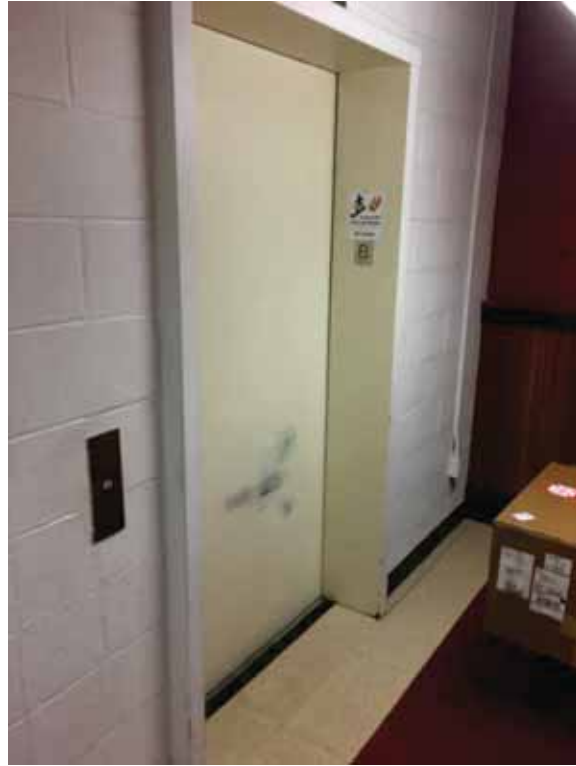
Figure 10 & 11: Basement mechanical and elevator

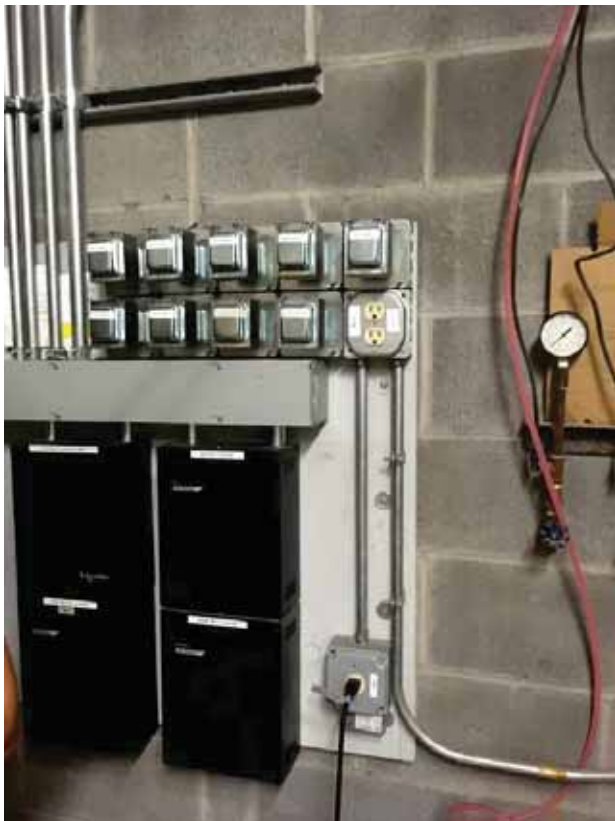
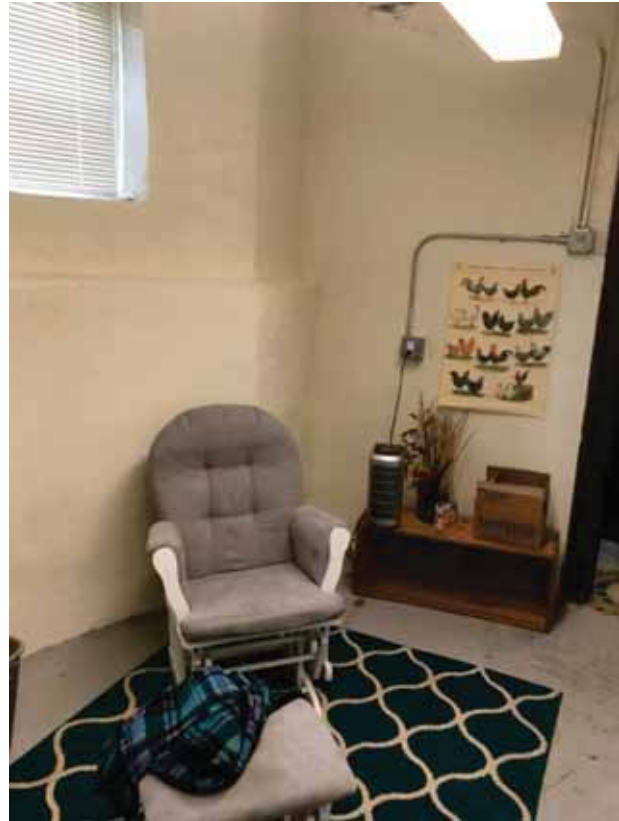
Figure 12 & 13: Basement electrical and seating space

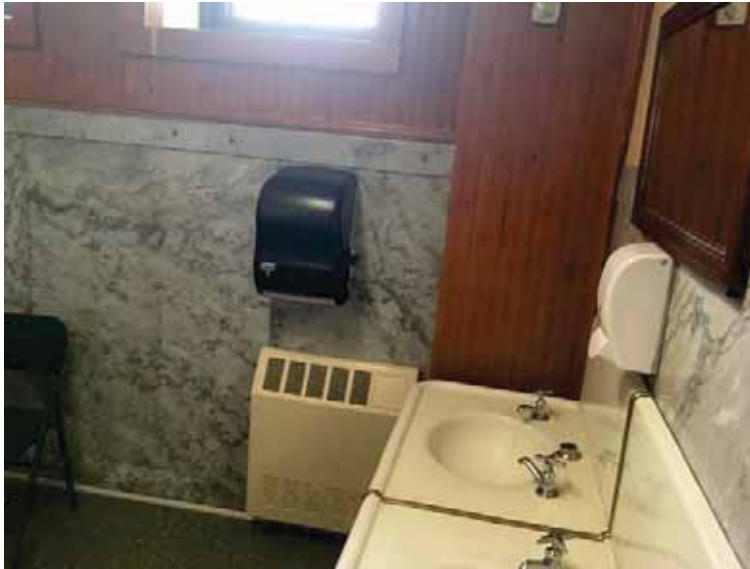
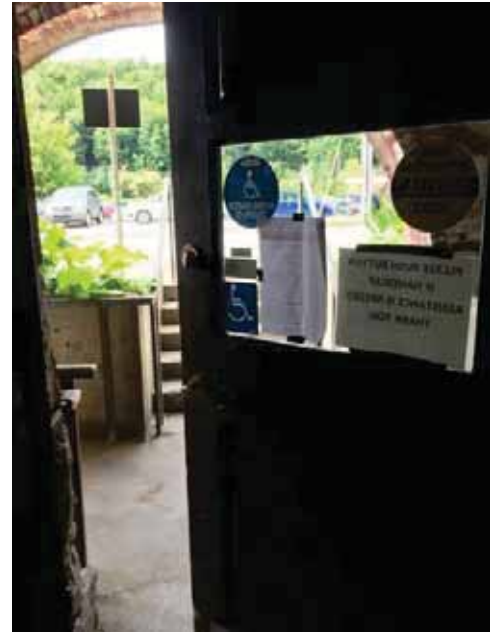
Figure 14 & 15: Basement restroom and recessed entry

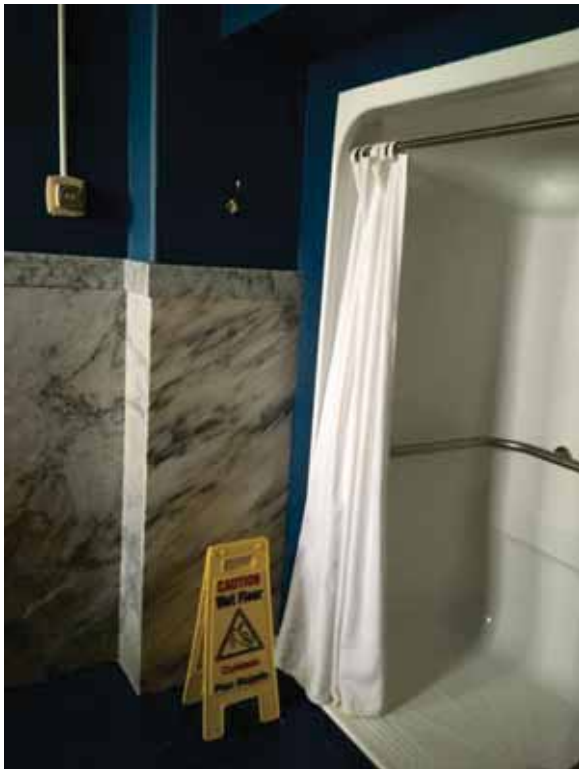
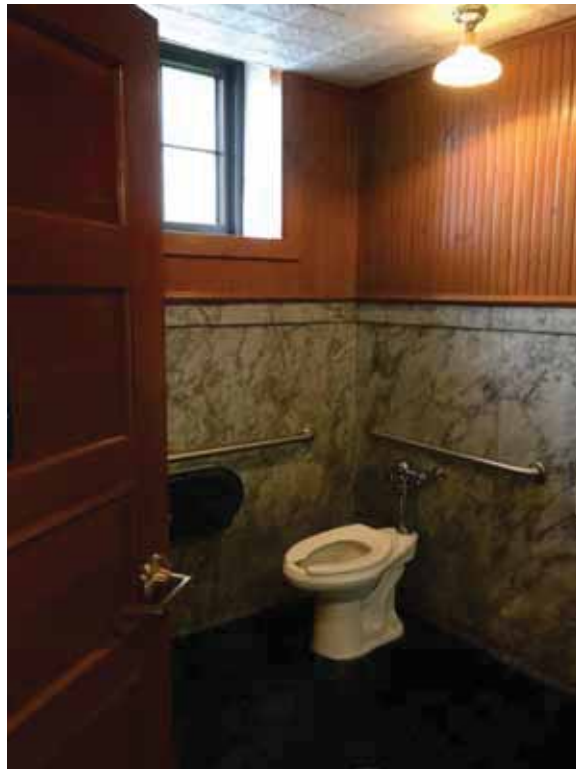
Figure 16 & 17: Basement shower and restroom

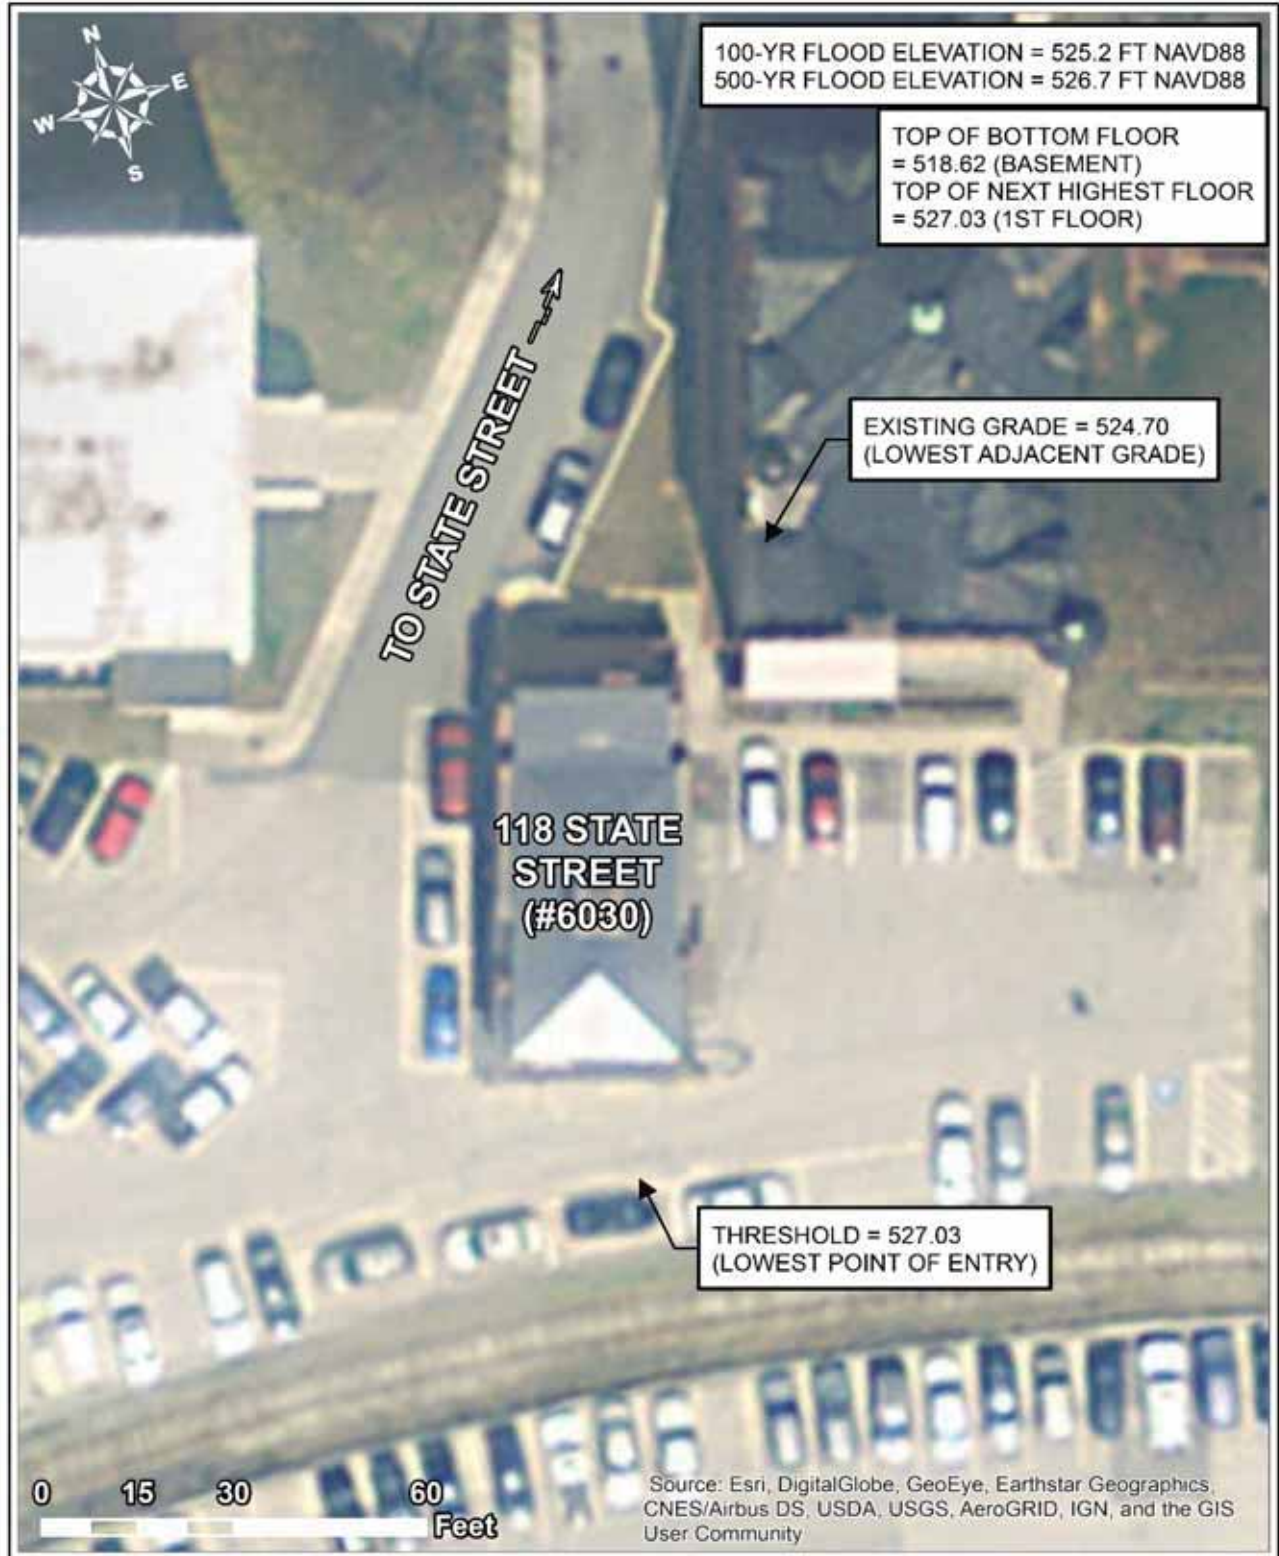
Figure 3: Lowest Point of Entry (1in = 30 ft, elevations reference NAVD 88 vertical datum)

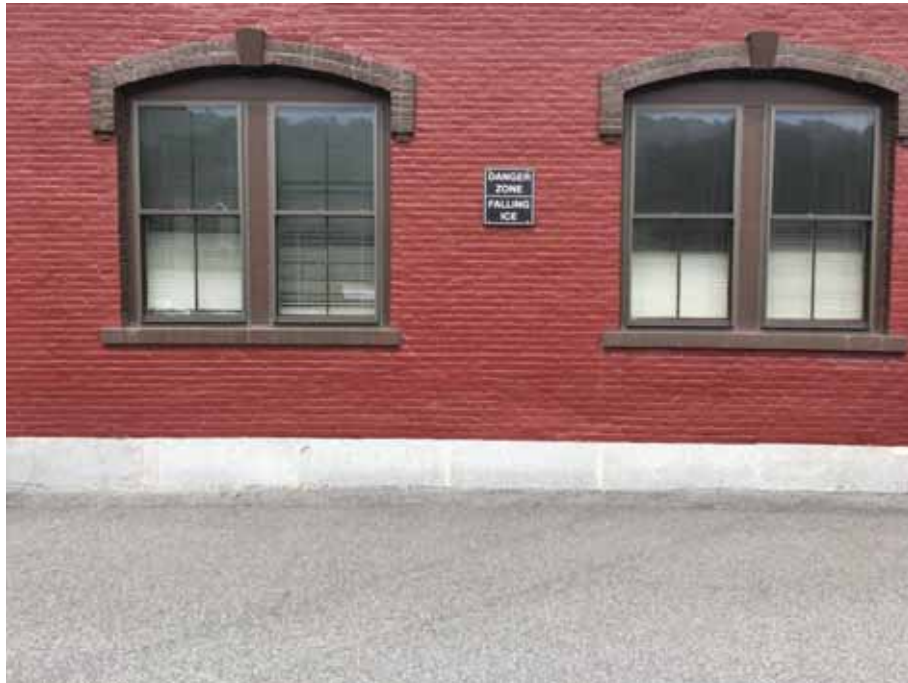
Figure 6: West Elevation

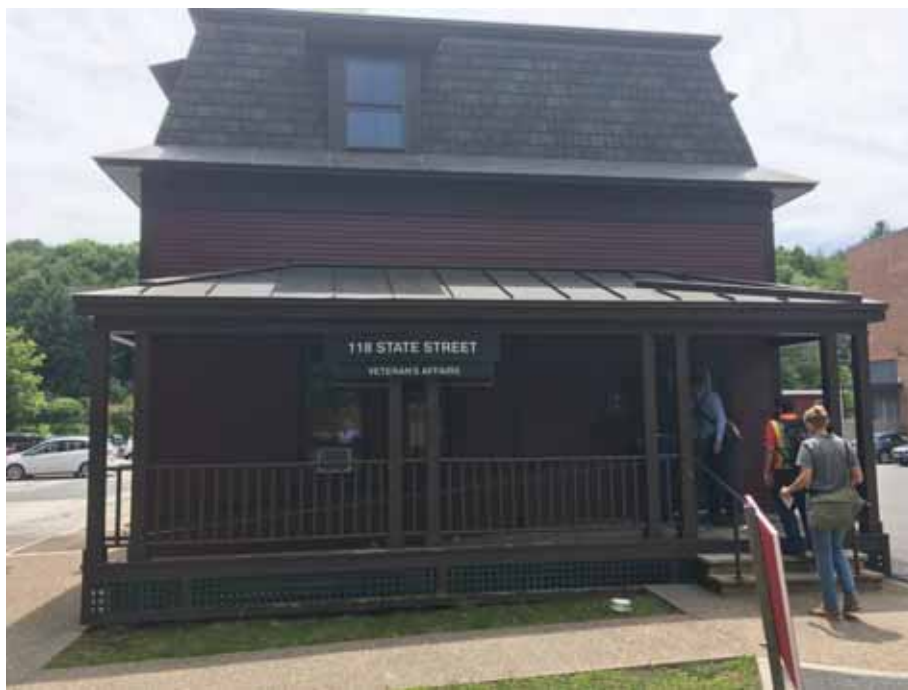
Figure 7: North Elevation

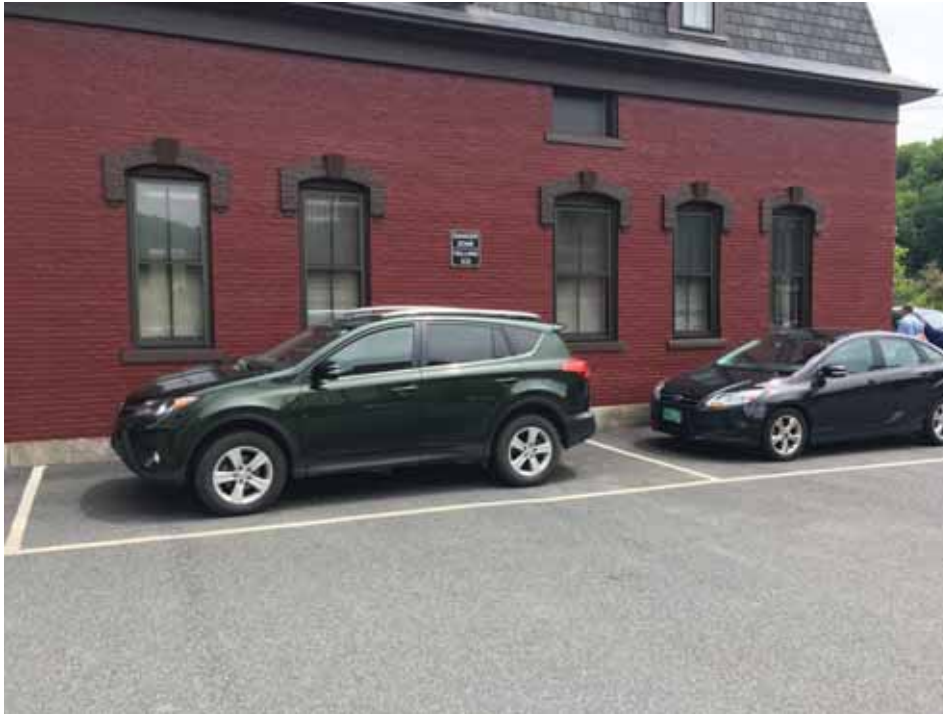
Figure 8: West Elevation

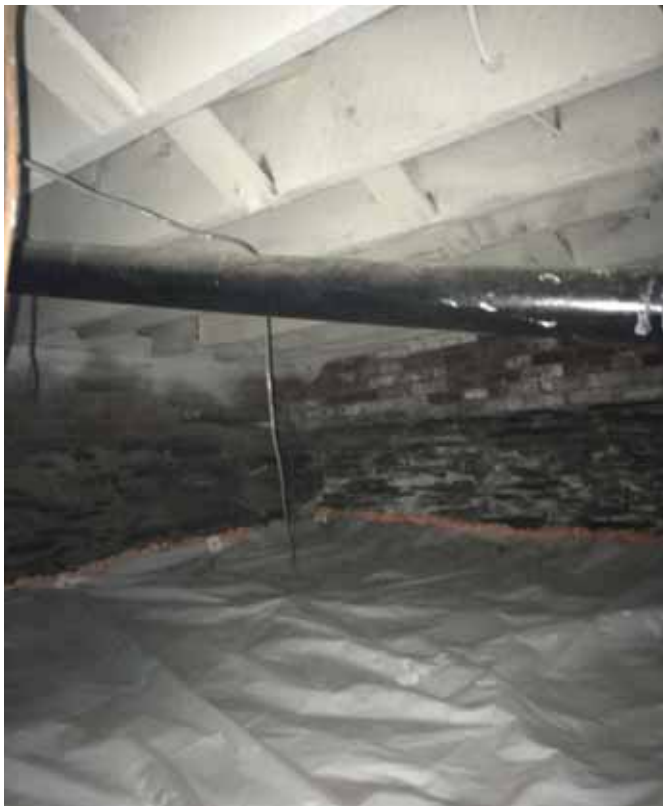
Figure 9: Crawl Space

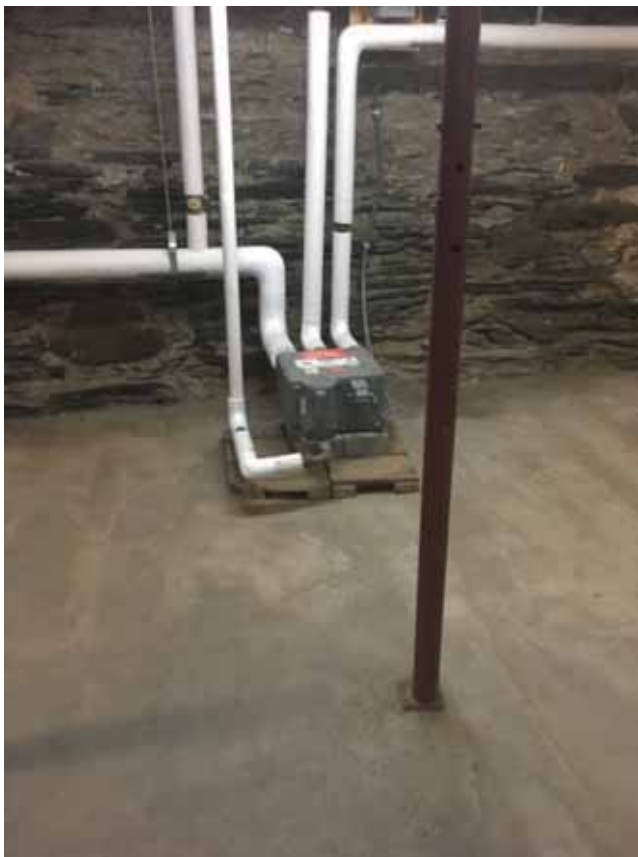
Figure 11: Basement Steam

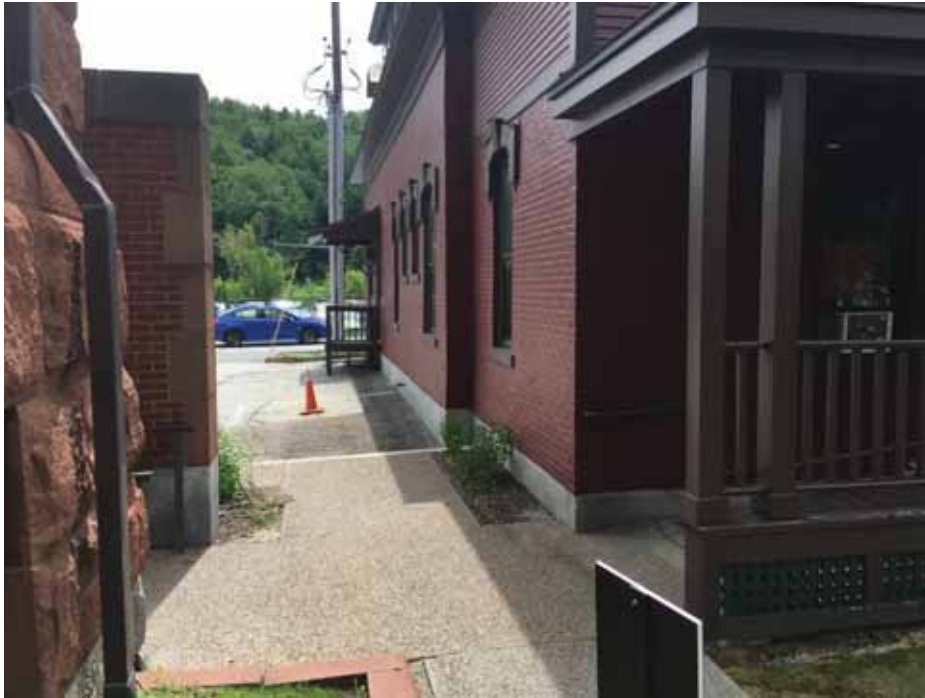
Figure 12: East elevation

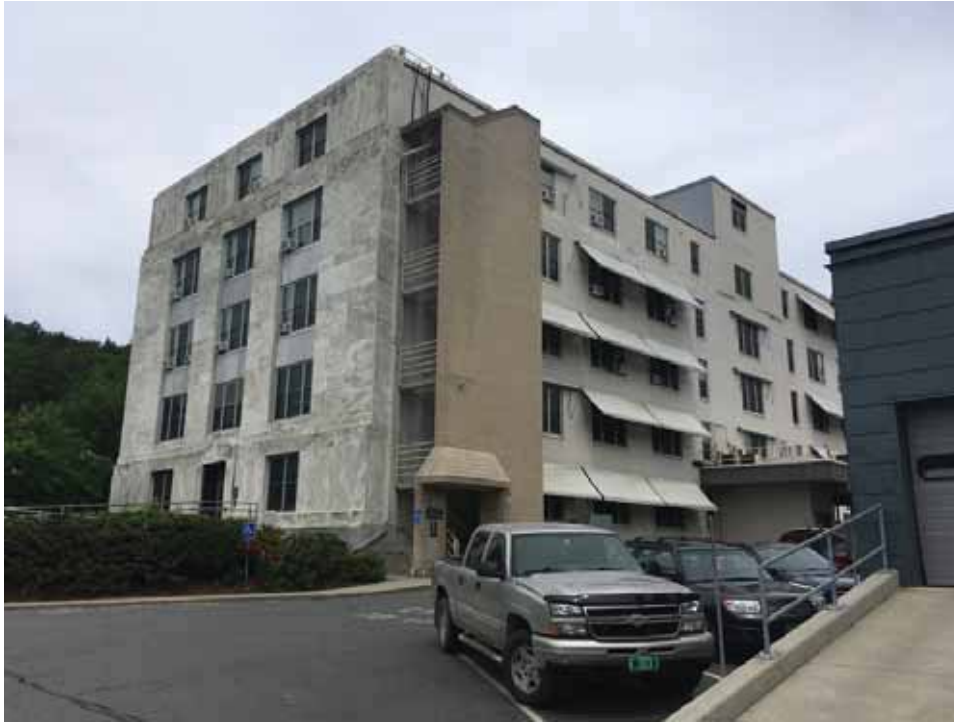
Figure 6: West and south façades

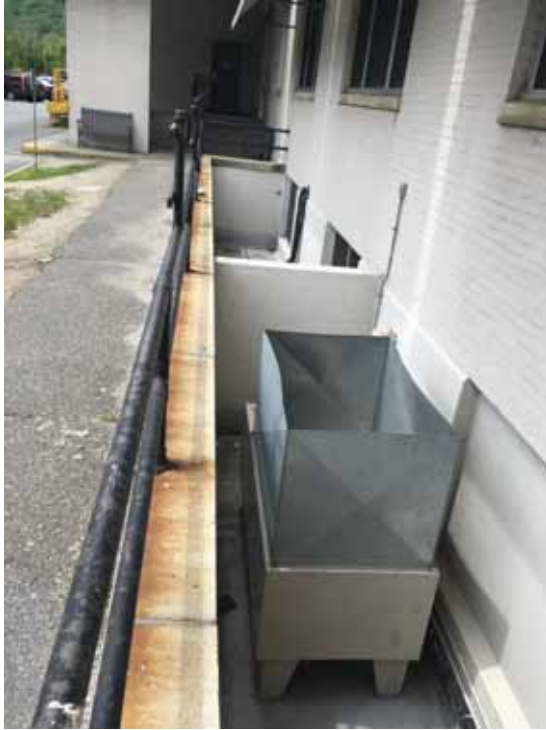
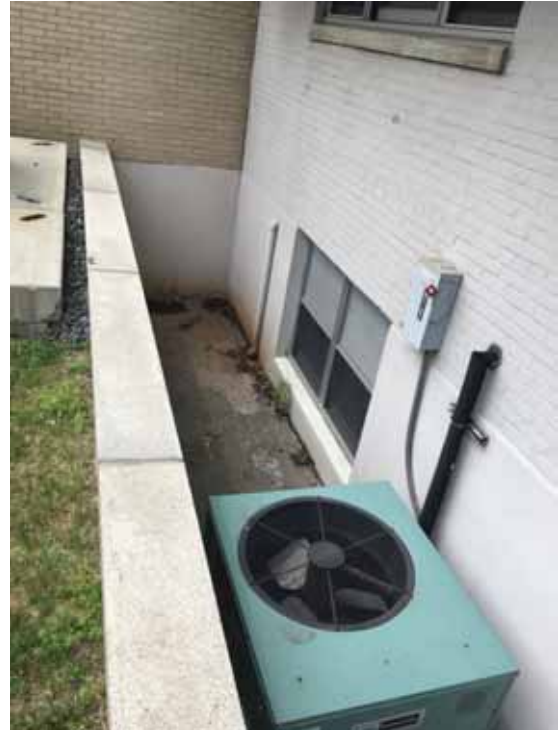
Figure 8 & 9: East areaway

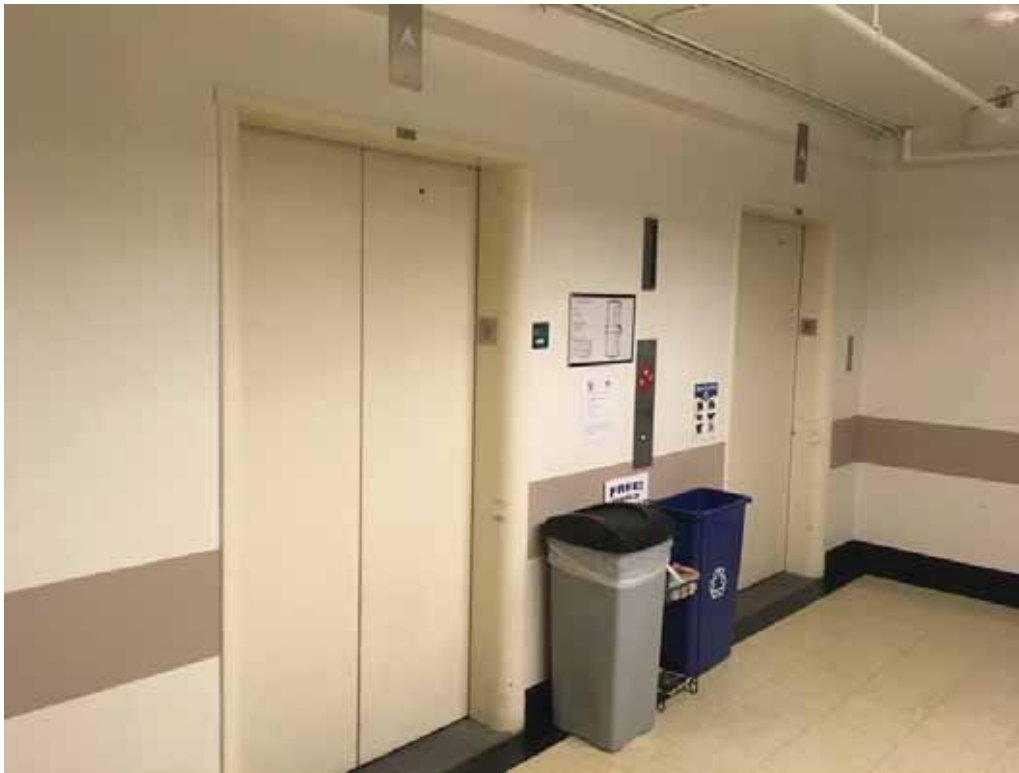
Figure 21: Basement elevators

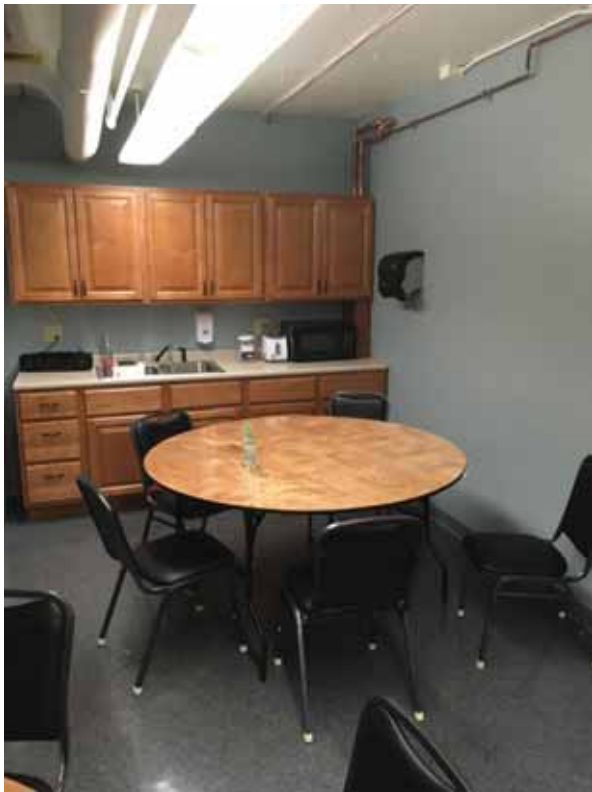
Figure 23: Basement breakroom space

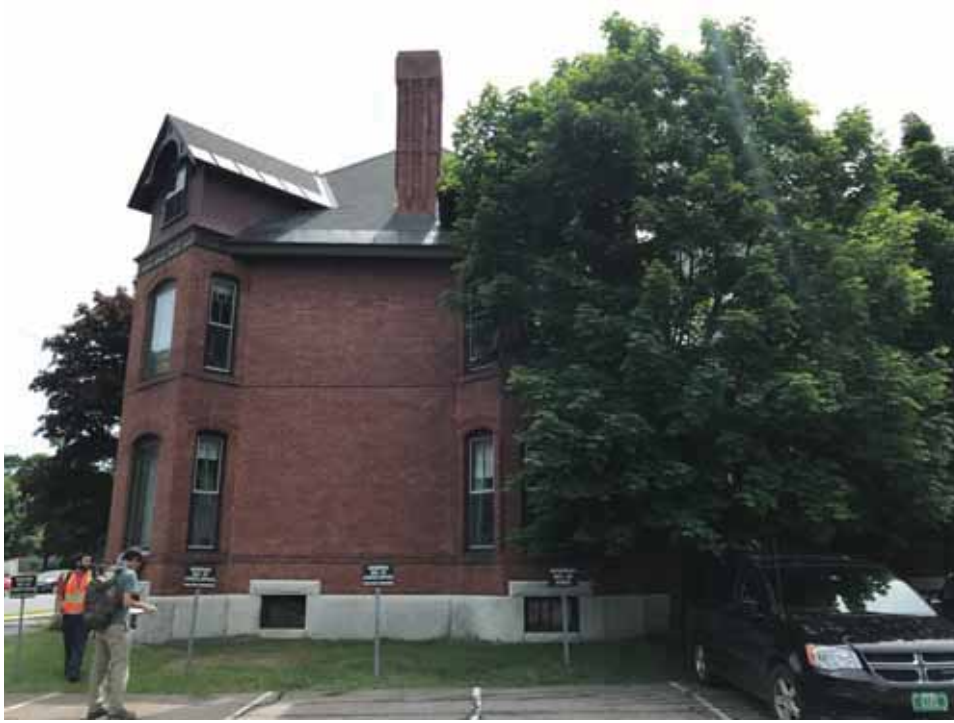
Figure 6: West elevation

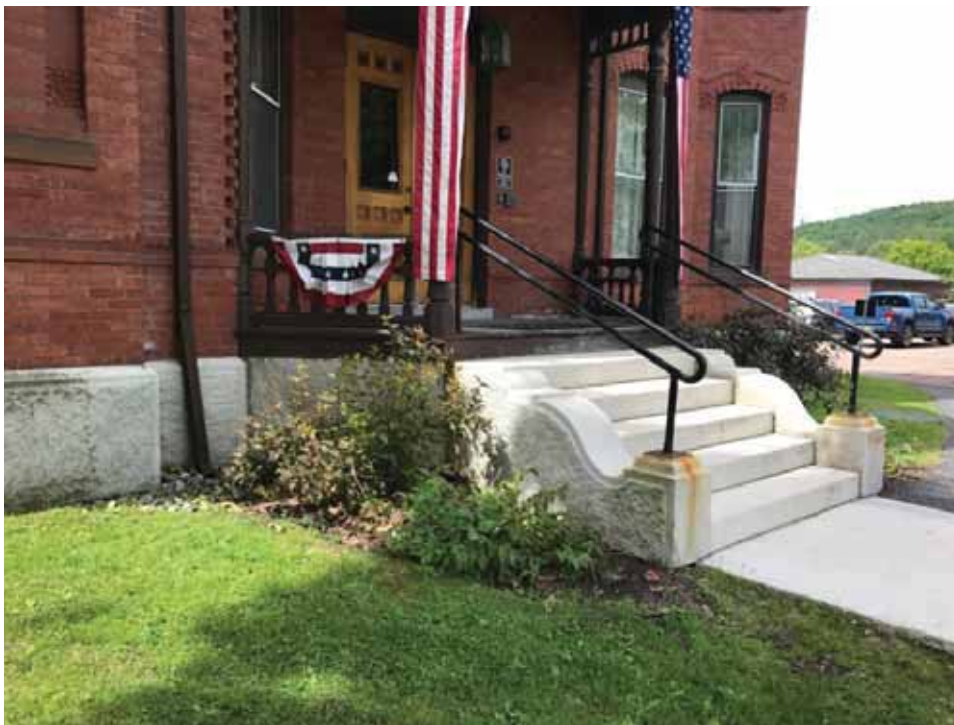
Figure 7: North elevation

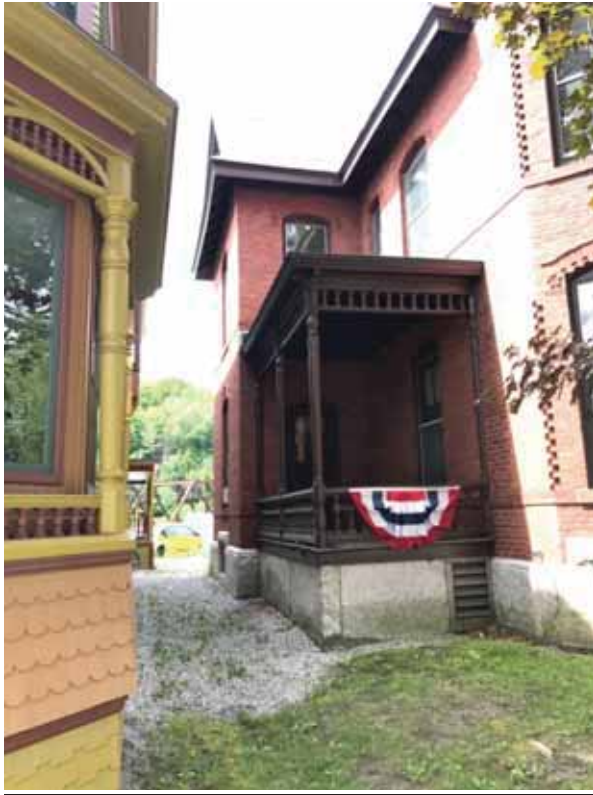
Figure 8: East elevation

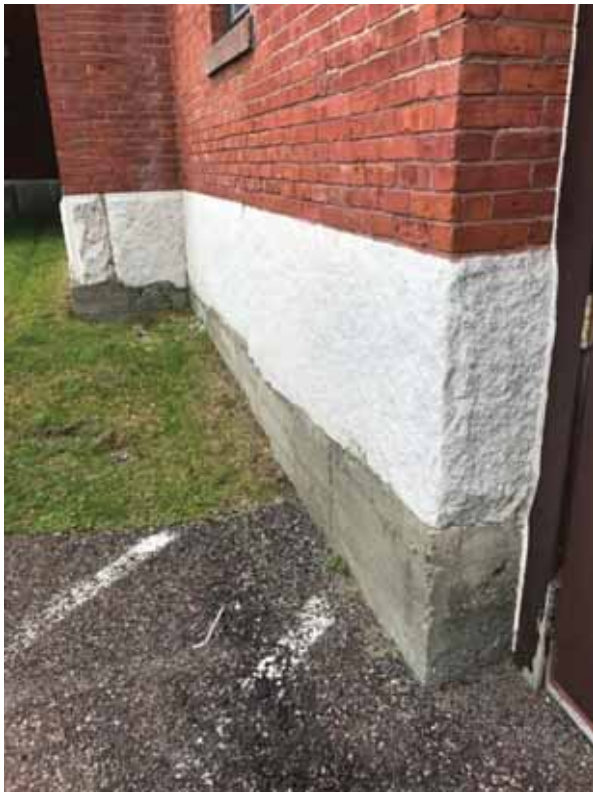
Figure 9: Partial west elevation

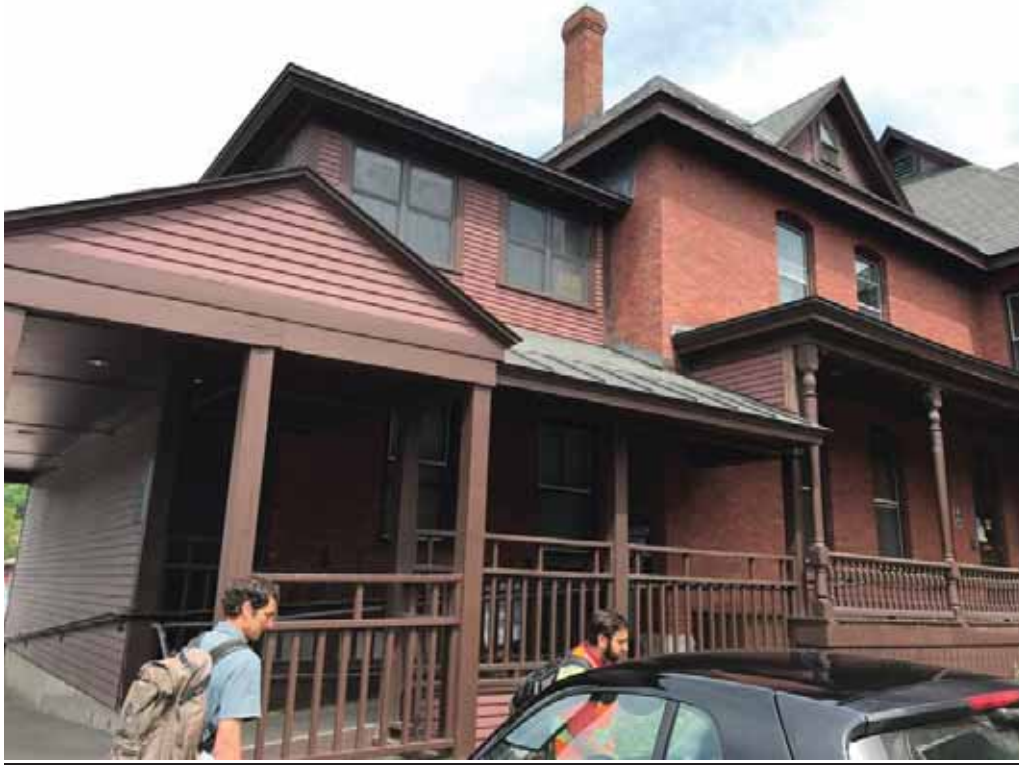
Figure 12: Southeast façade

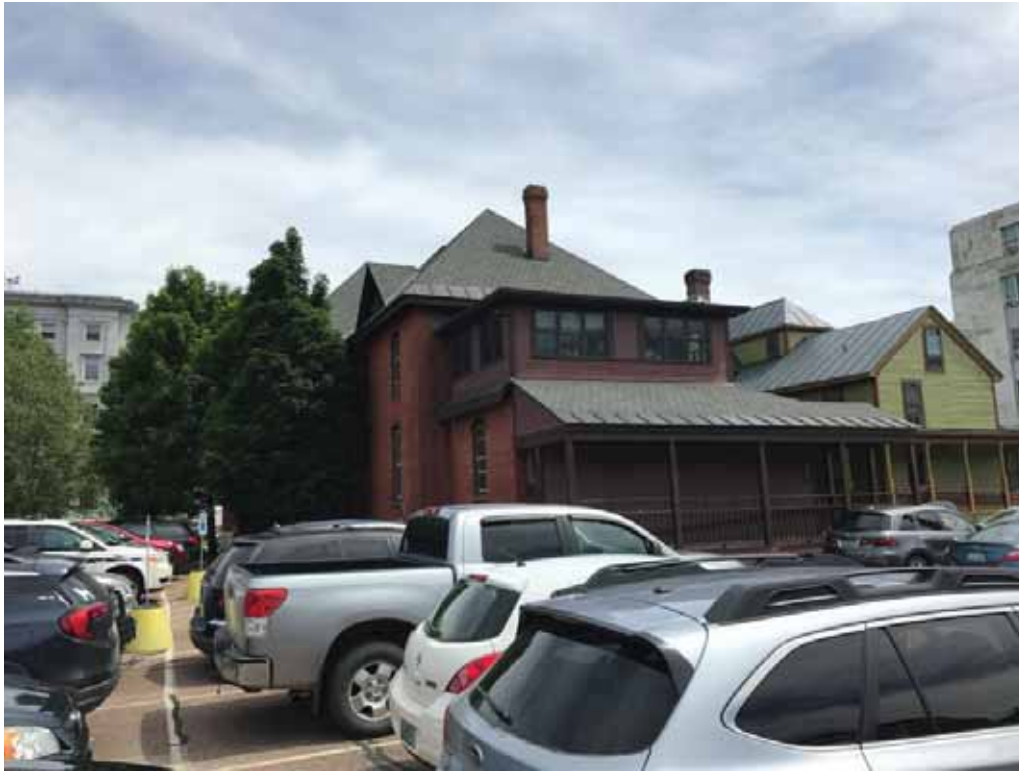
Figure 14: South façade
