Appendix - Section 3 - State & Local Capabilities Supplemental

Building Prioritization: Methodology

BGS Subgrant Project - Priority Building Assessment

BUILDING ASSESSMENT FORM

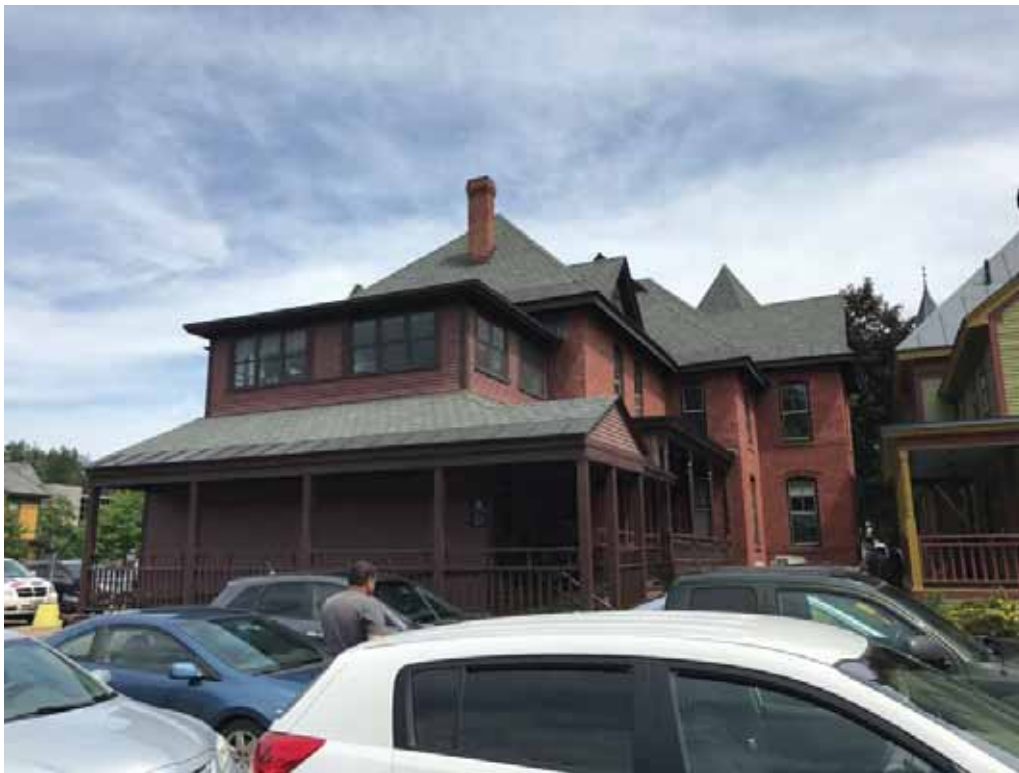
Figure 15: South façade

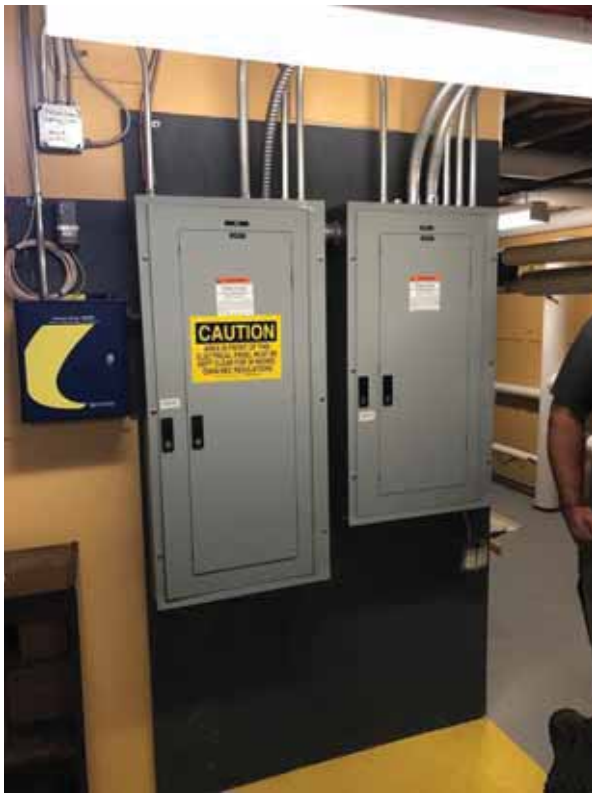
Figure 23: Basement electrical

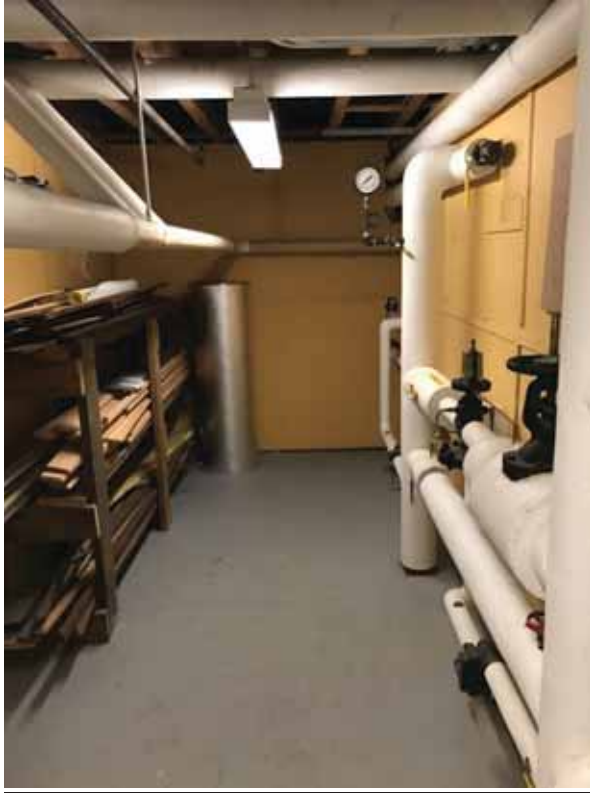
Figure 24: Basement steam

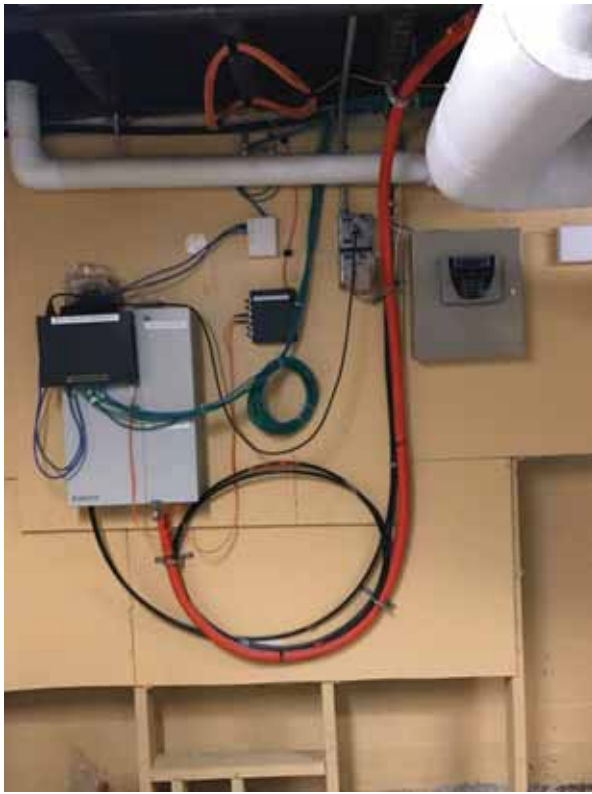
Figure 27: Basement fiber-optic

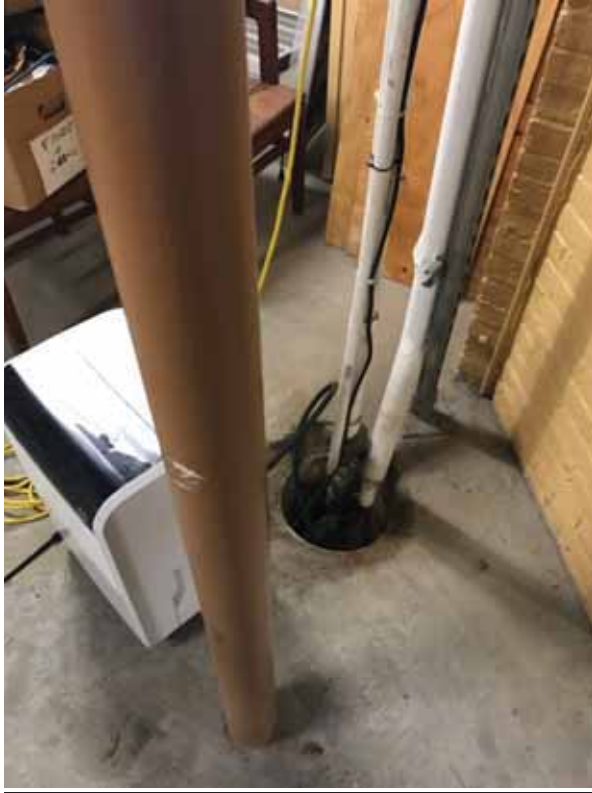
Figure 28: Basement sump

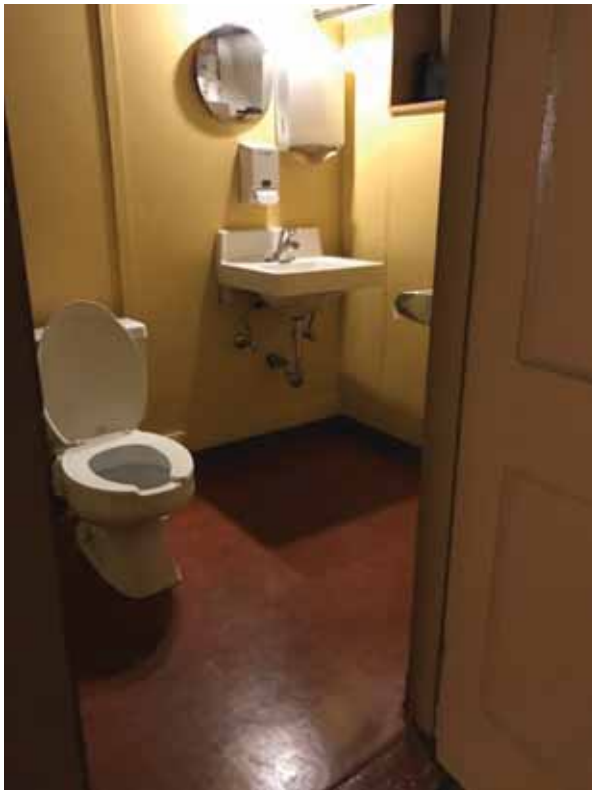
Figure 29: Basement restroom

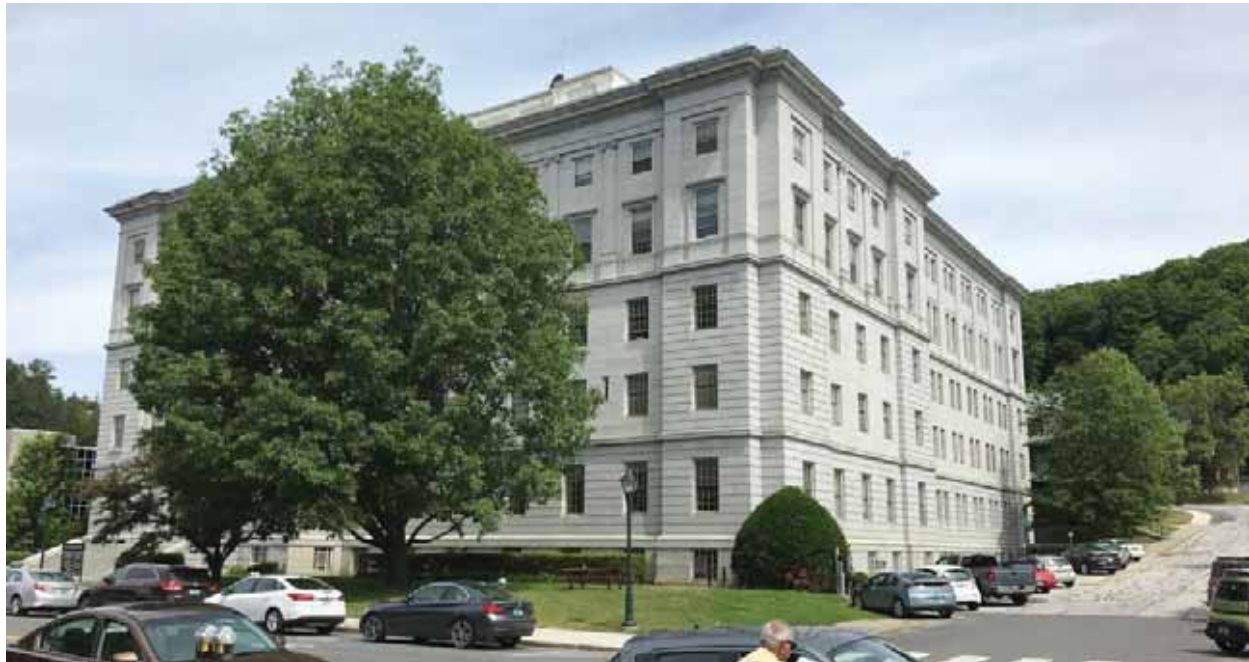
Figure 1: South and east elevations (photo credit: Freeman French Freeman)

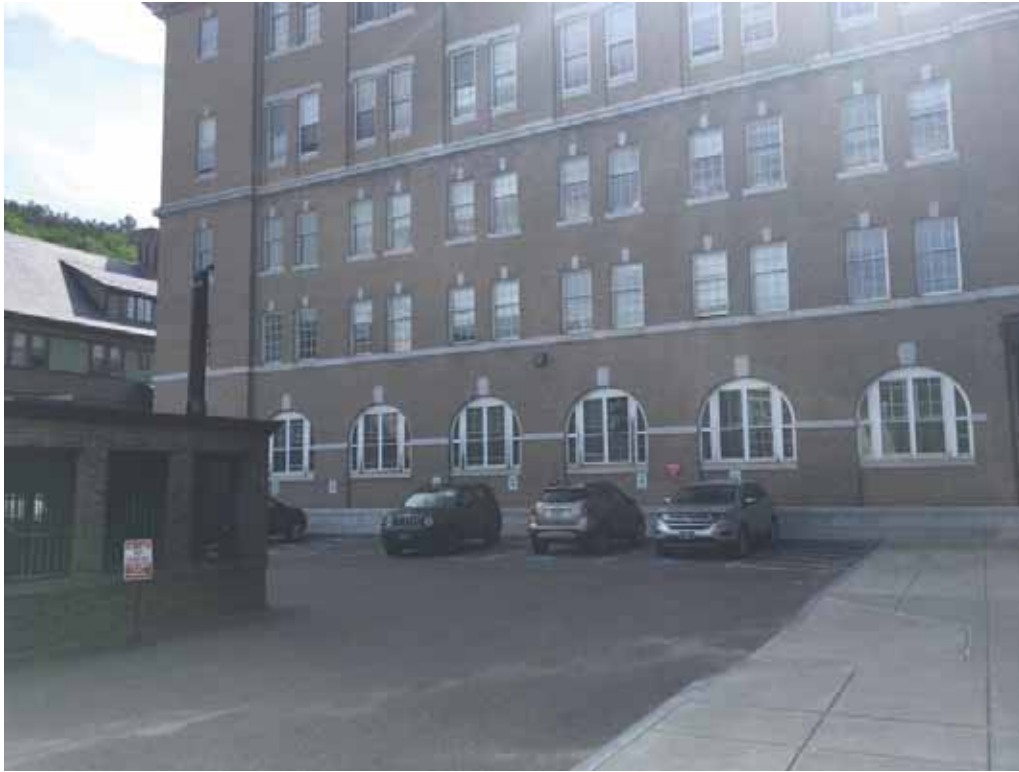
Figure 7: Northwest façade

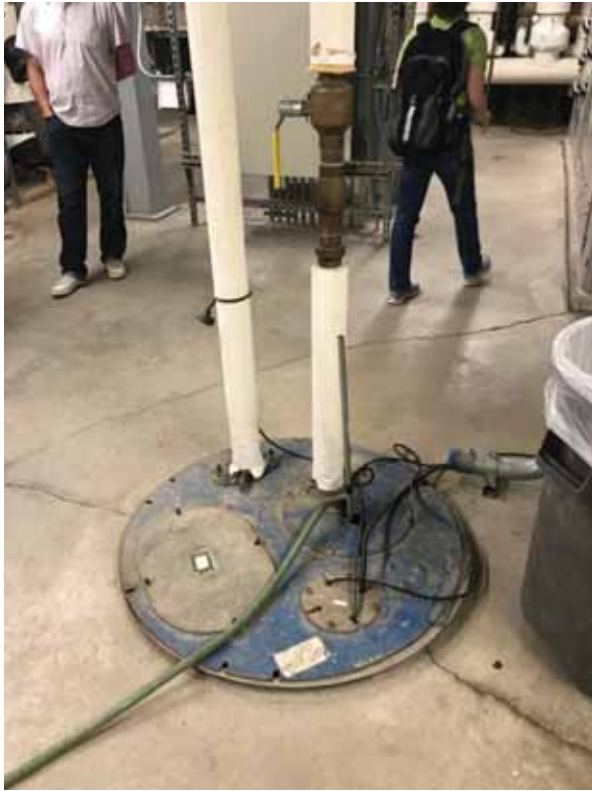
Figure 18: Sub-basement electrical panels / mechanicals

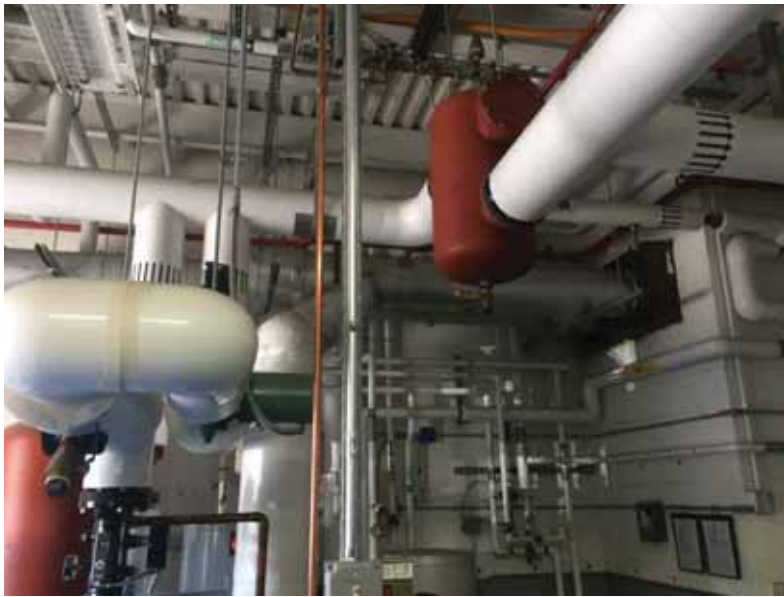
Mechanical / Electrical

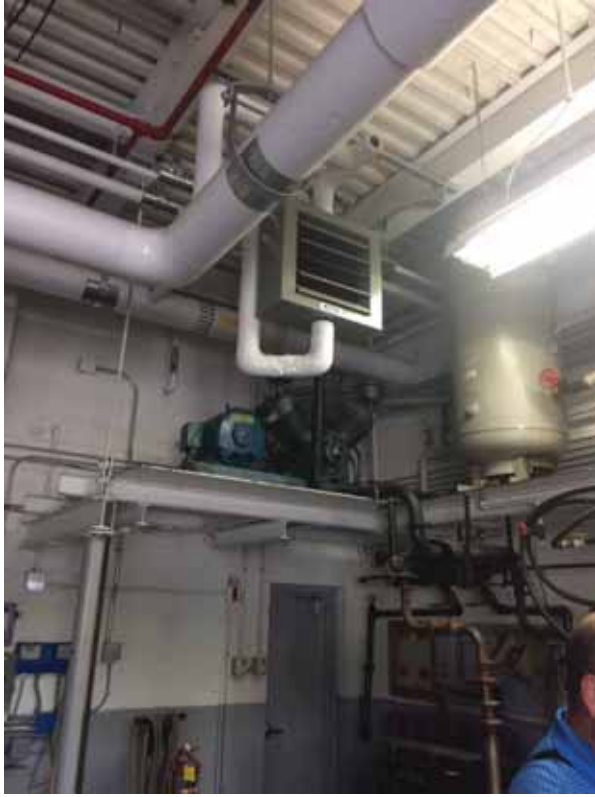
Mechanical/ Steam

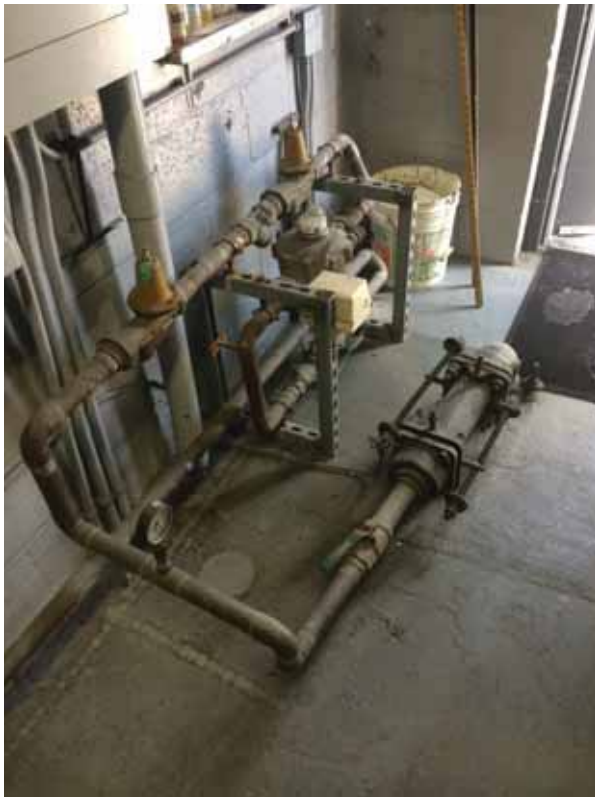
Mechanical

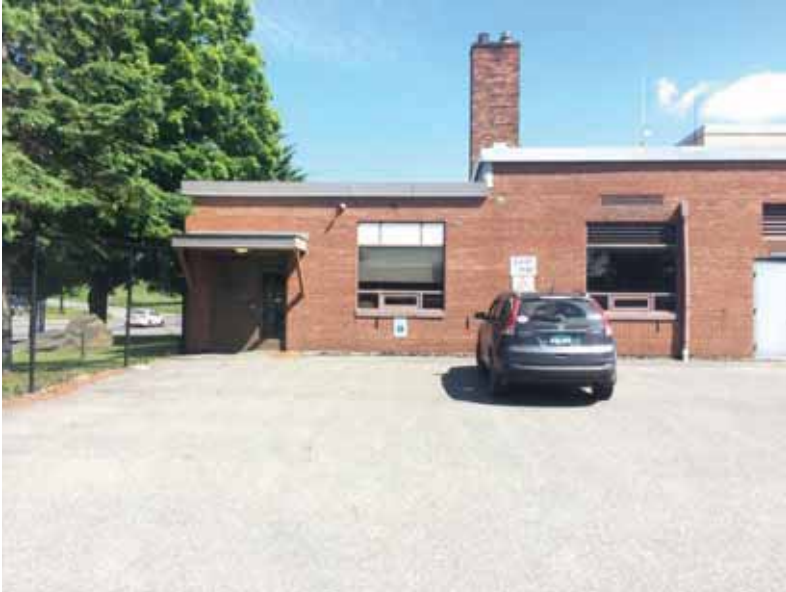
Contents could be hazardous if not addressed prior to flood event

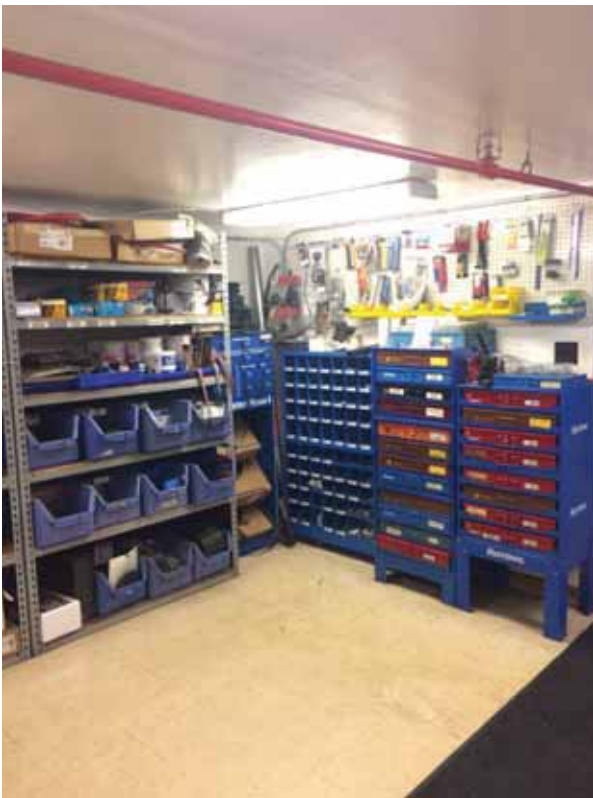
Parts storage

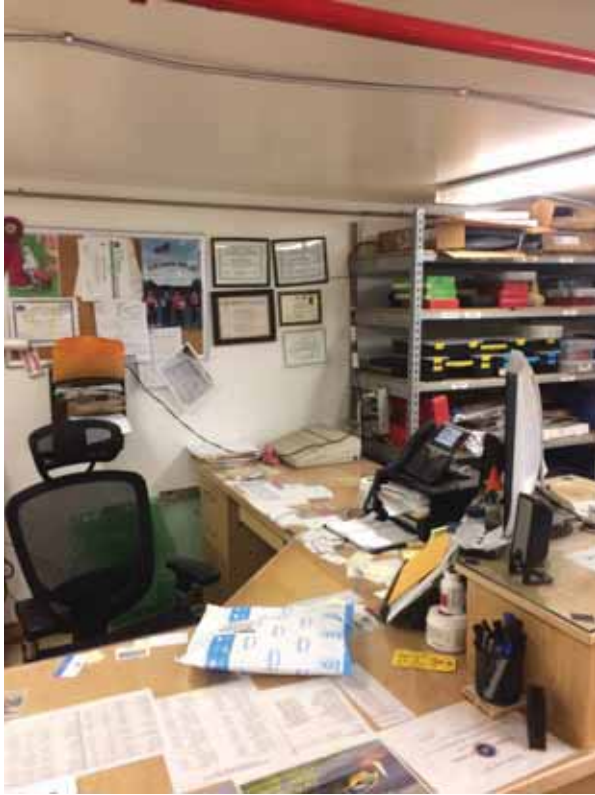
Parts storage and office space

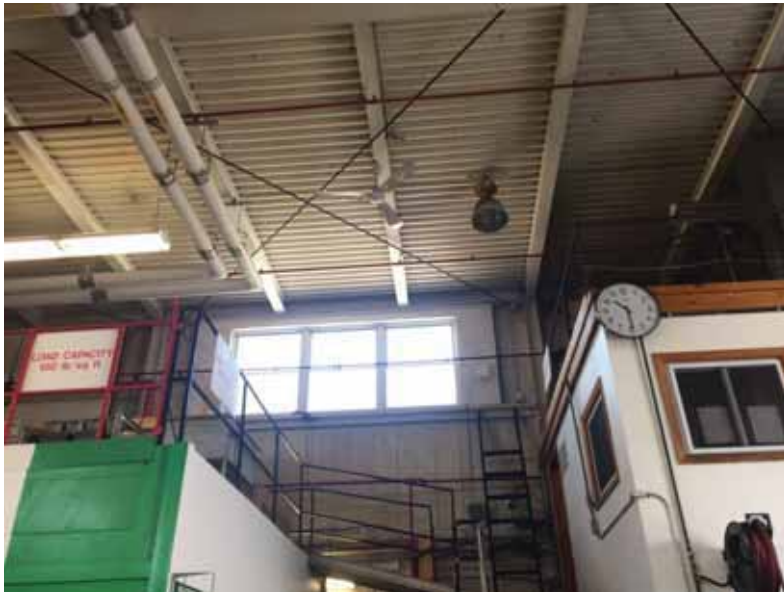
Storage mezzanine

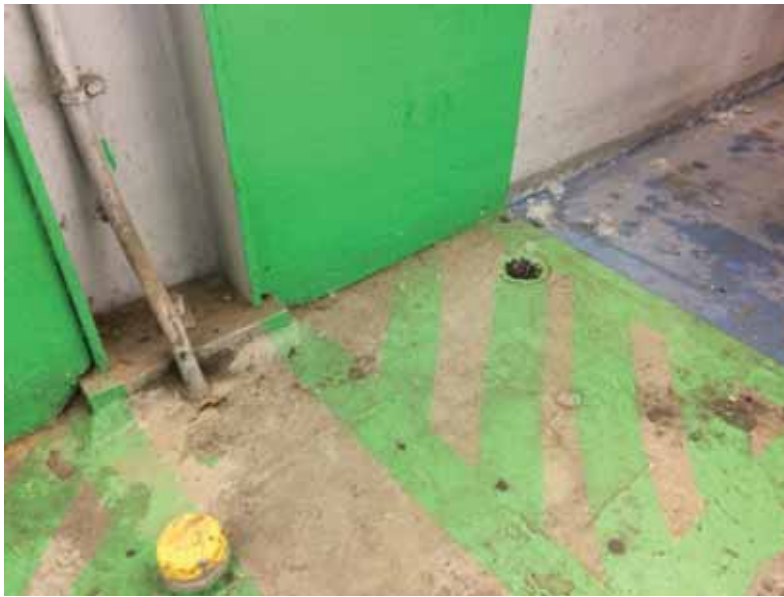
Floor openings

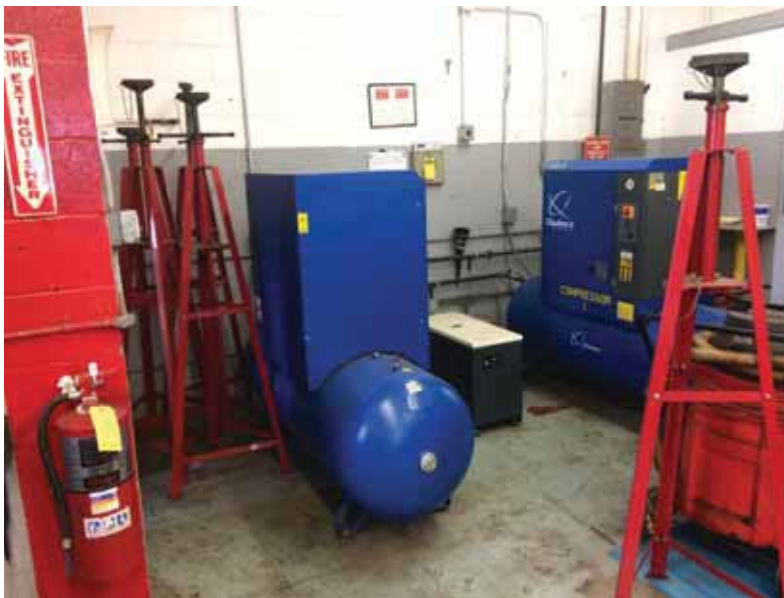
Compressors

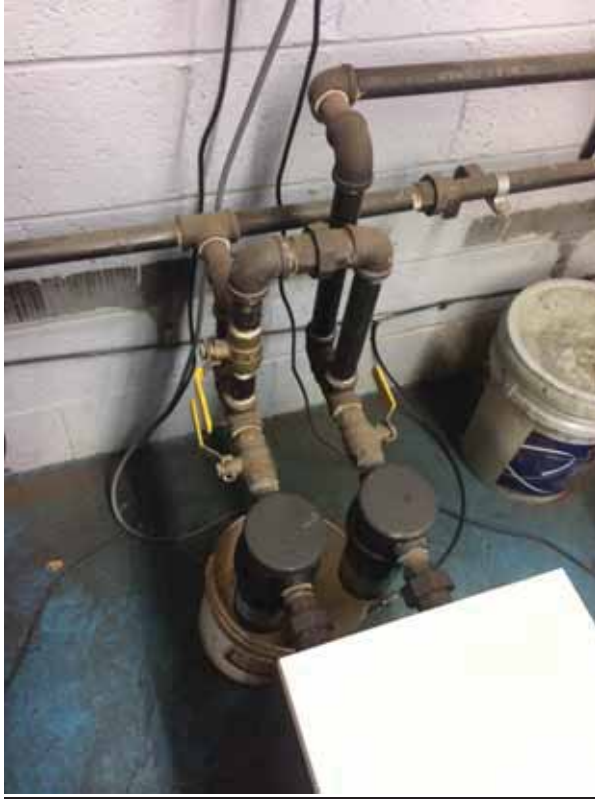
Low piping

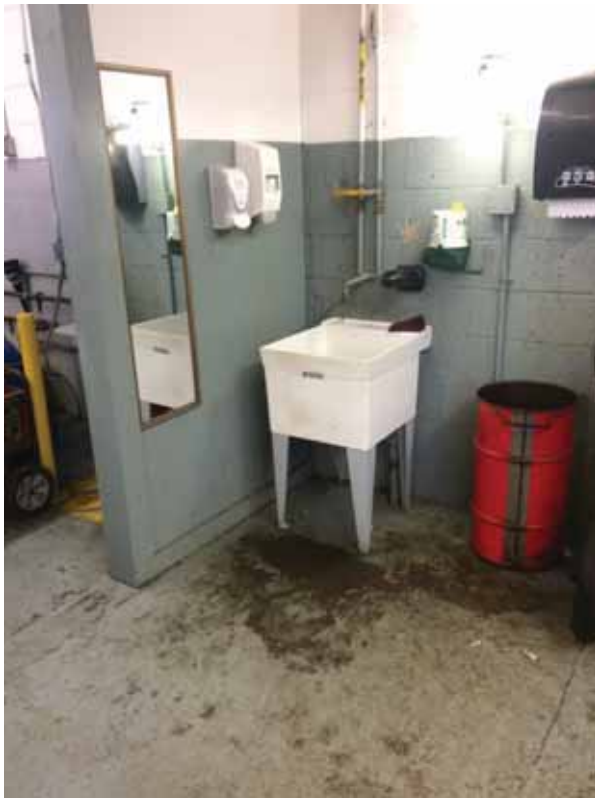
Utility sink

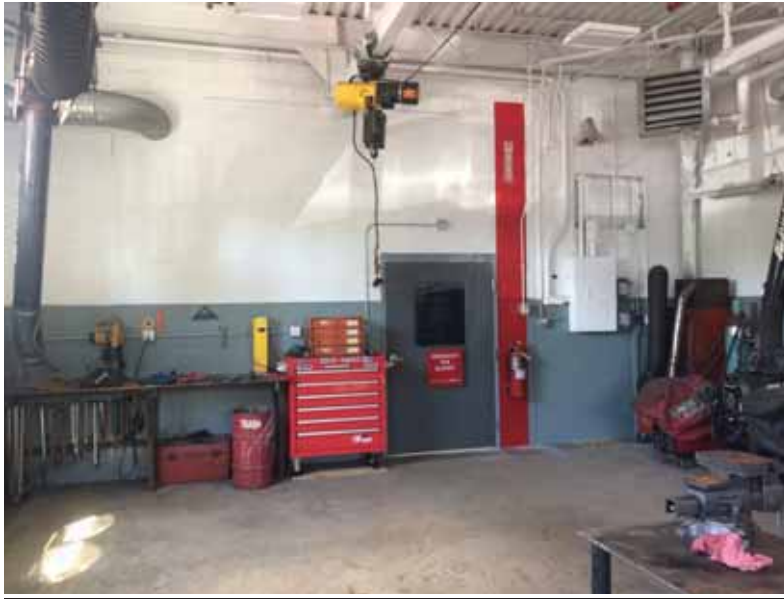
Tools and storage
