Building Prioritization: Methodology

BGS Subgrant Project - Priority Building Assessment

FLOOD HAZARD MITIGATION ASSESSMENT & ANALYSIS FOR STATE-OWNED BUILDINGS

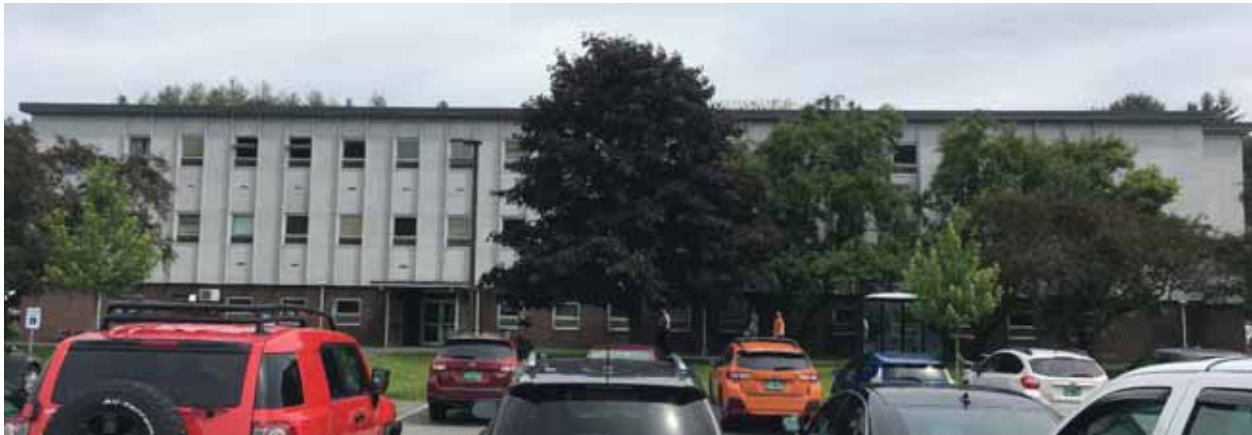
Figure 1: West Façade looking East (photo credit: Freeman French Freeman)

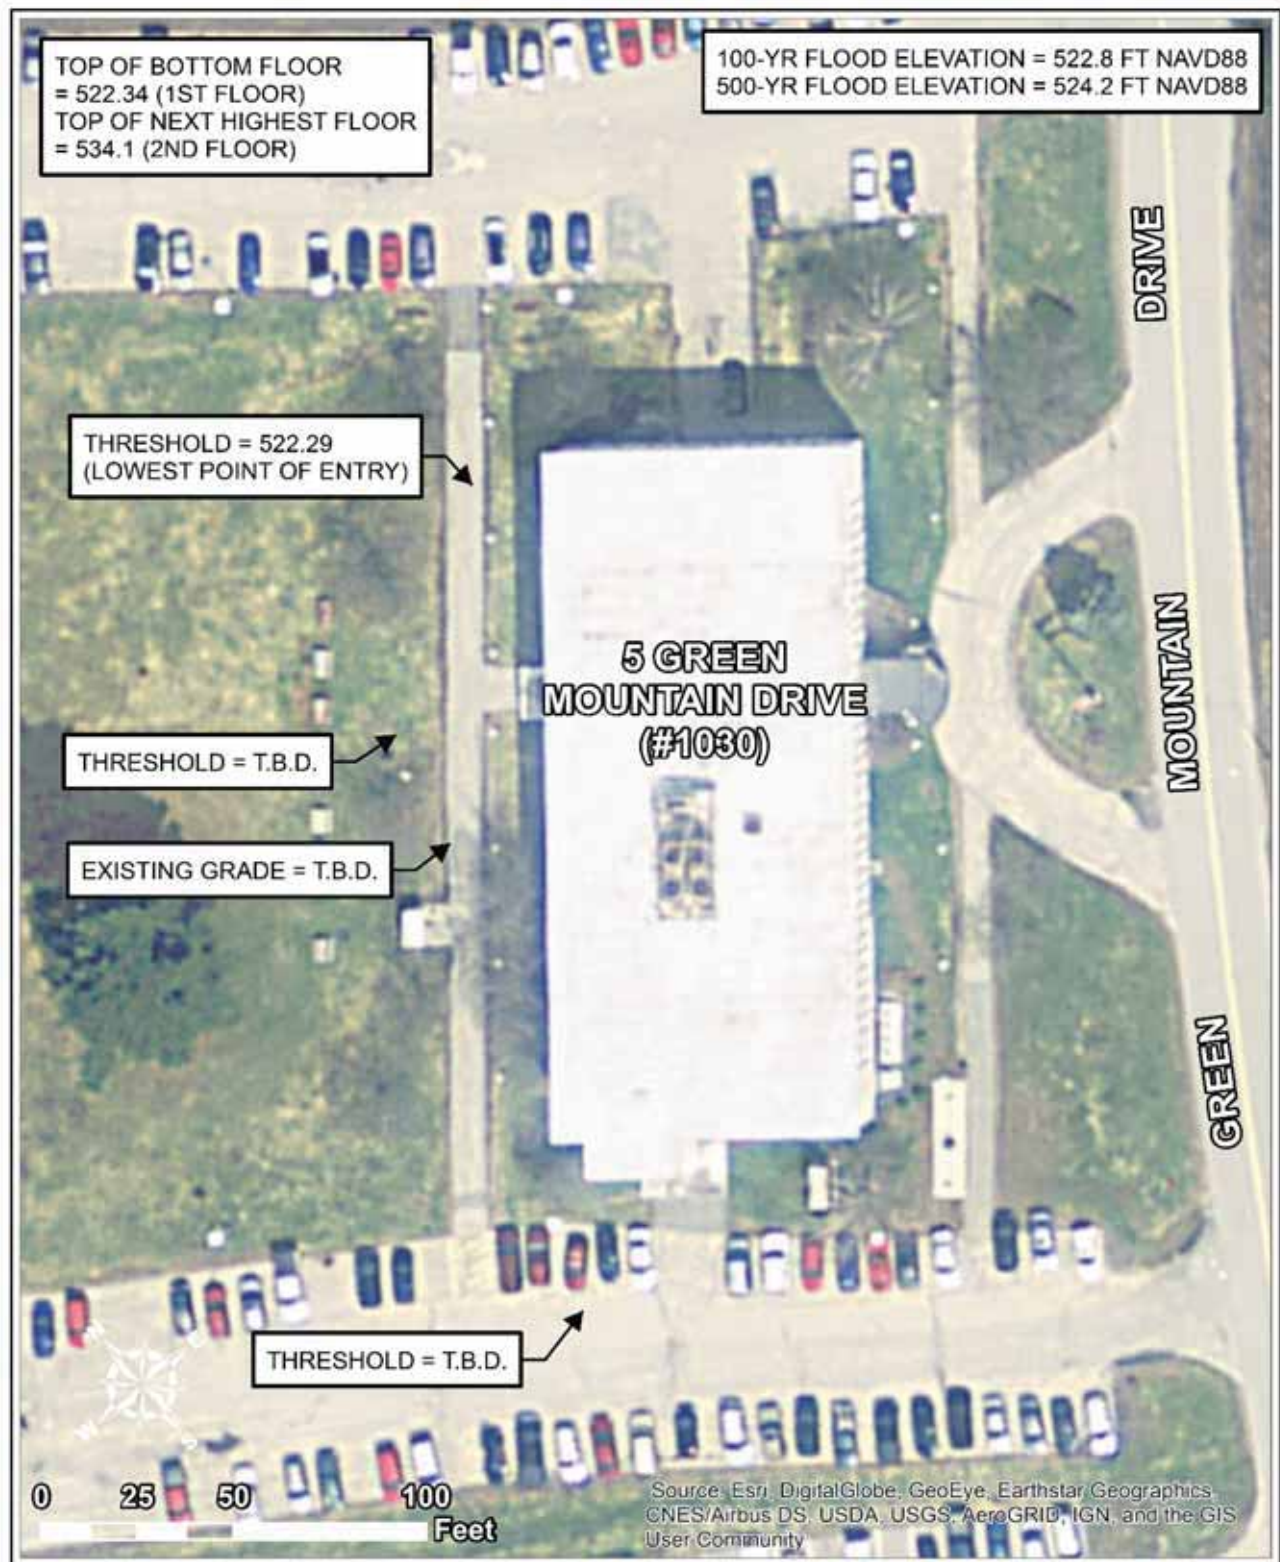
Figure 3: Lowest Point of Entry (1in = 50 ft, elevations reference NAVD 88 vertical datum)

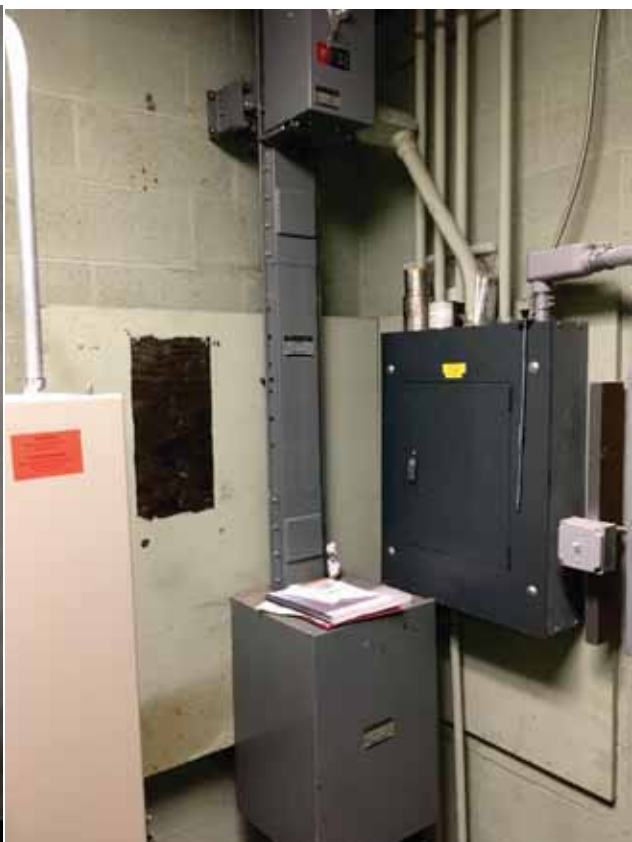
Figure 9: EMR equipment

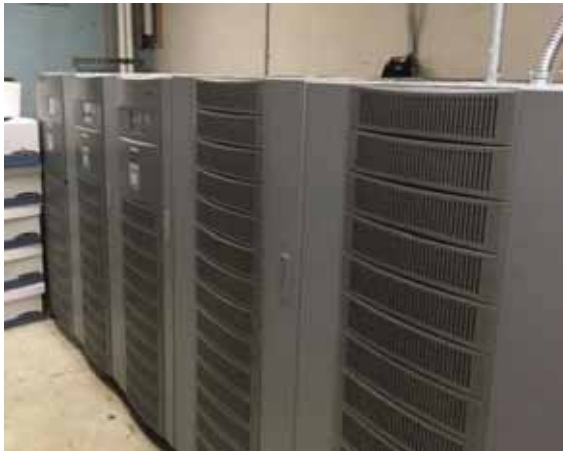
Figure 10: Liebert network power units

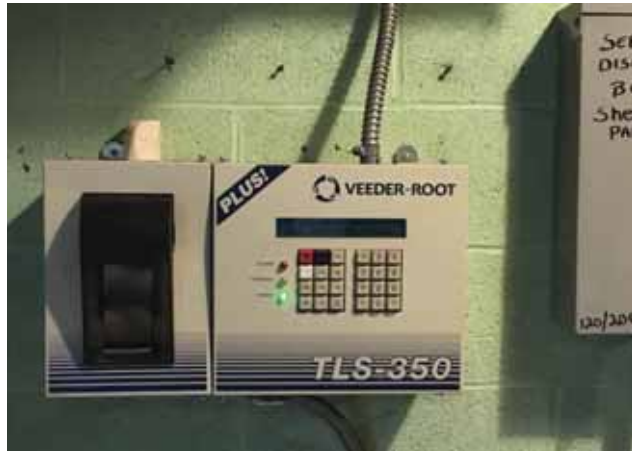
Figure 11: Emergency Generator Tank Monitor

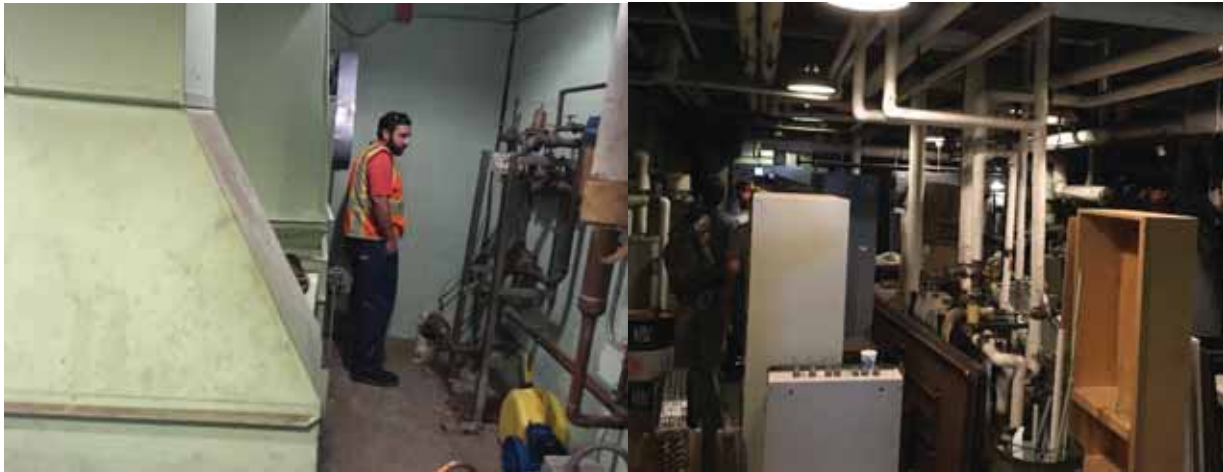
Figure 13 & 14: Mechanical rooms

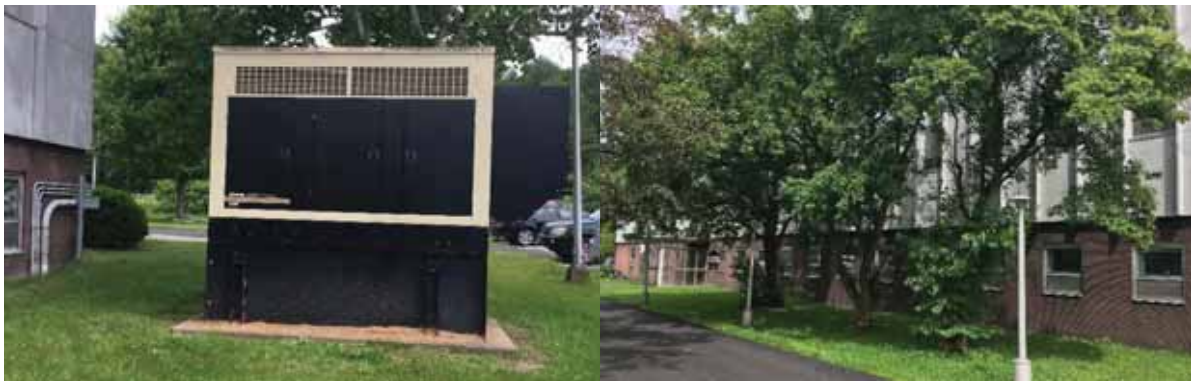
Figure 15: Pad mounted Generator (SE corner)

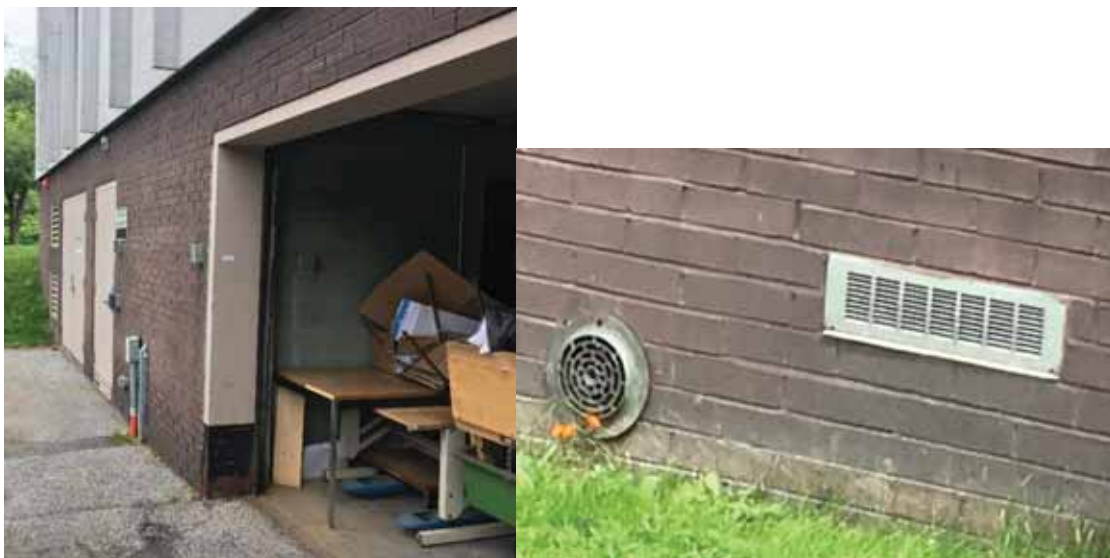
Figure 17: Openings in south façade

Figure 18: Vents and openings in west façade

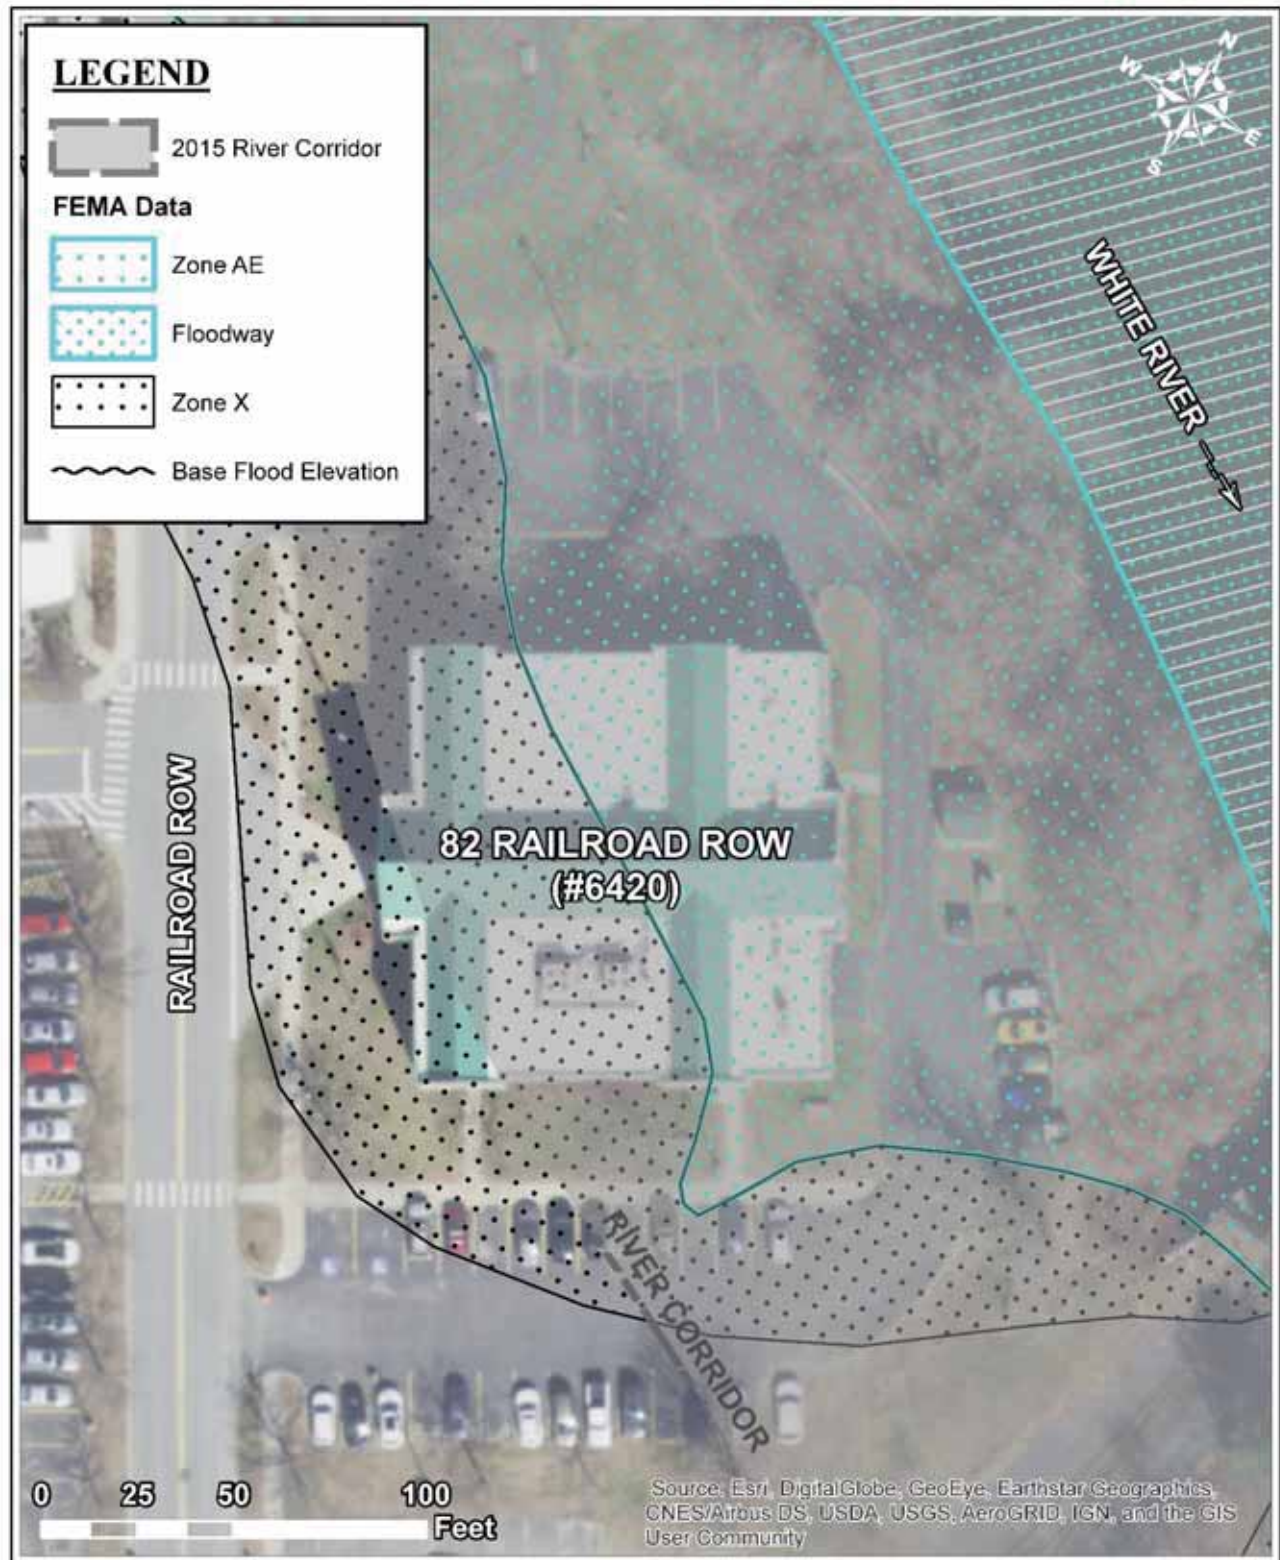
Figure 2: Flood Hazard Map (1in = 50 ft)

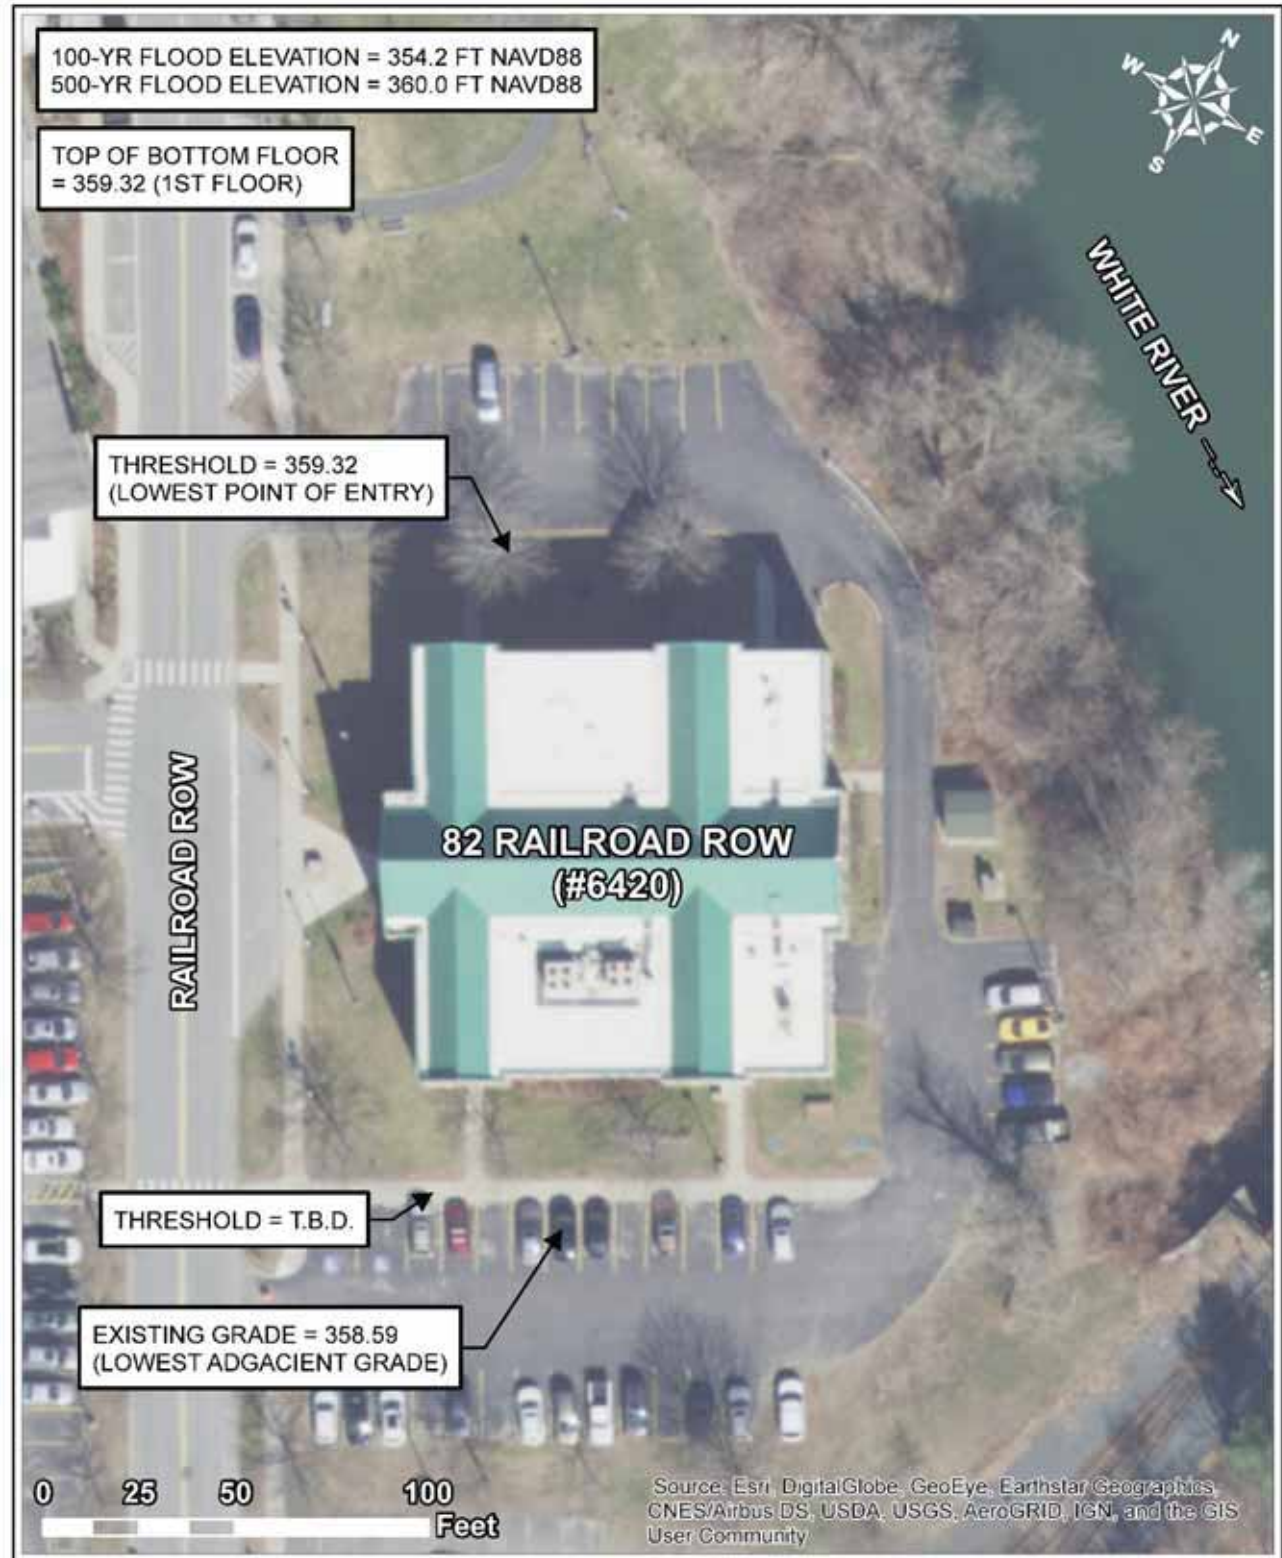
Figure 3: Lowest Point of Entry (1in = 50 ft, elevations reference NAVD 88 vertical datum)

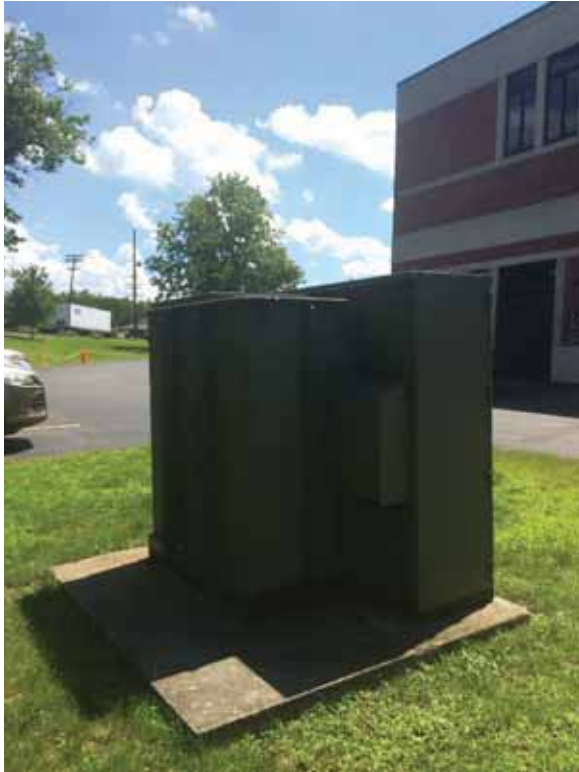
Figure 5: Exterior pad mount transformer.

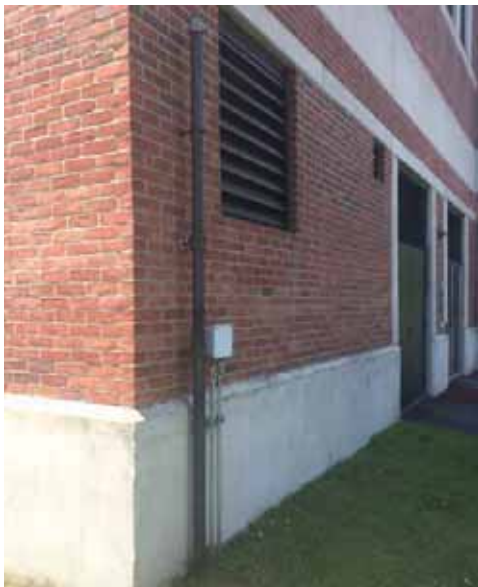
Figure 7: Vent pipe
(underground fuel tank?).

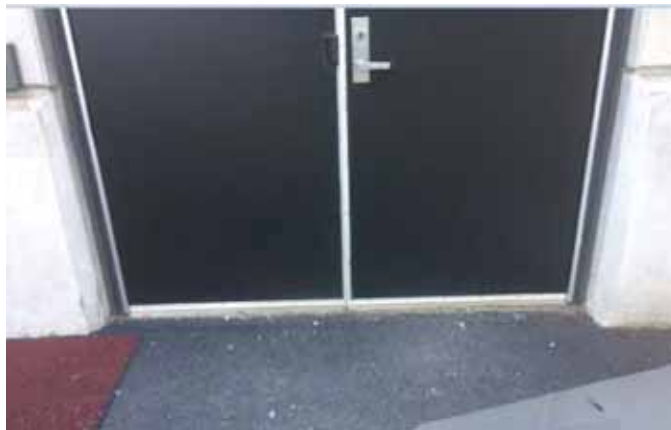
Figure 8: Exterior doors.

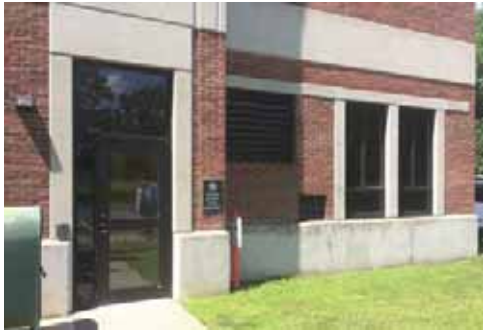
Figure 9: Exterior doors/ windows/ vents.

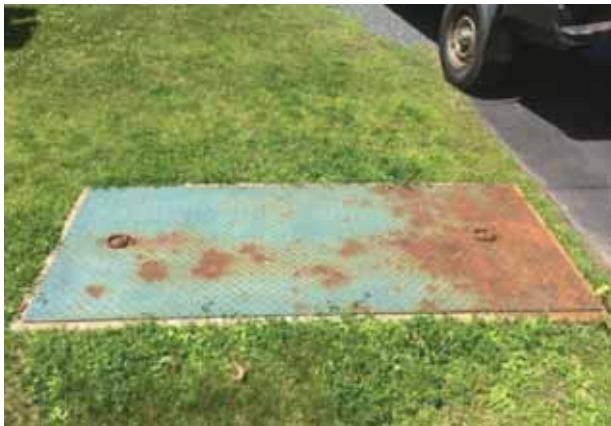
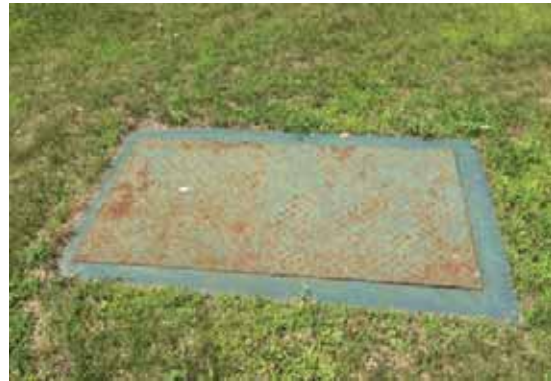
Figure 10 & 11: At-grade access panels on site, contents unknown.

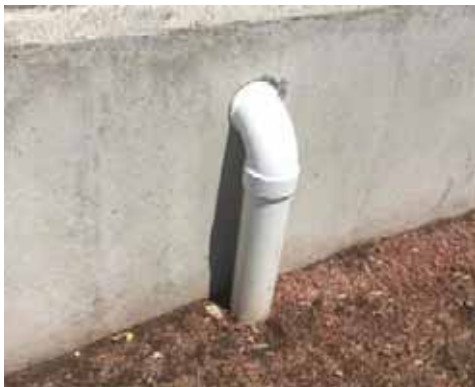
Figure 12: Unsealed exterior wall penetration(s).

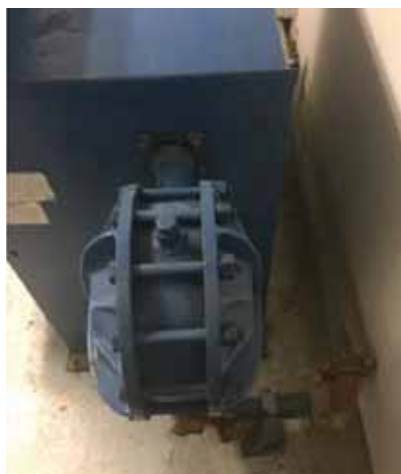
Figure 16: Emergency Generator

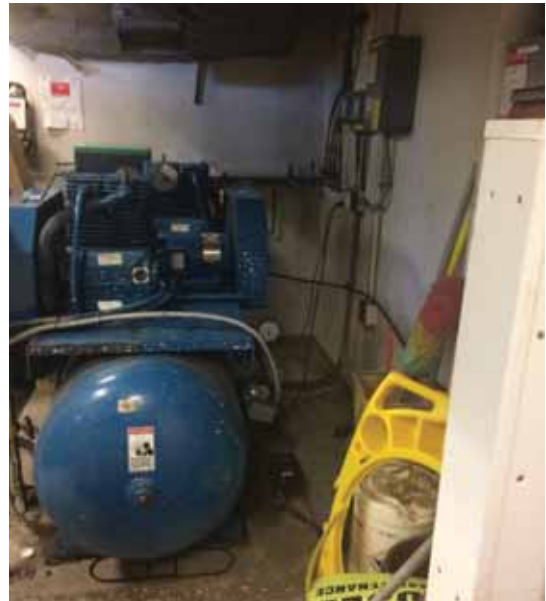
Figure 19: Compressor.

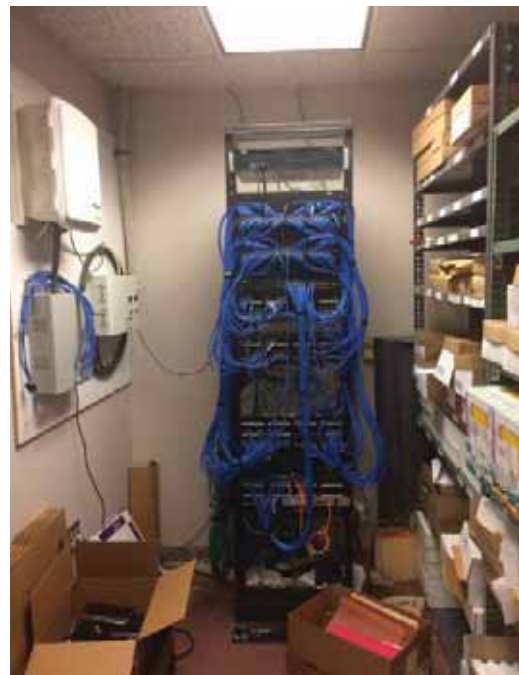
Figure 21: Network Server Room

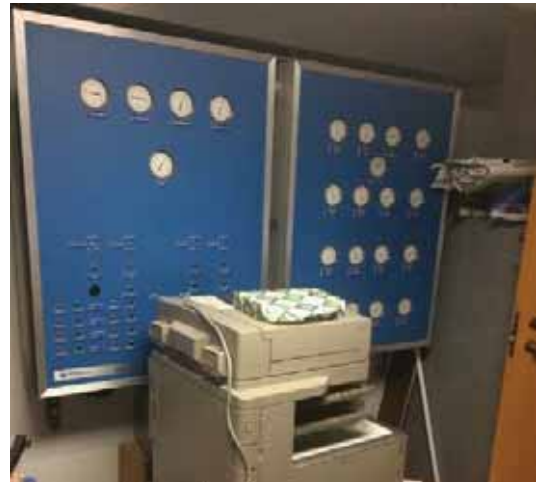
Figure 23: Control Panels

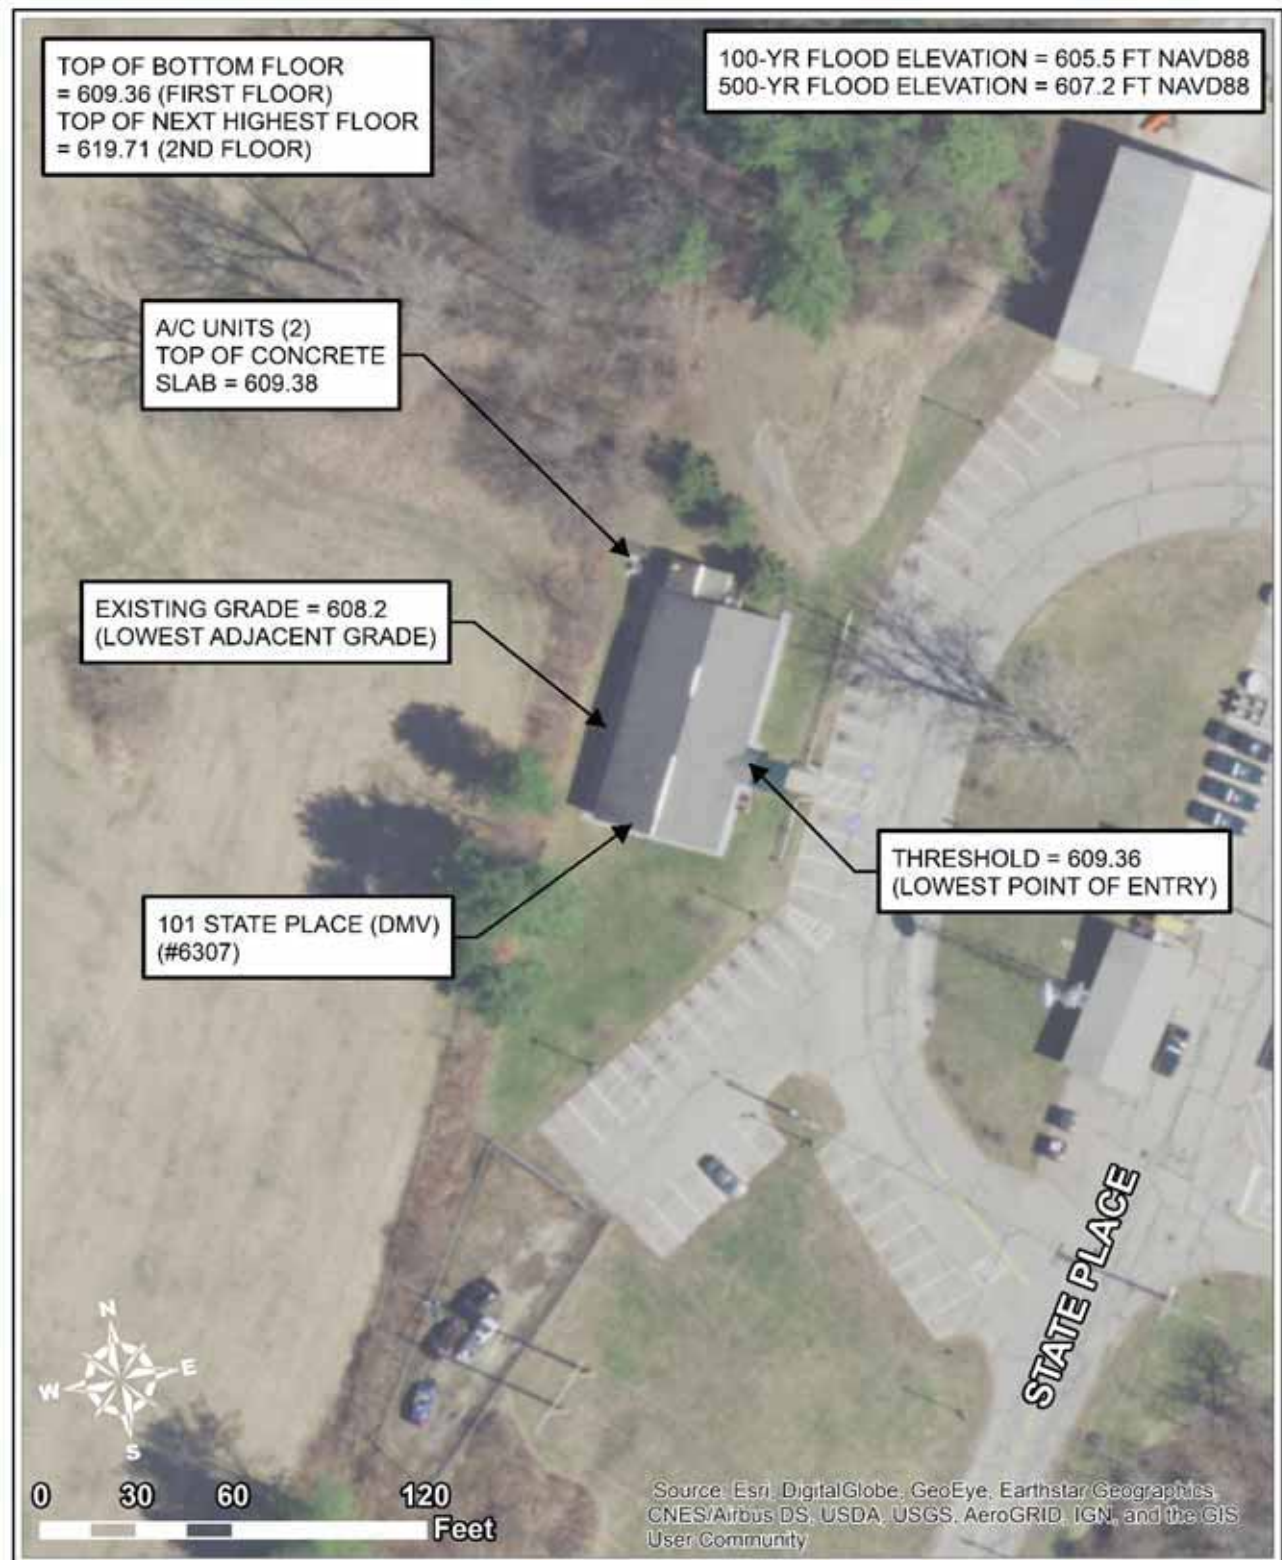
Figure 3: Lowest Point of Entry (1in = 60 ft, elevations reference NAVD 88 vertical datum)

The data collected as part of the Elevation Certificate indicates that the first floor of the building and lowest grade adjacent to the building are above the published FEMA 100-year or Base Flood Elevation (BFE) and the 500-year Flood Elevation by at least a foot (see Figure 3).

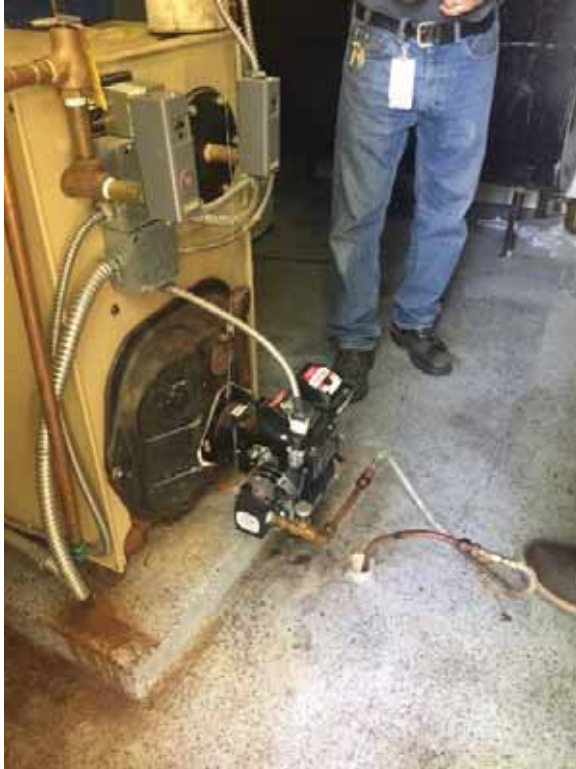
Figure 5: Boiler in Mechanical Room (Source: MSK)

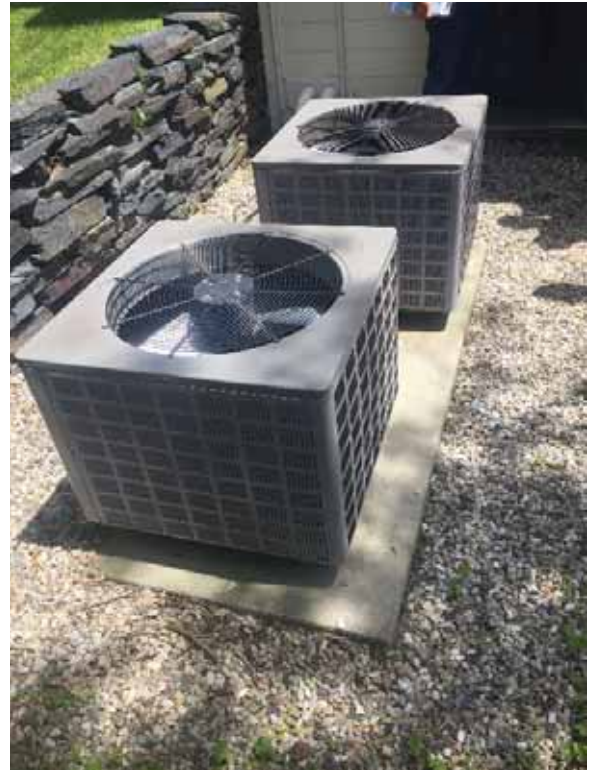
Figure 6: Exterior A/C Units (Source: MSK)

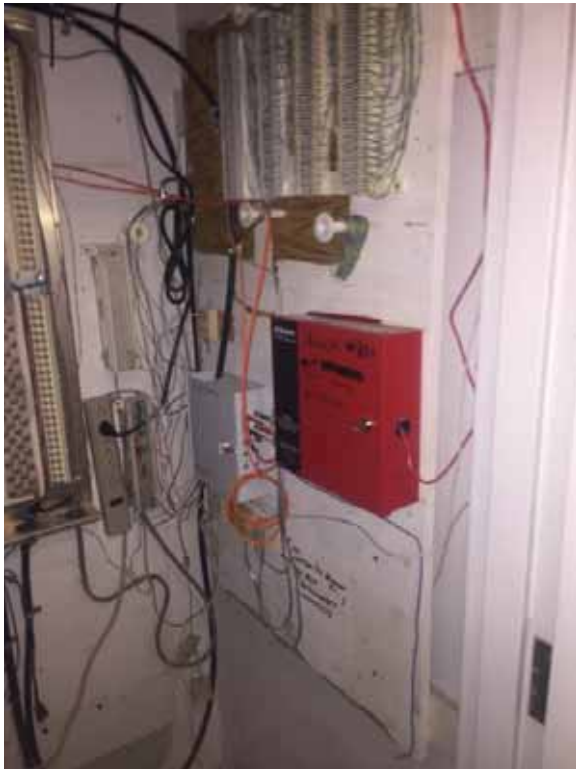
Figure 7: Telcom / Security Panels (Source: MSK)

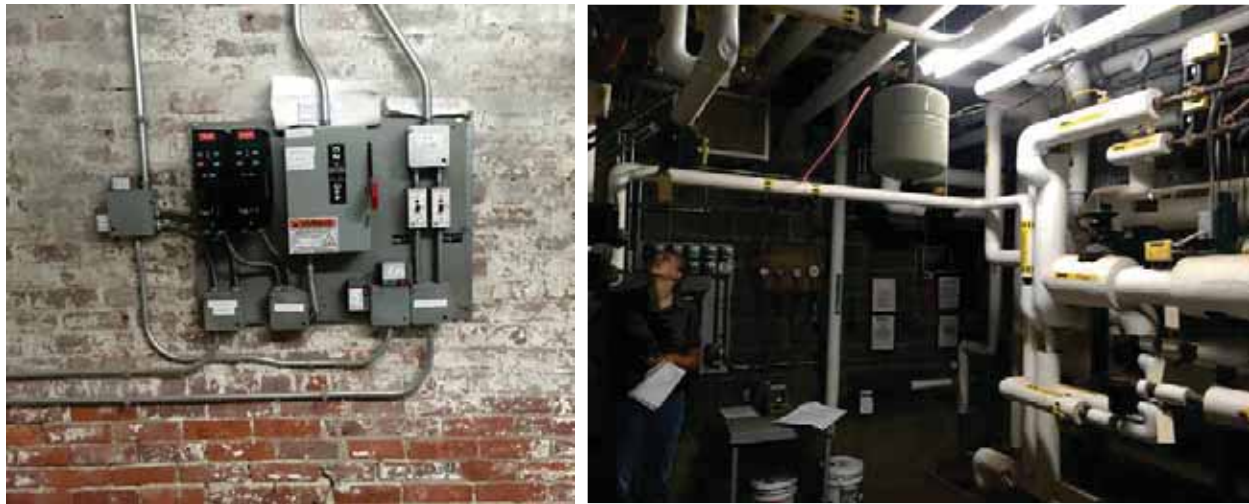
Figure 6 & 7: Basement Electrical and mechanical

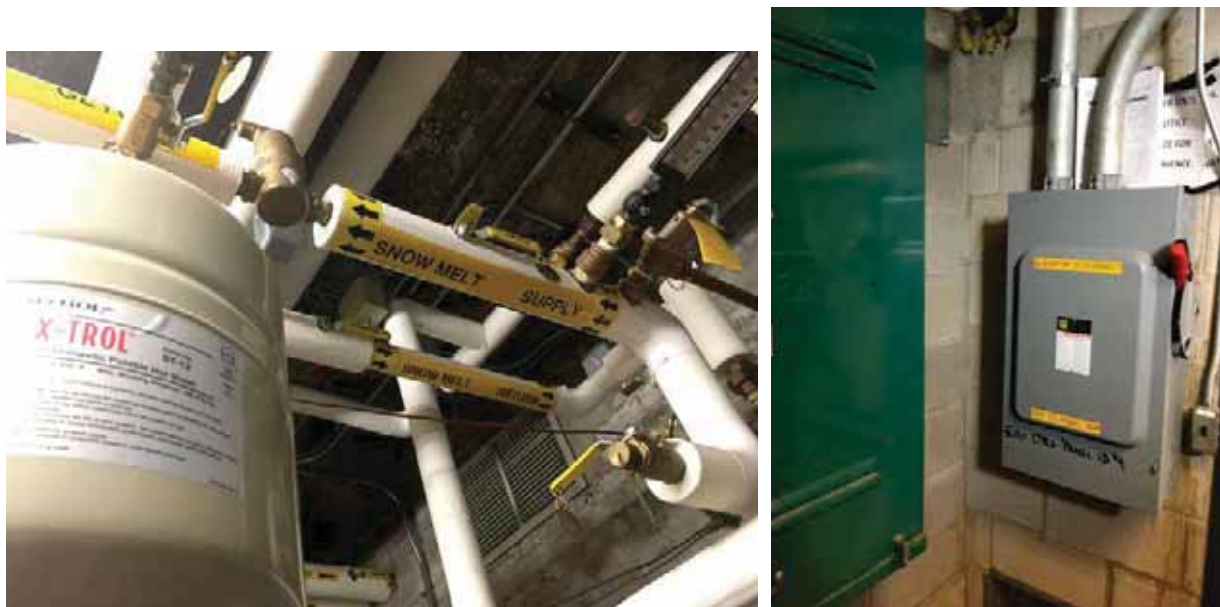
Figure 8 & 9: Basement mechanical and electrical

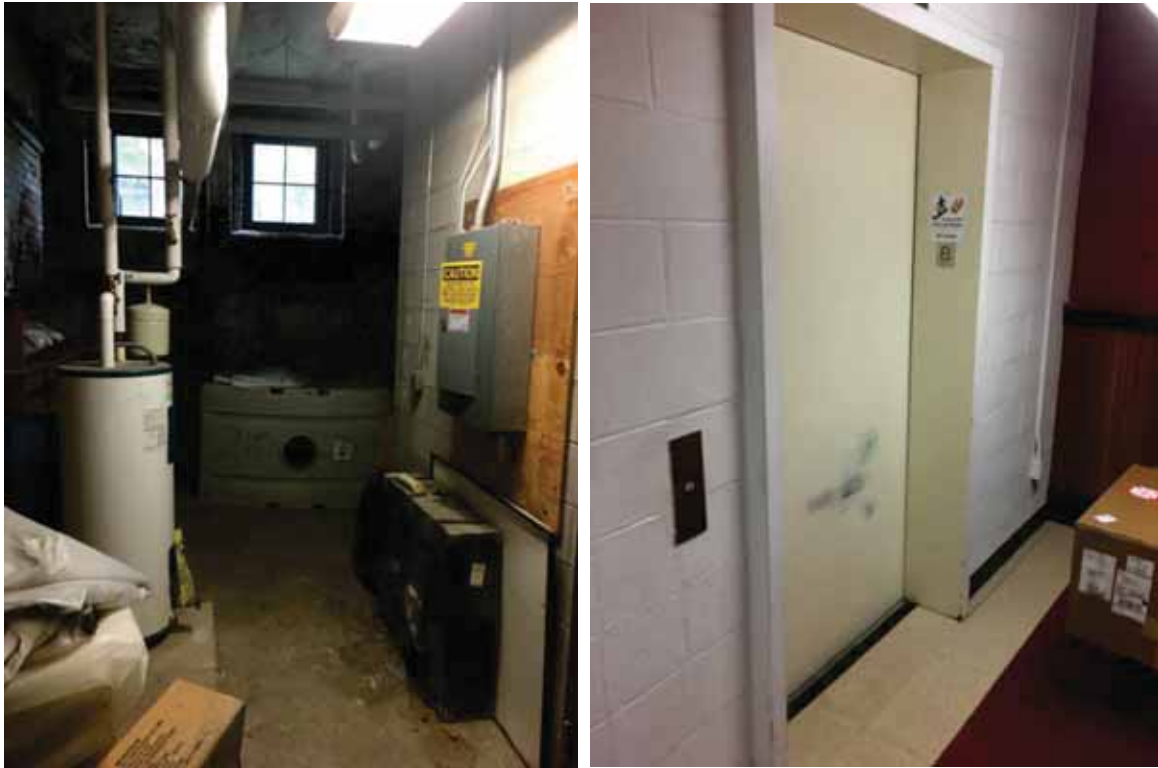
Figure 10 & 11: Basement mechanical and elevator

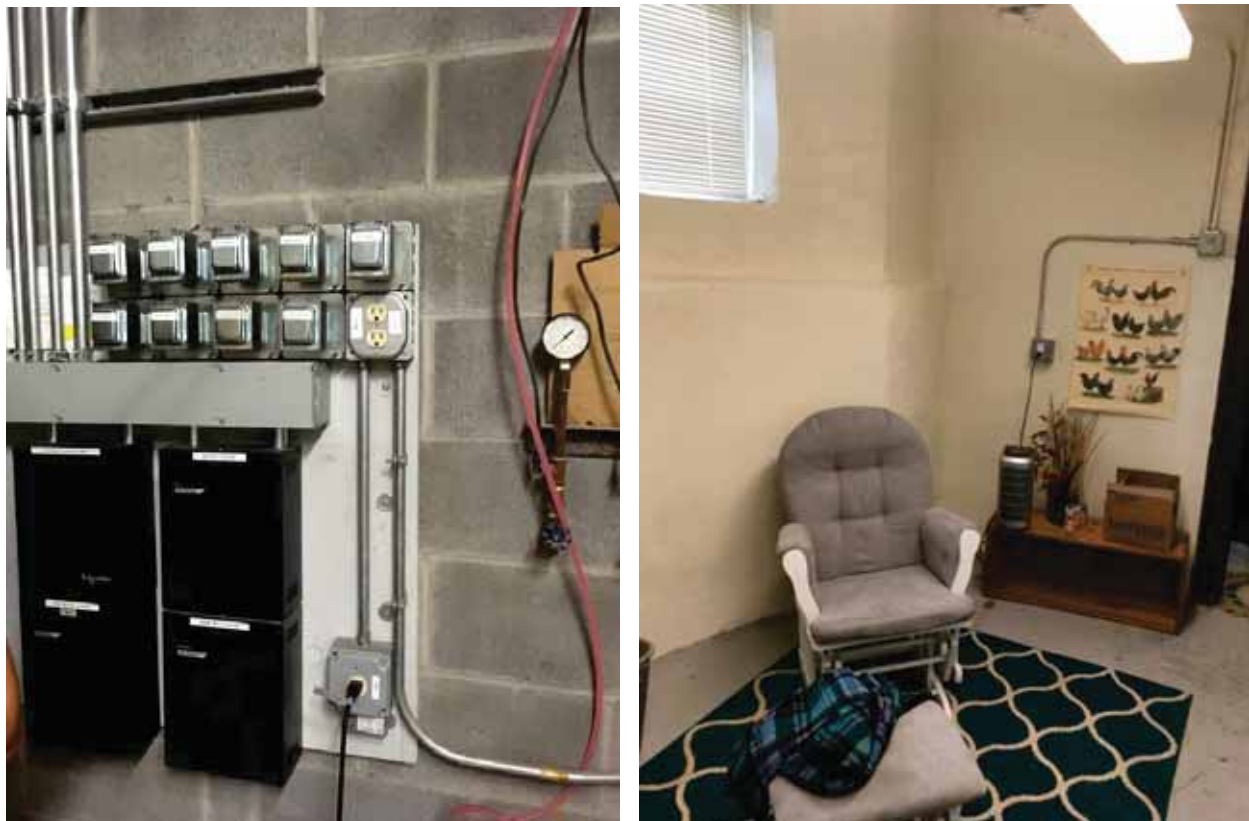
Figure 12 & 13: Basement electrical and seating space

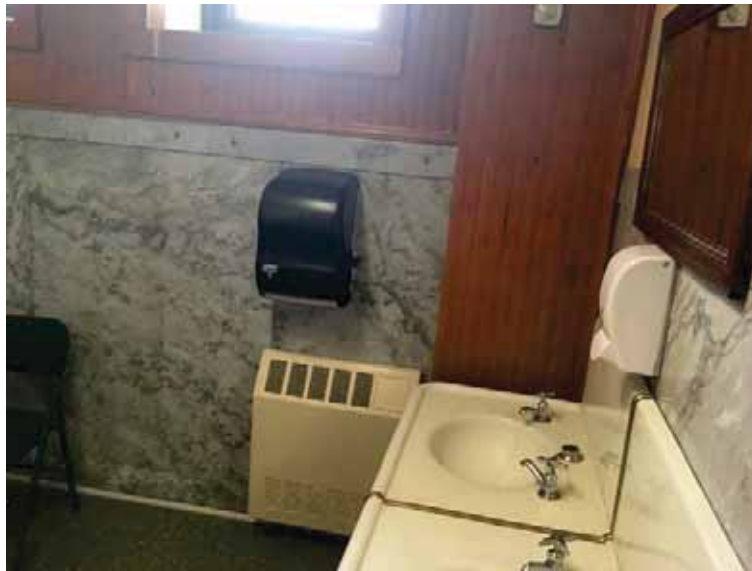
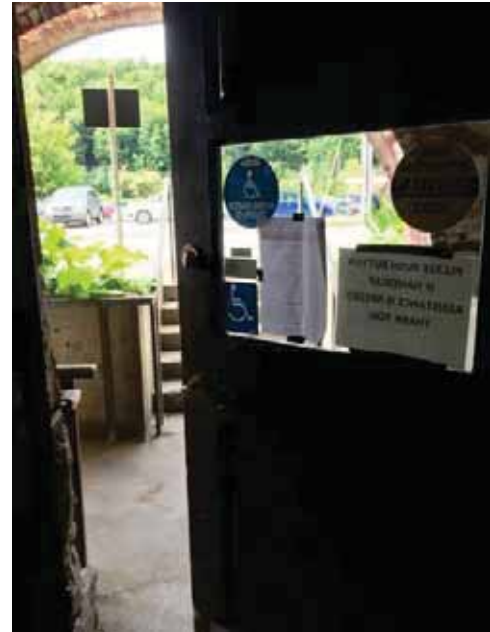
Figure 14 & 15: Basement restroom and recessed entry

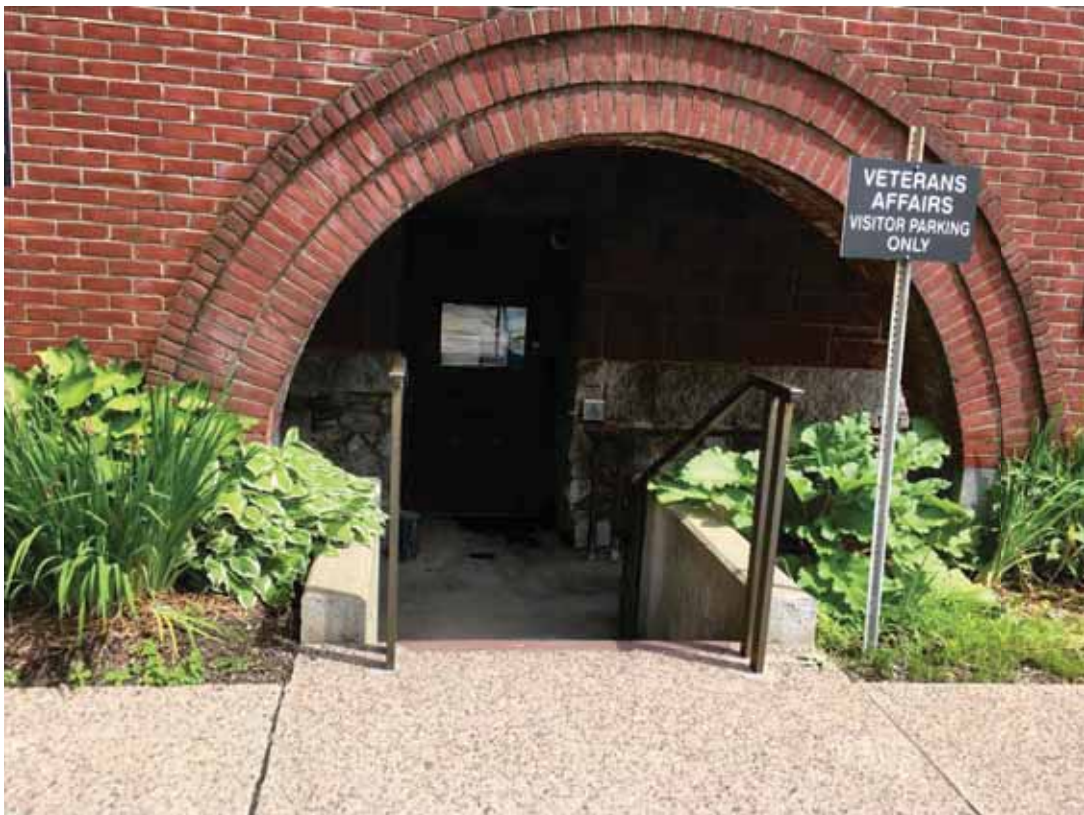
Figure 19: Basement recessed entry

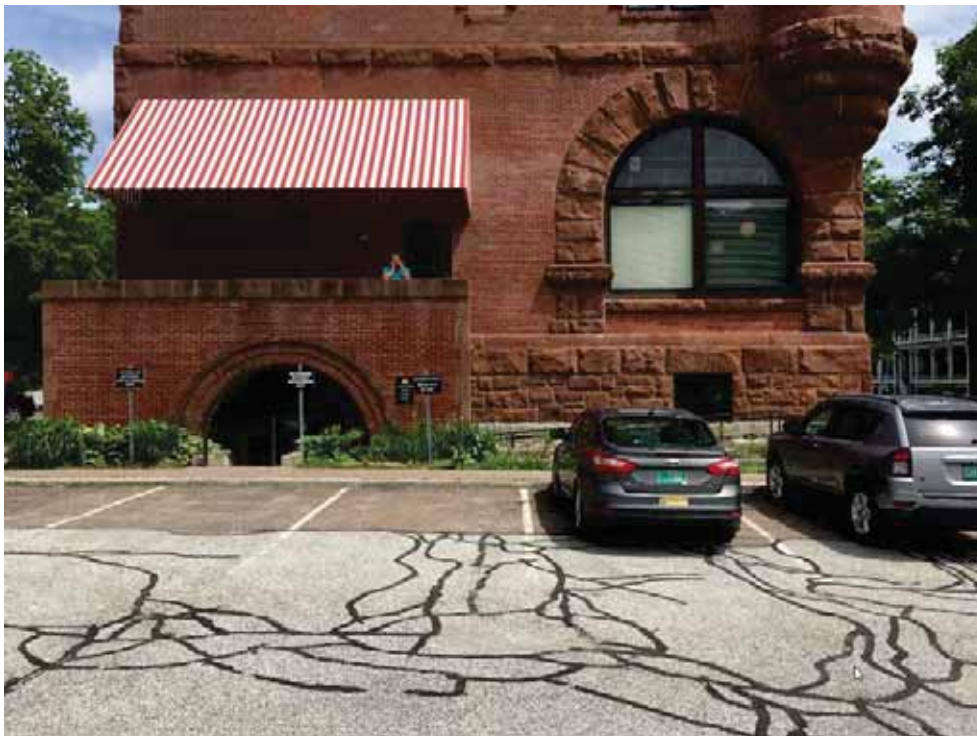
Figure 21: South façade and recessed basement entry

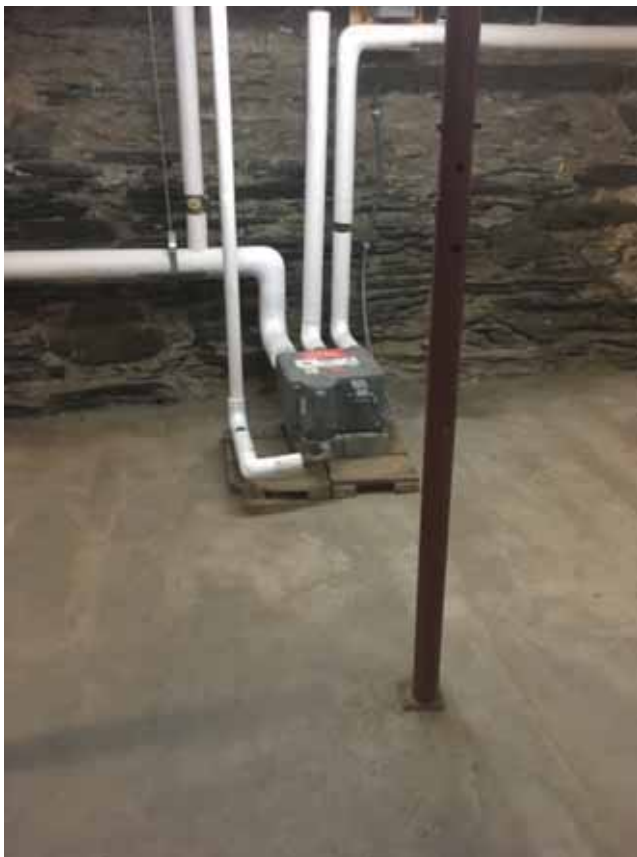
Figure 11: Basement Steam

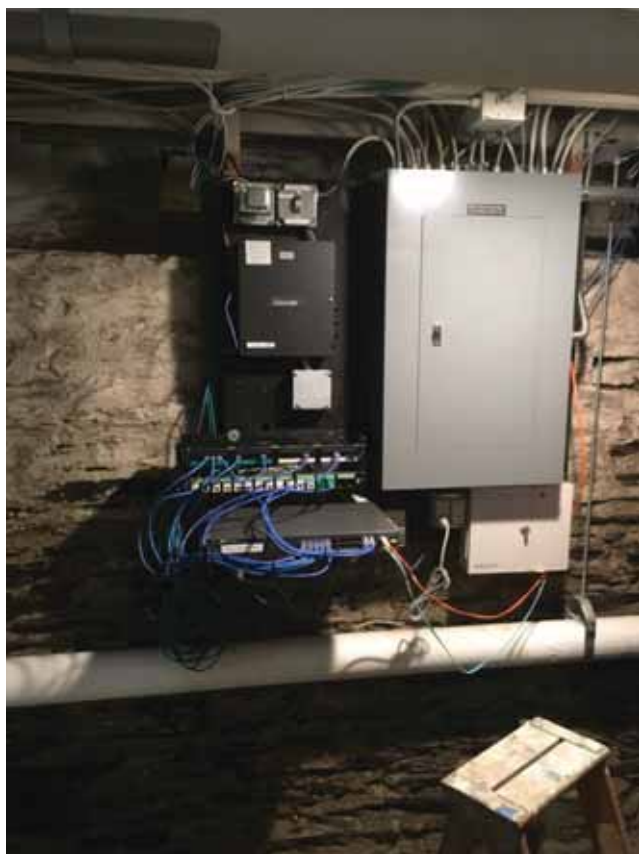
Figure 13: IT, Electrical, Security
