Building Prioritization: Methodology

BGS Subgrant Project - Priority Building Assessment

FLOOD HAZARD MITIGATION ASSESSMENT & ANALYSIS FOR STATE-OWNED BUILDINGS

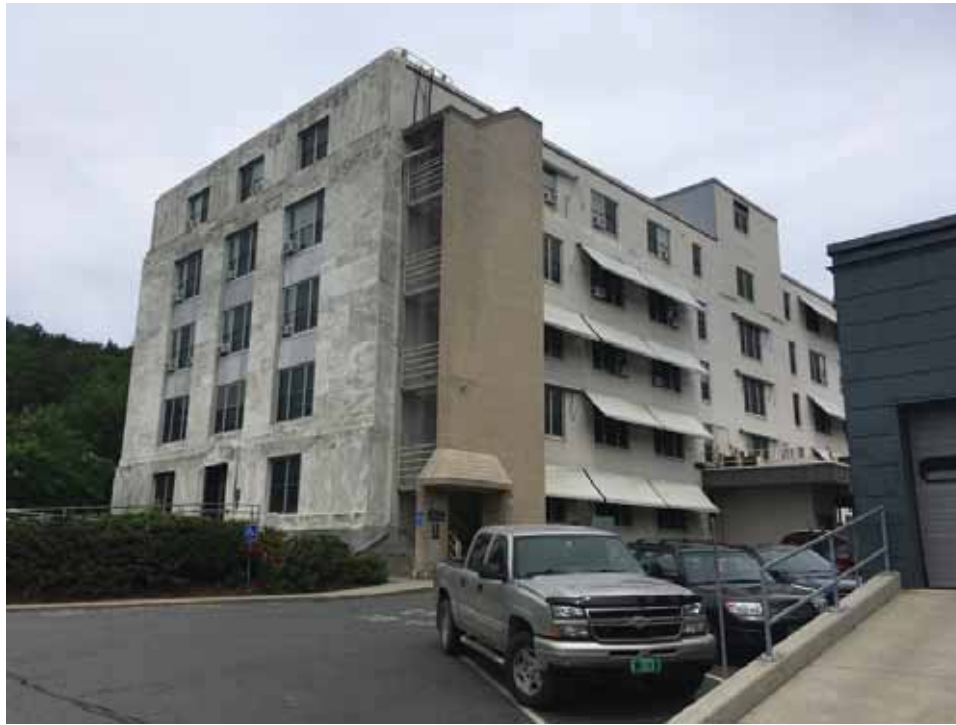
Figure 6: West and south façades

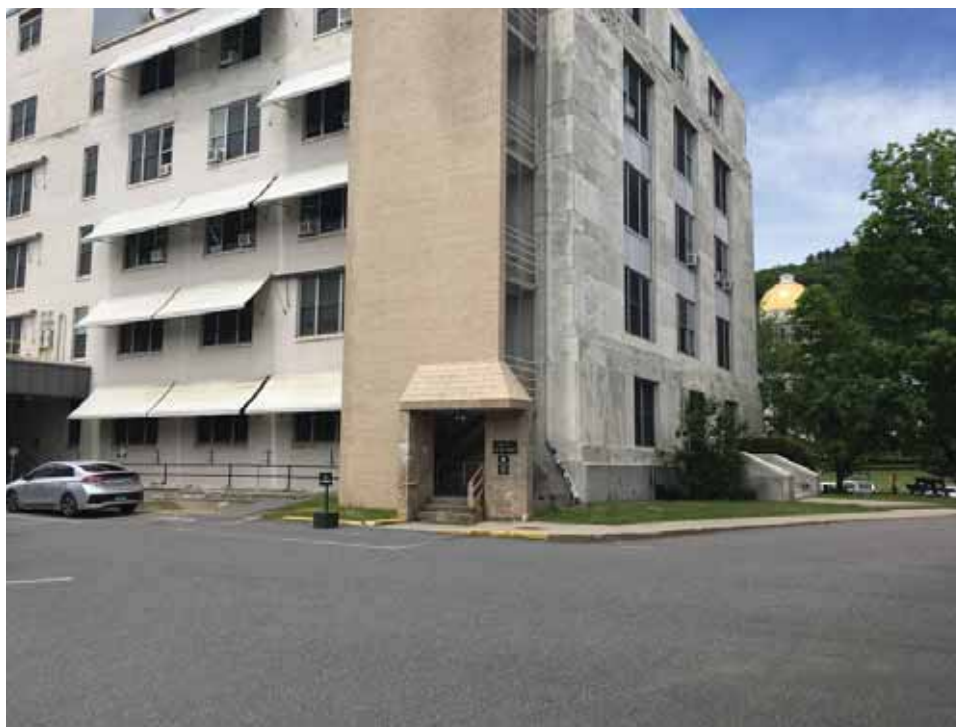
Figure 7: East and south façades

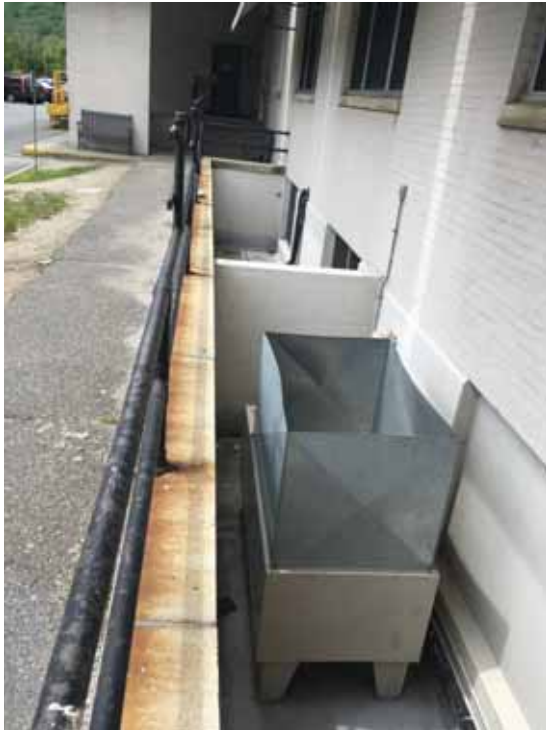
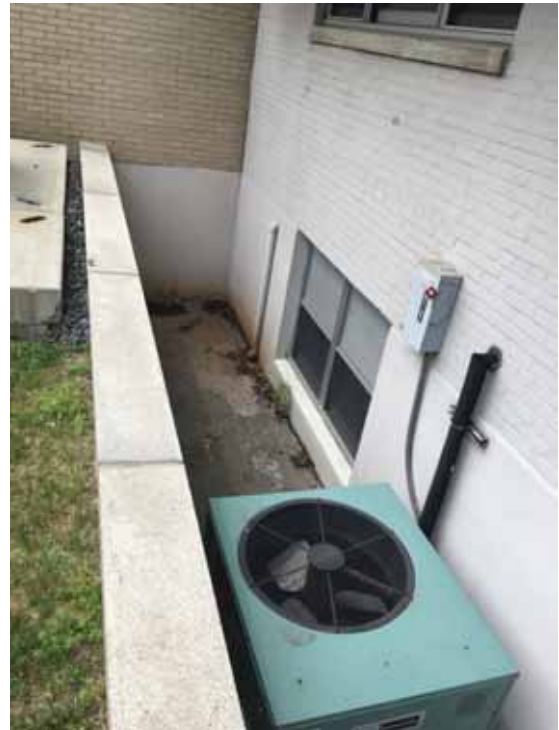
Figure 8 & 9: East areaway

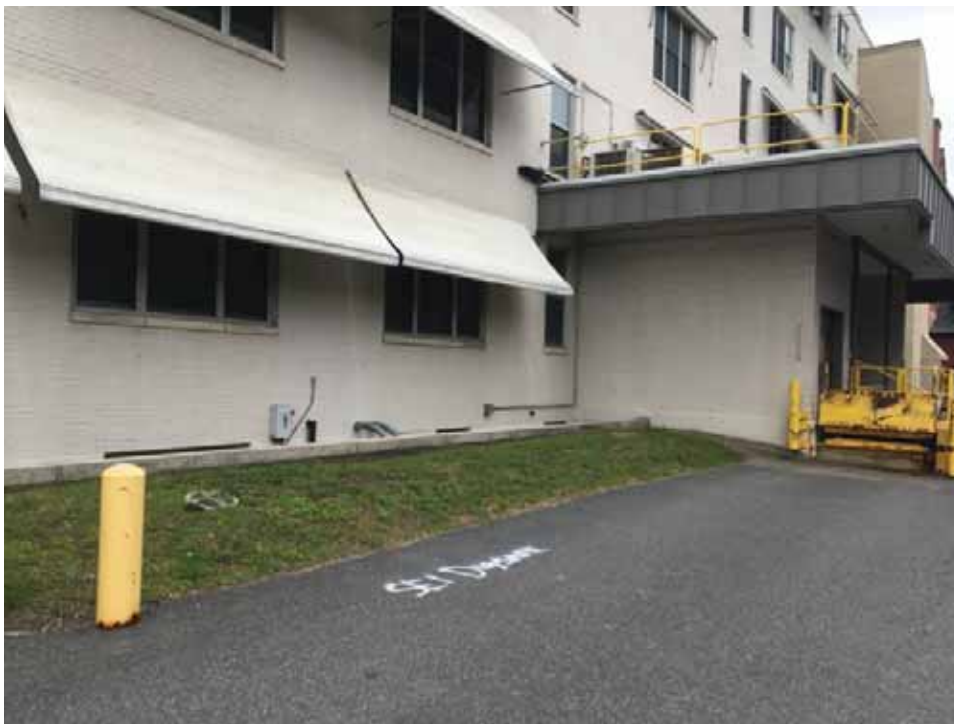
Figure 10: South areaway and loading dock

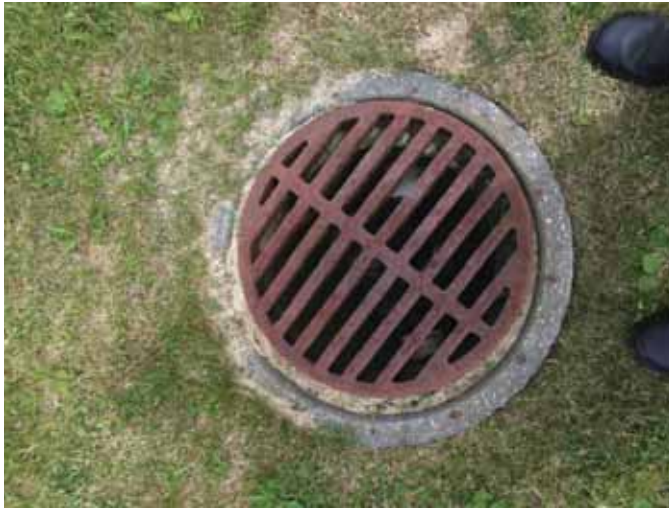
Figure 11: Exterior drainage structure

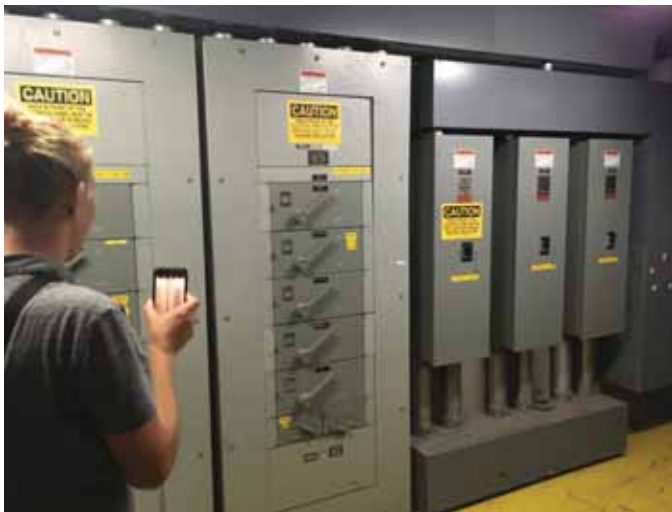
Figure 12: Basement electrical equipment

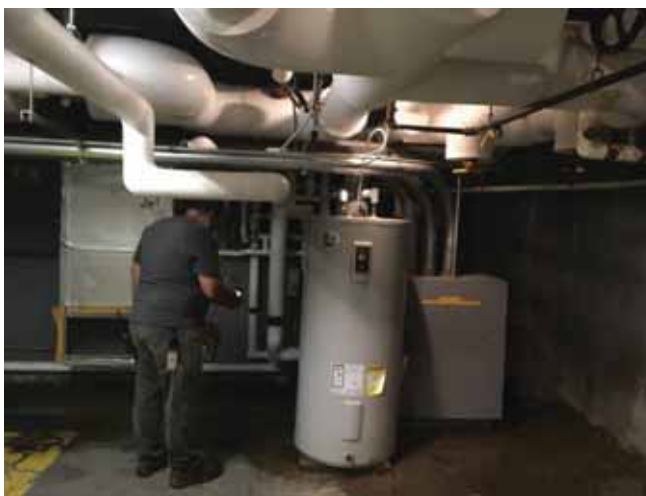
Figure 13: Basement mechanical equipment

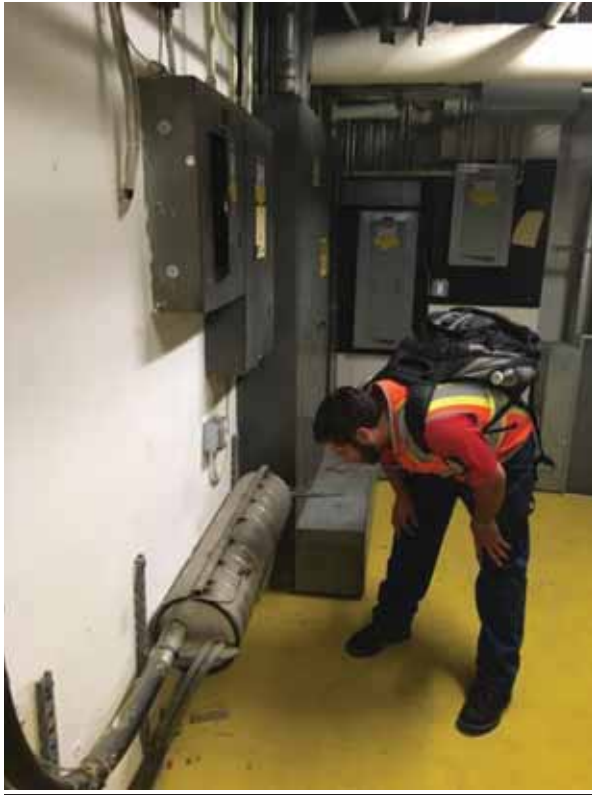
Figure 14: Basement electrical equipment

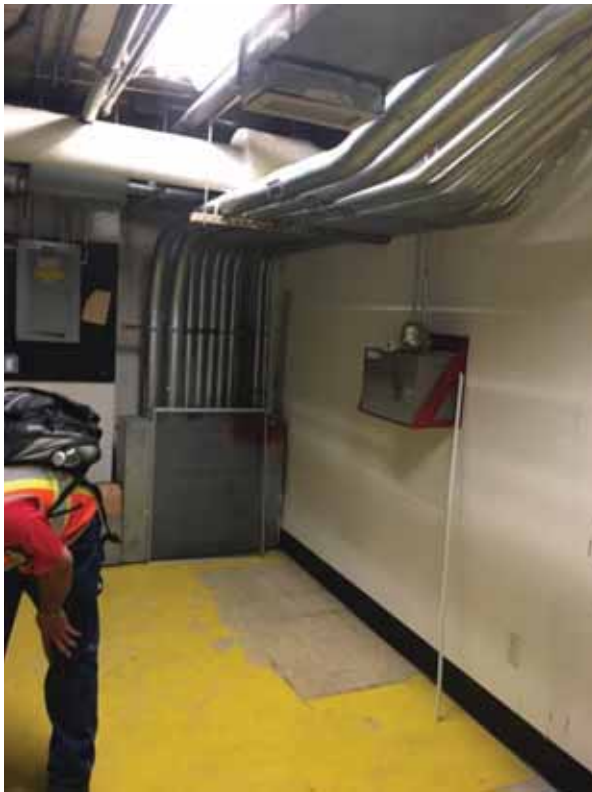
Figure 15: Basement electrical equipment

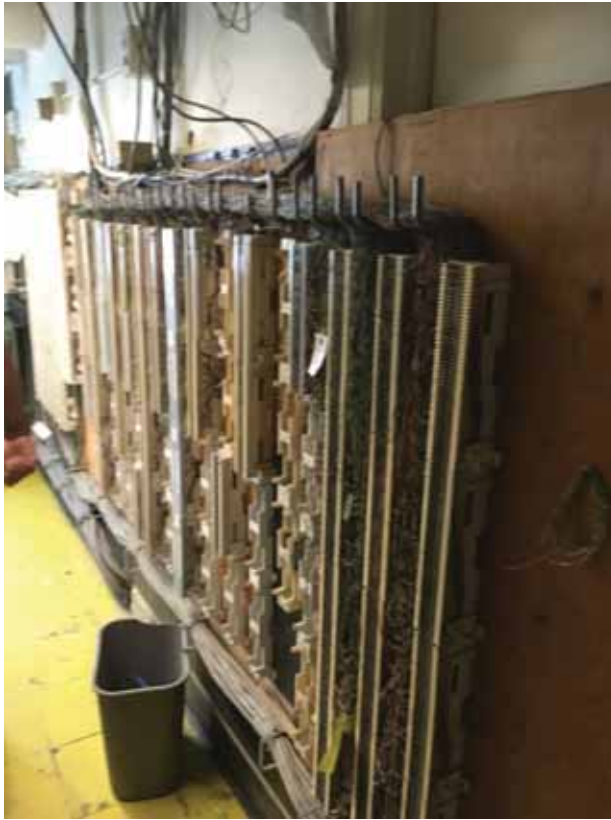
Figure 16: Basement Tel-com equipment

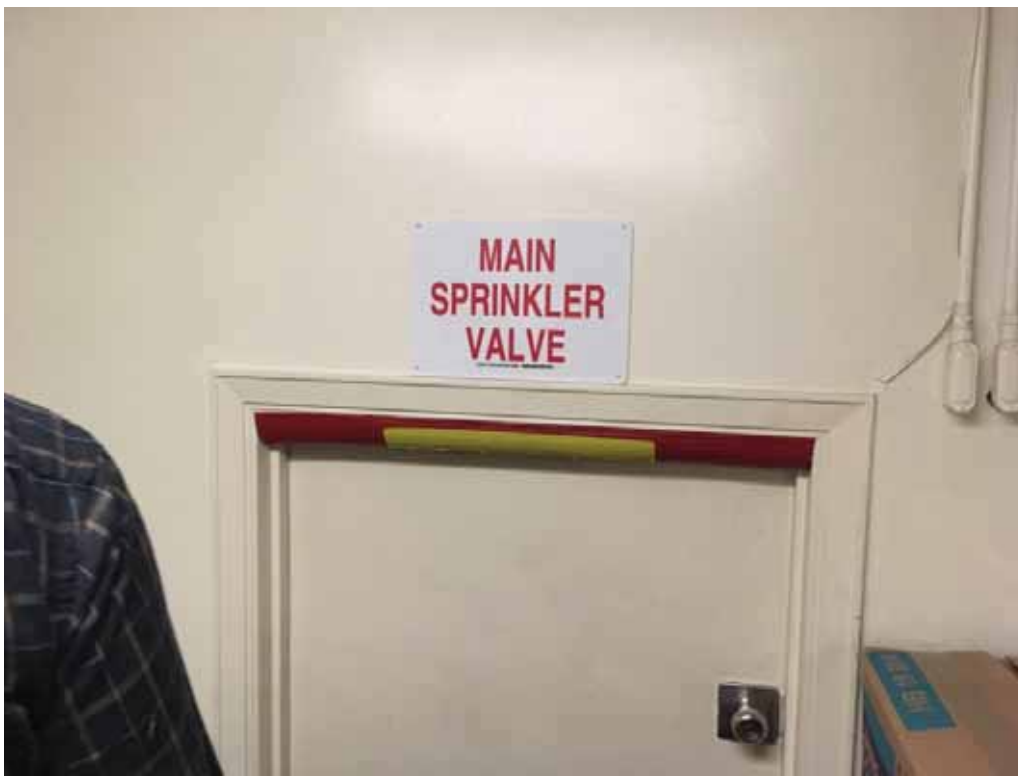
Figure 17: Basement sprinkler room

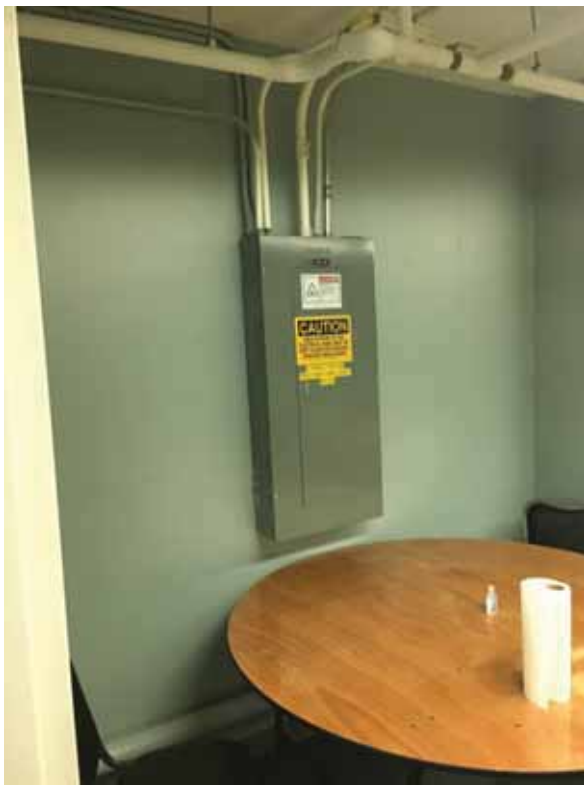
Figure 19: Basement electrical equipment

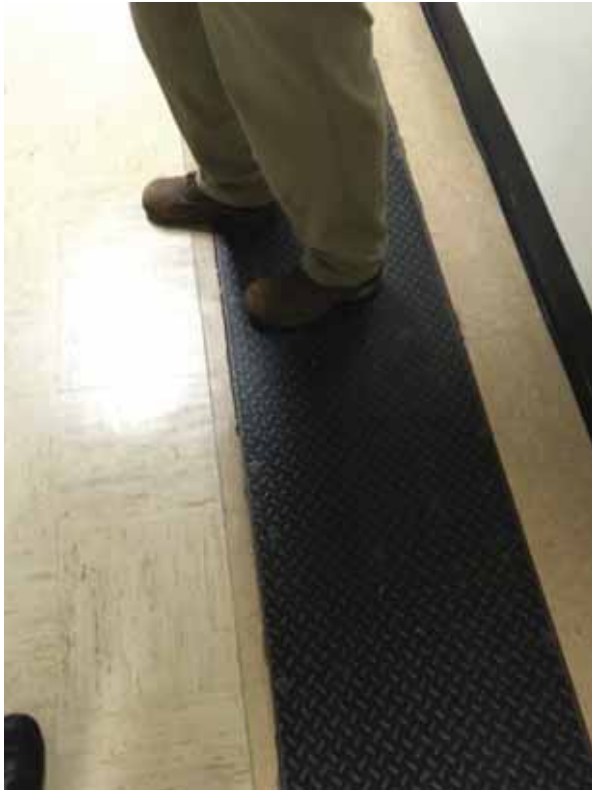
Figure 20: Basement floor trench with cover plate

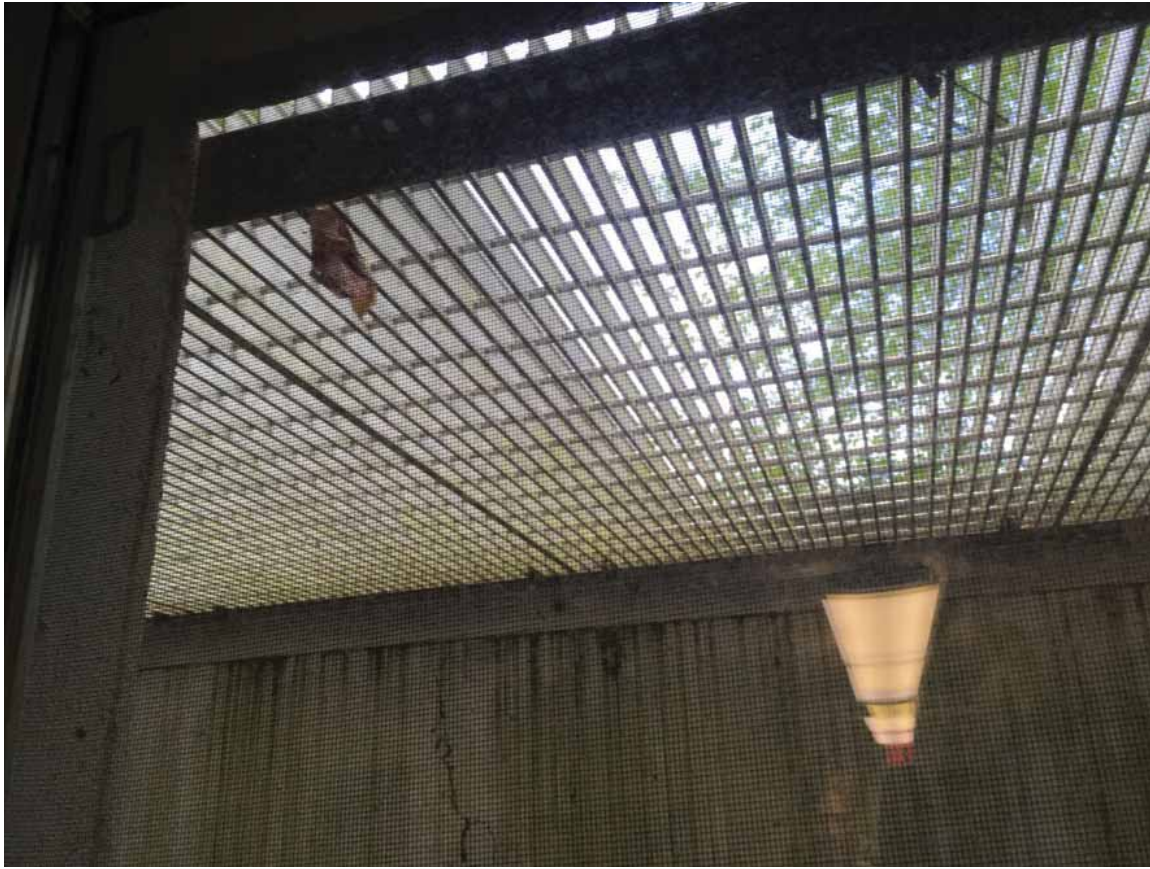
Figure 26: Areaway with grate cover

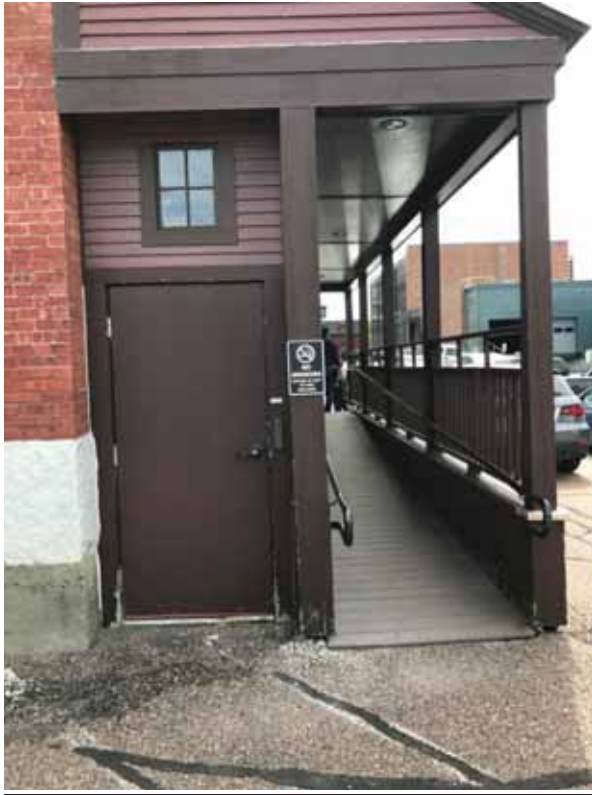
Figure 10: Basement access door

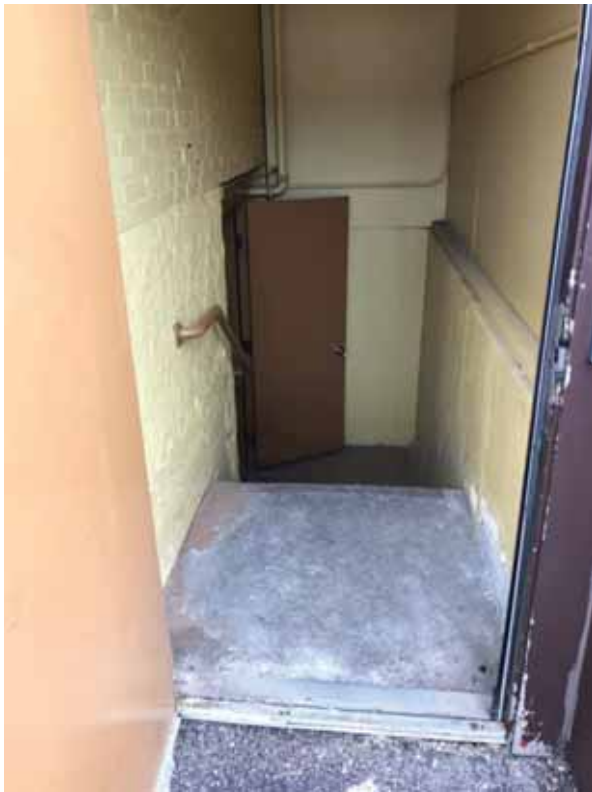
Figure 11: Basement access door open and stairs to basement

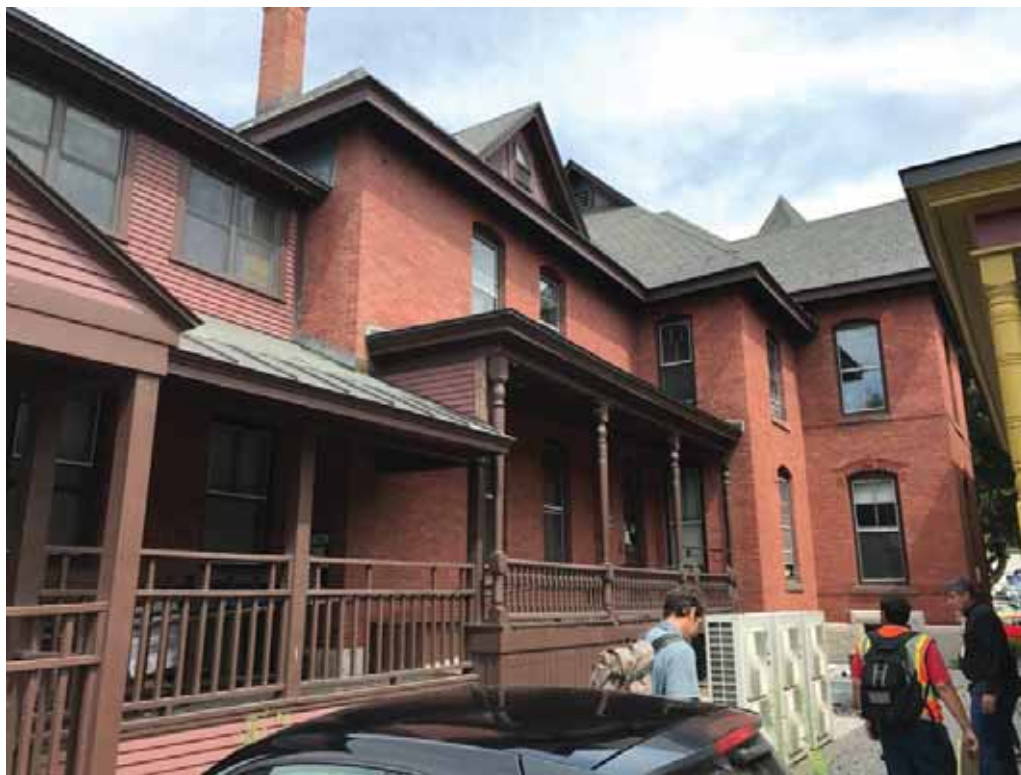
Figure 13: Site mounted split system AC units

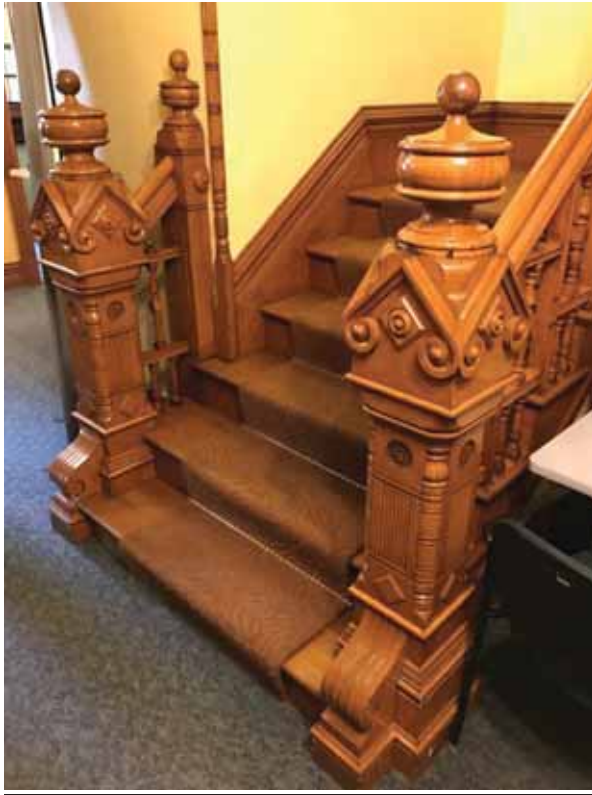
Figure 16: First floor woodwork (understood to be above predicted flood elevations)

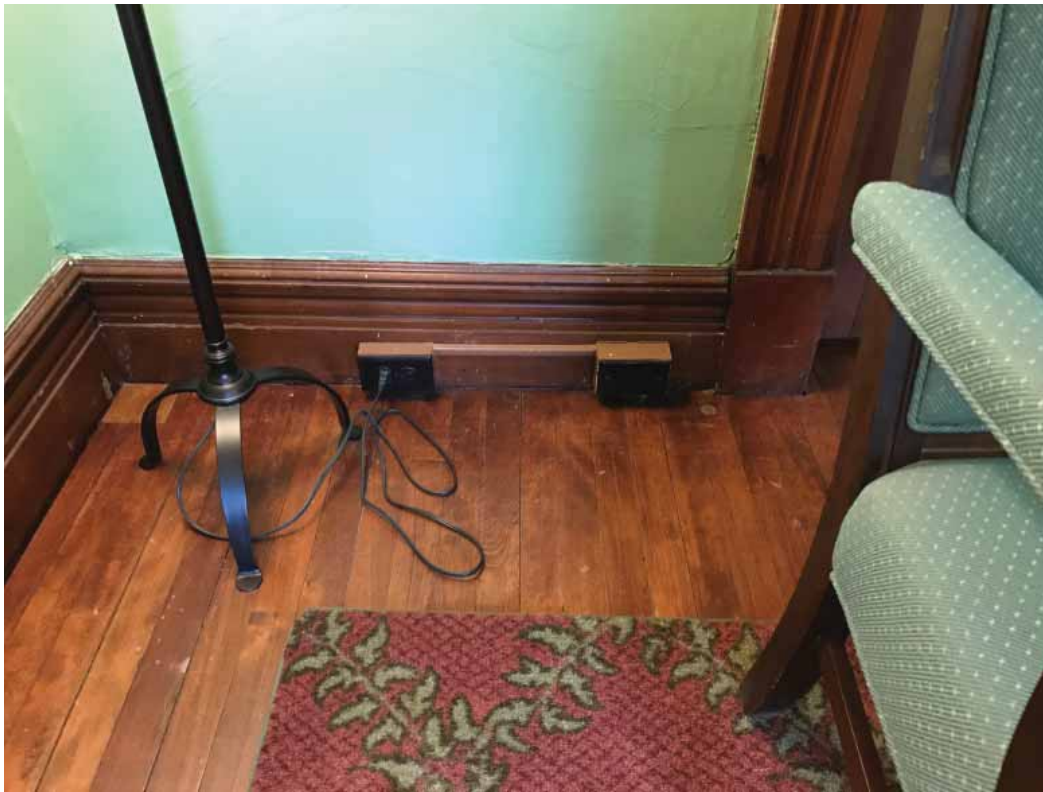
Figure 17: First floor woodwork (understood to be above predicted flood elevations)

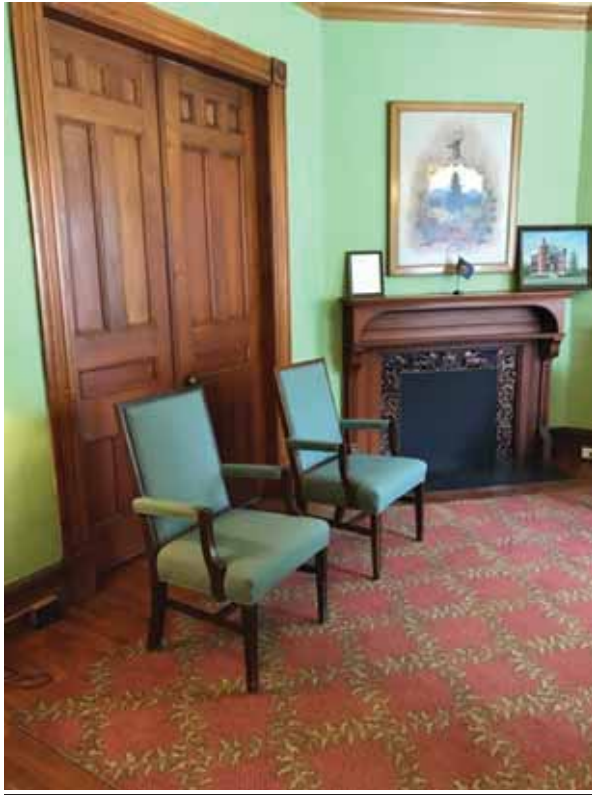
Figure 18: First floor woodwork (understood to be above predicted flood elevations)

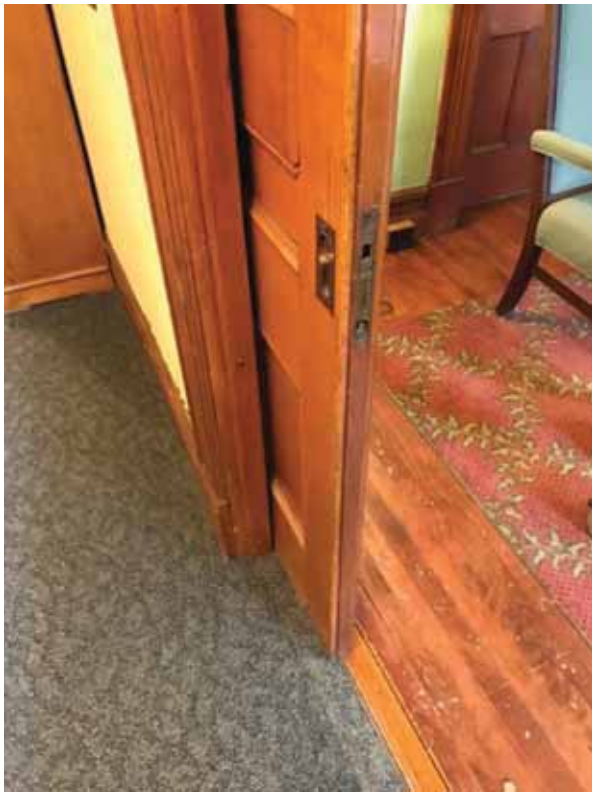
Figure 19: First floor woodwork (understood to be above predicted flood elevations)

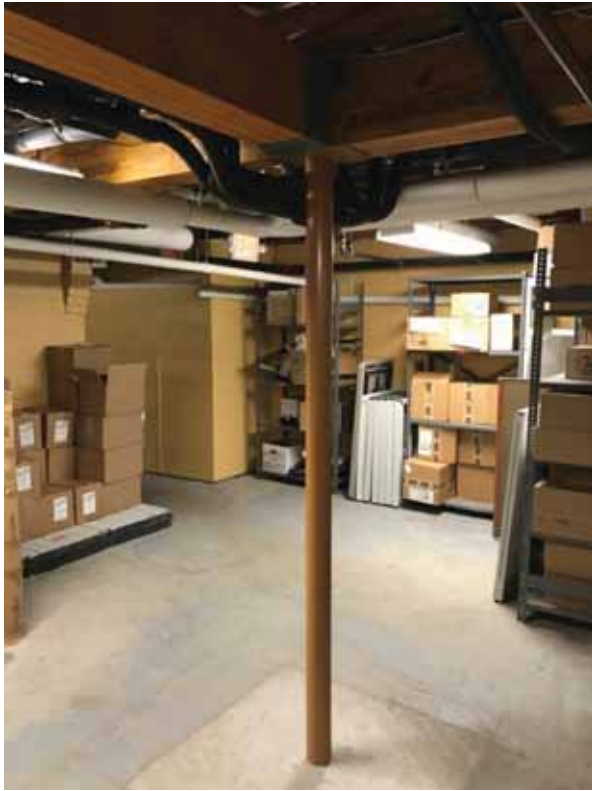
Figure 22: Basement column and stored supplies

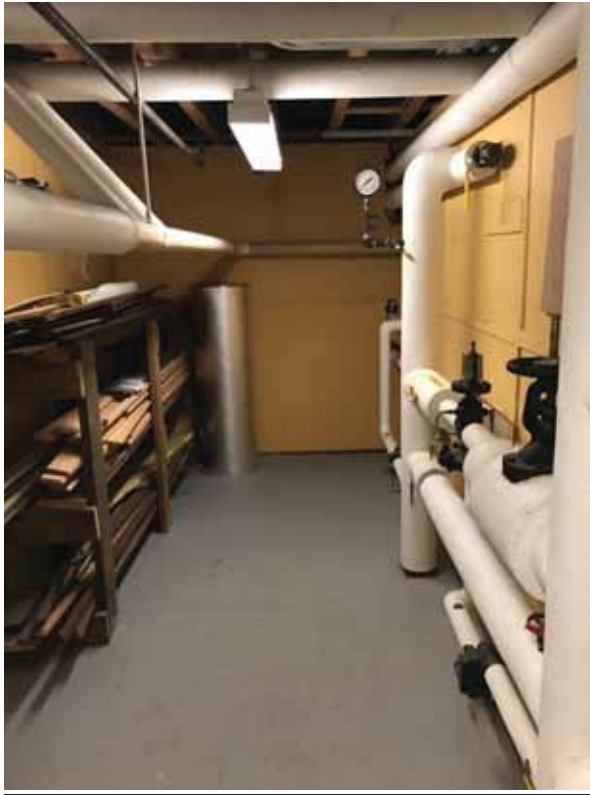
Figure 24: Basement steam

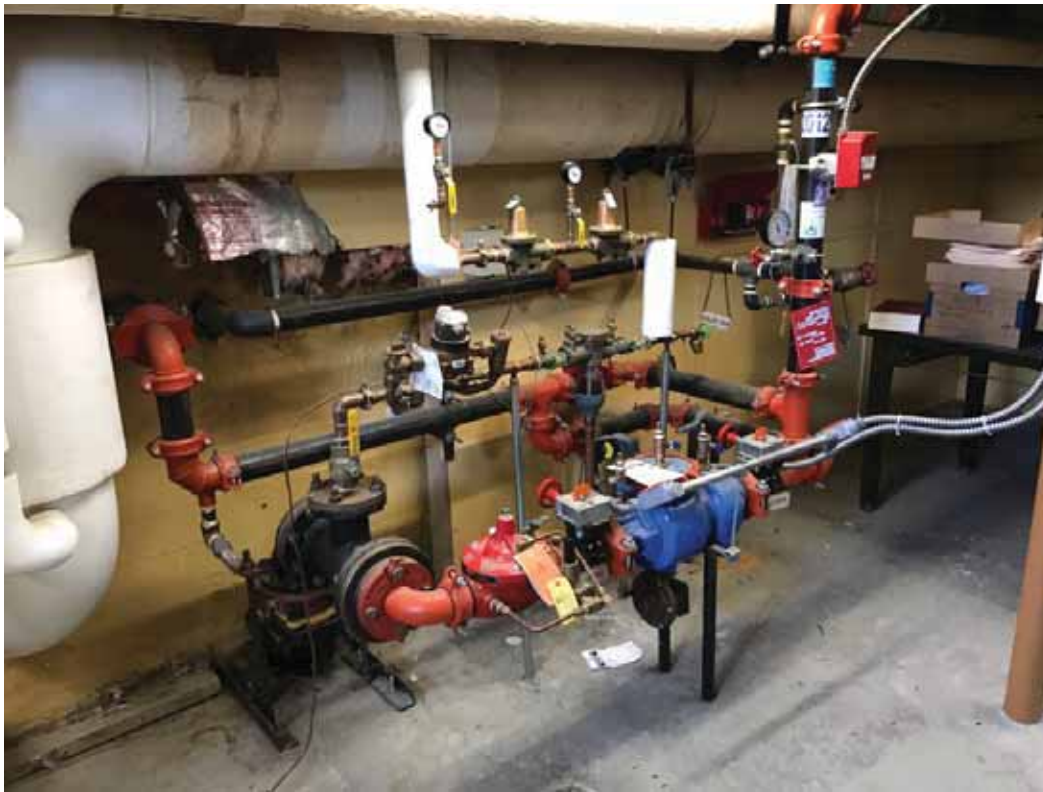
Figure 25: Basement sprinkler riser

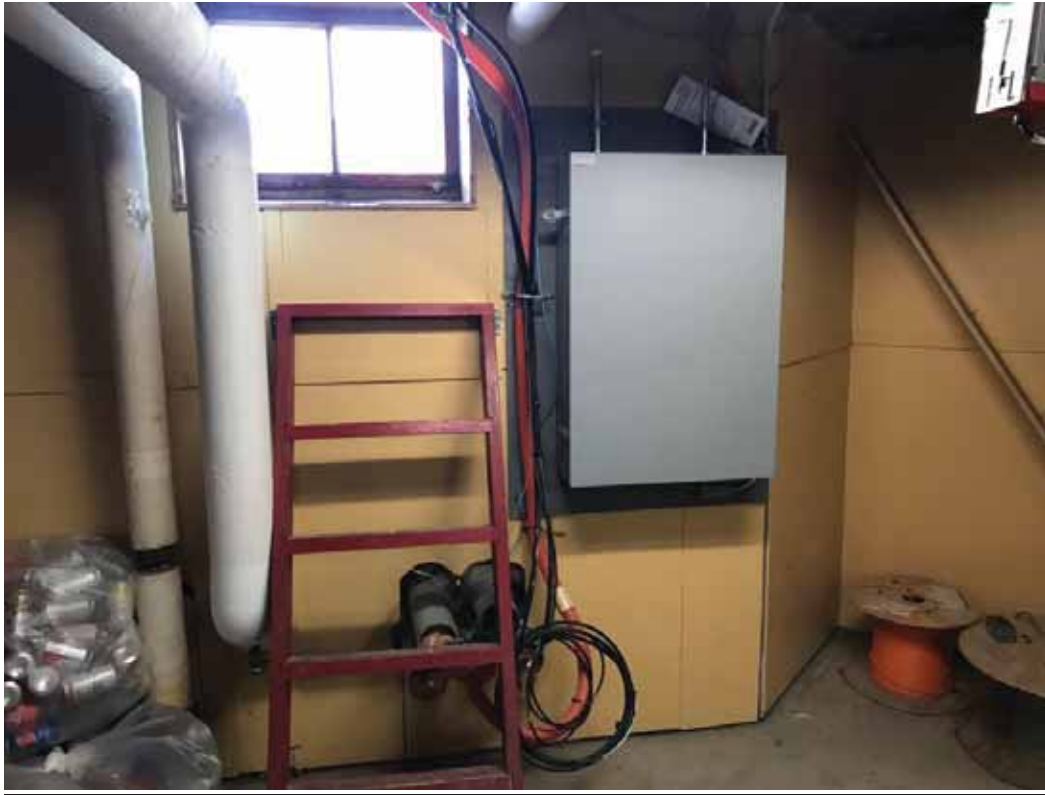
Figure 26: Basement fiber-optic and electrical panel

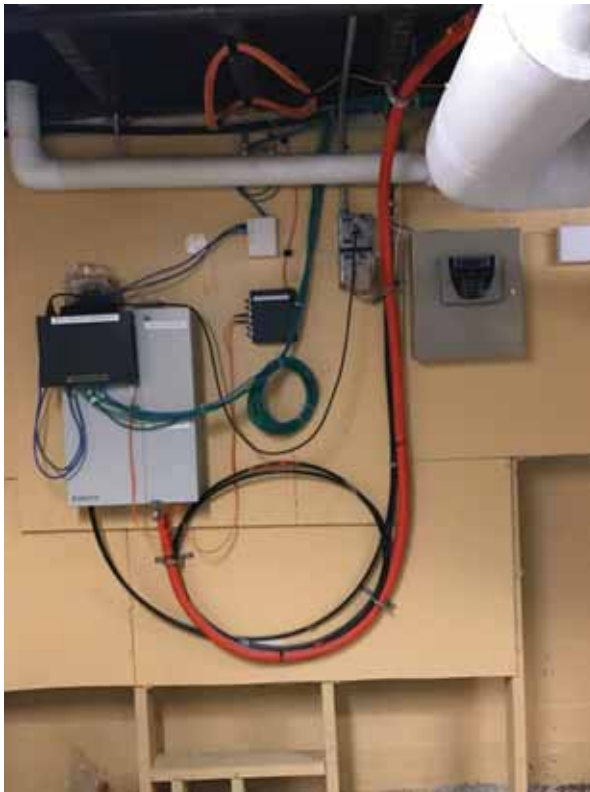
Figure 27: Basement fiber-optic

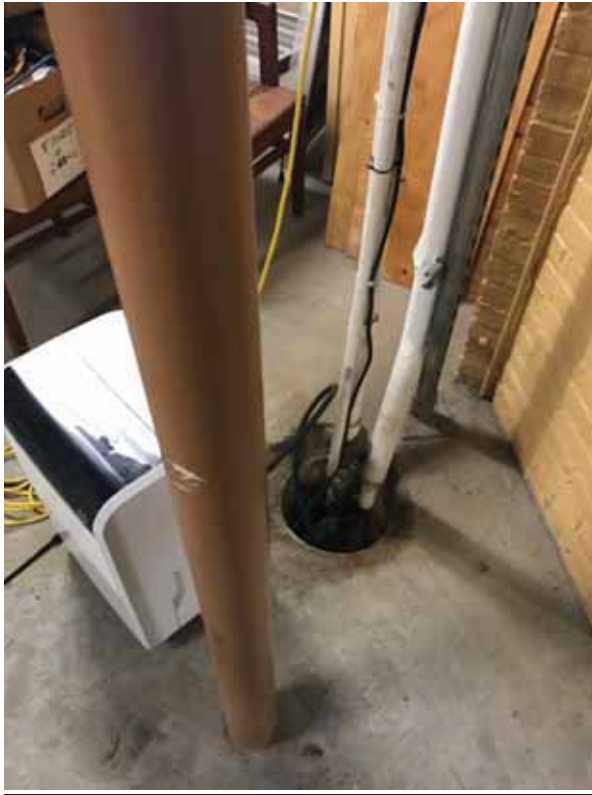
Figure 28: Basement sump

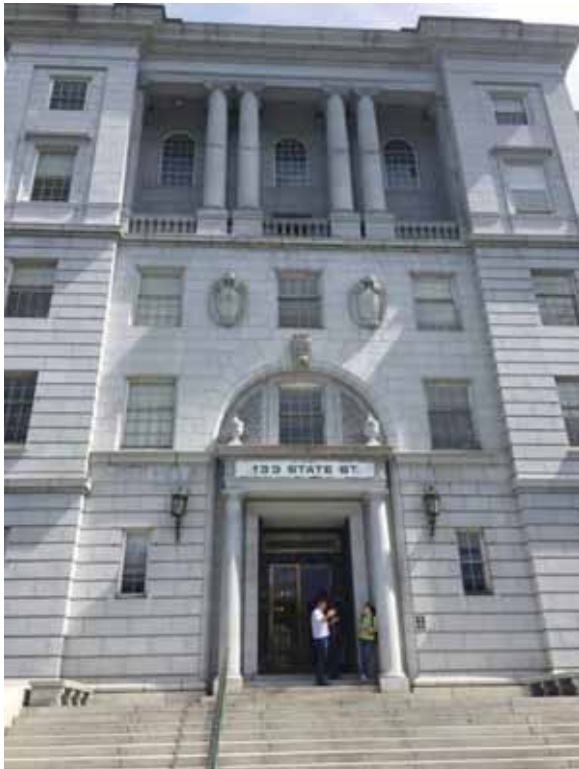
Figure 5: South façade and main entrance

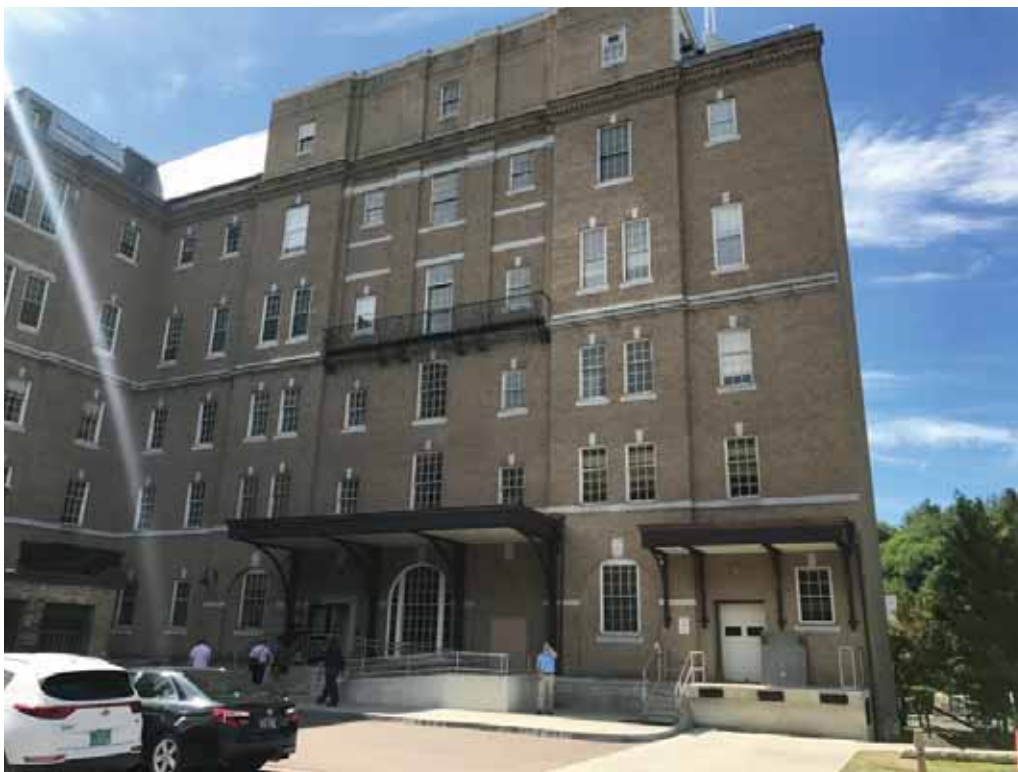
Figure 6: North façade and rear entrance

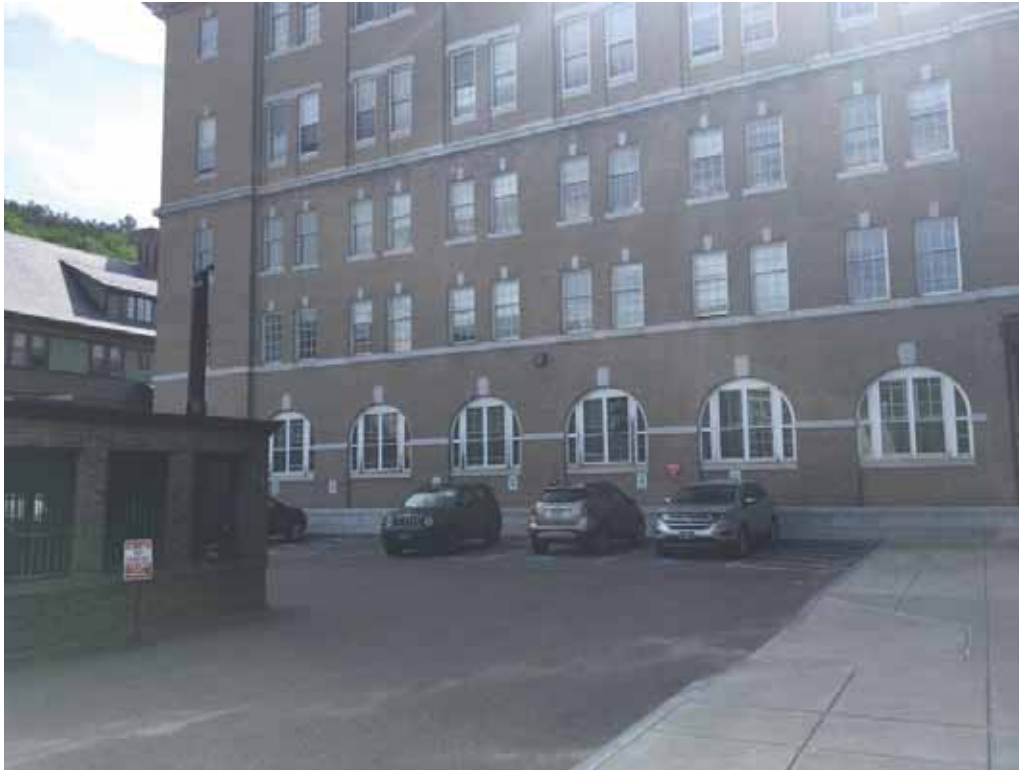
Figure 7: Northwest façade

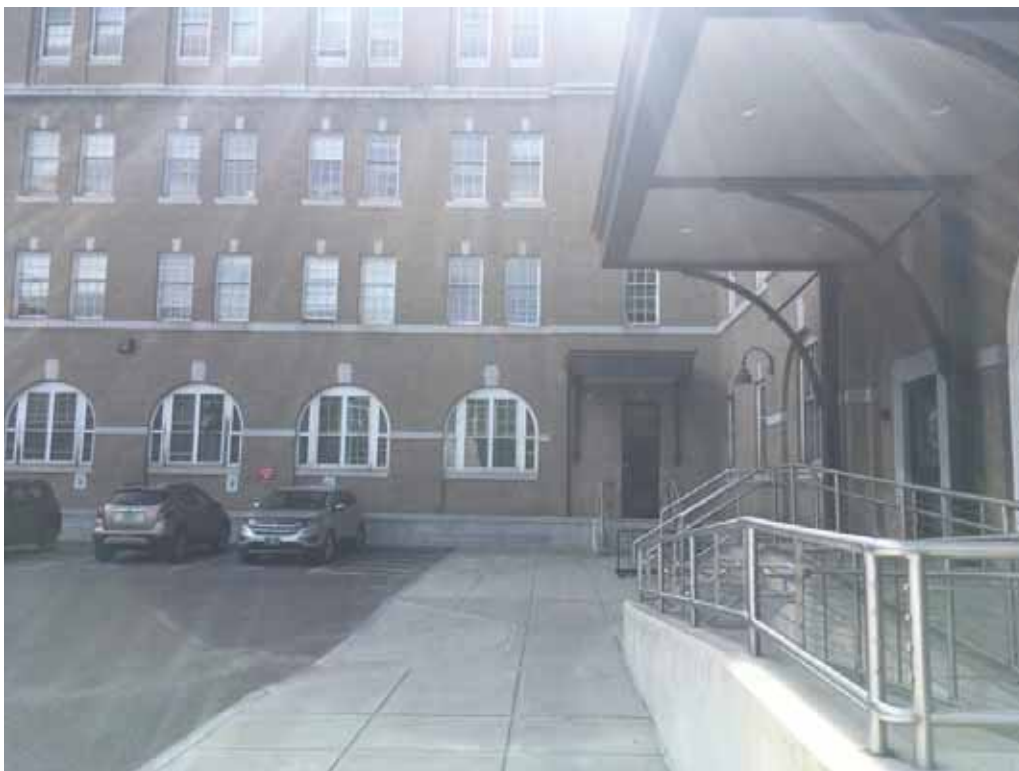
Figure 8: North and west façades

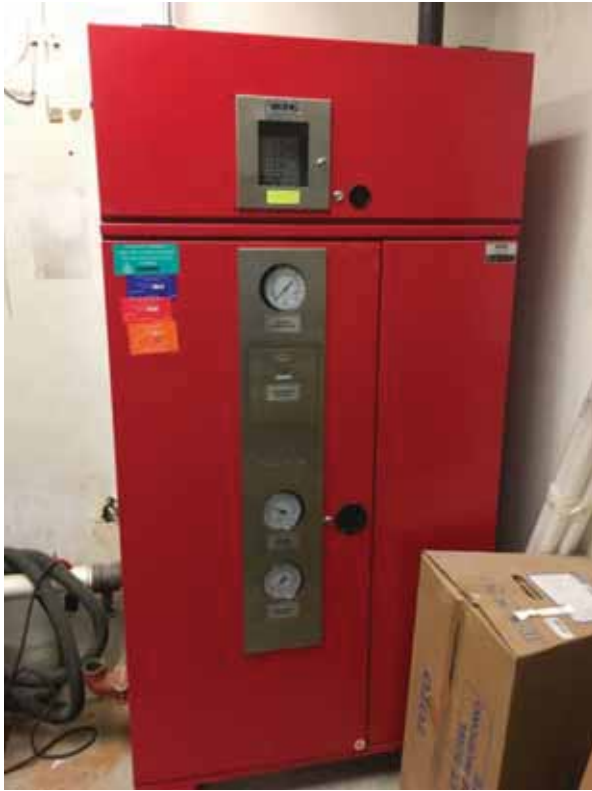
Figure 11: Basement level fire safety equipment

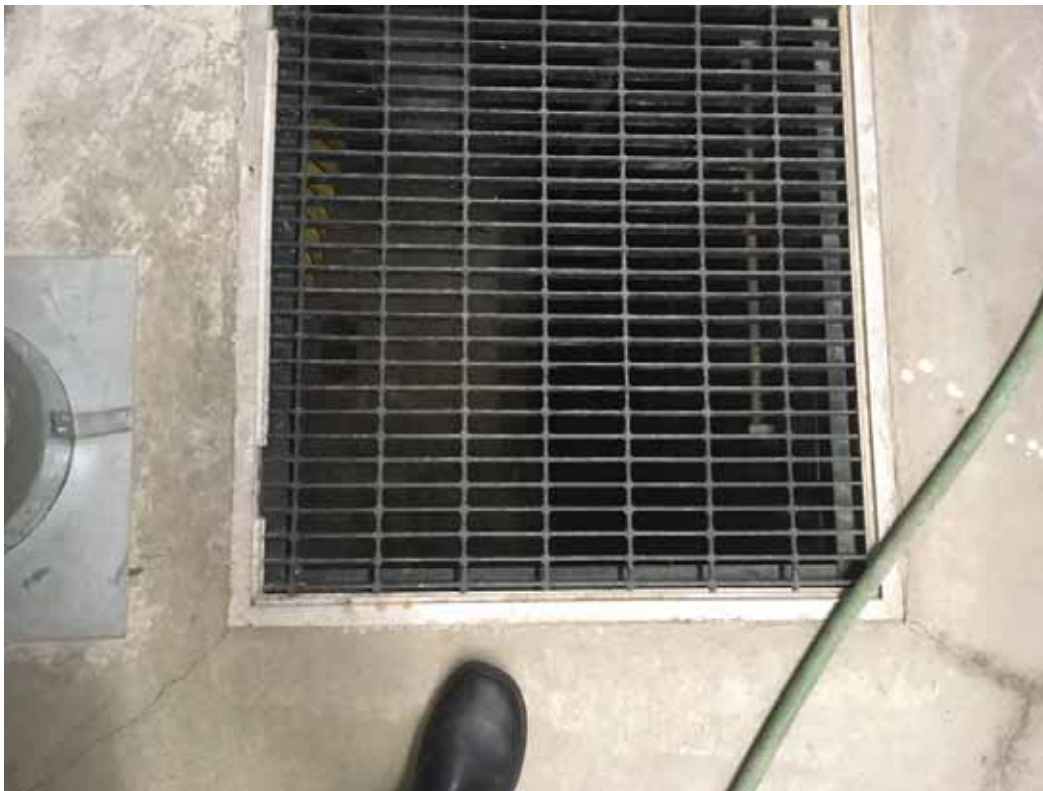
Figure 12: Sub-basement floor access grate to lower areaway(s)

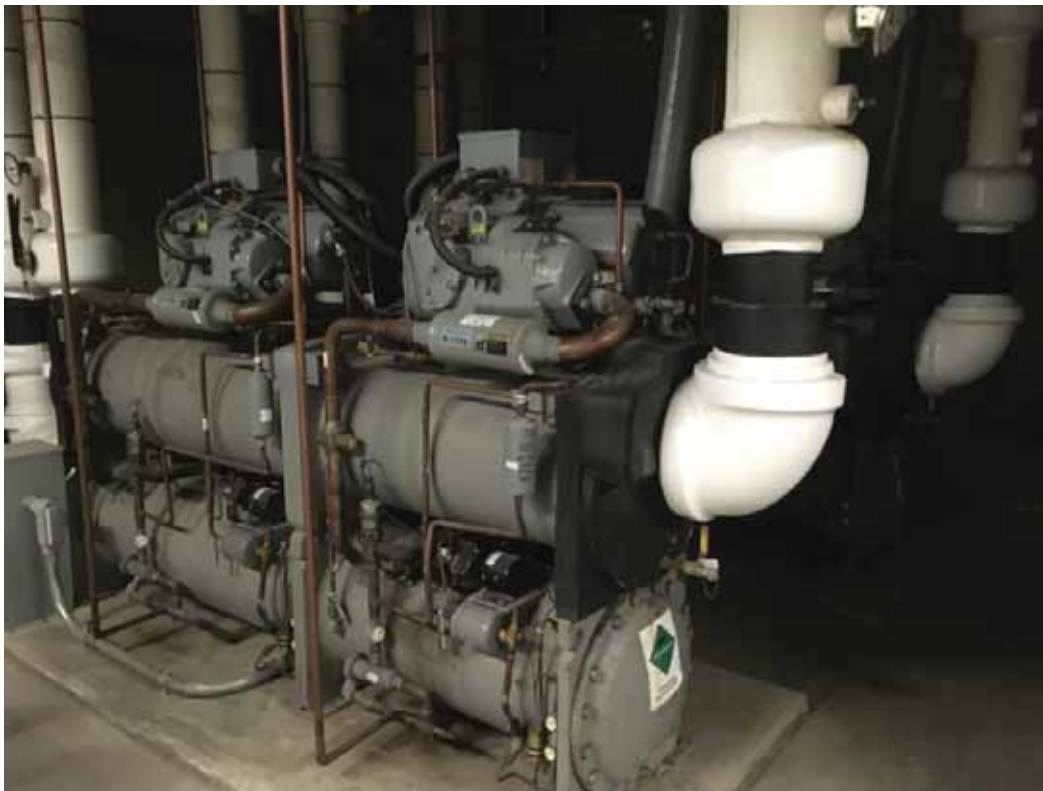
Figure 14: Sub-basement steam piping

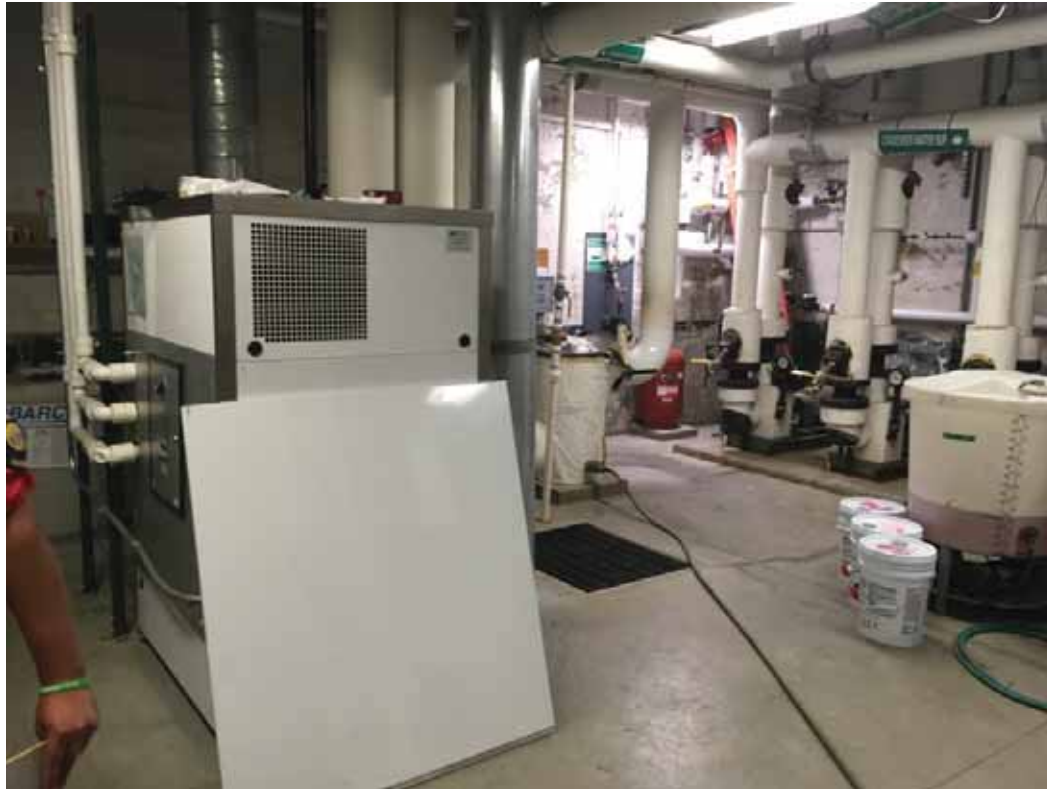
Figure 15: Sub-basement mechanicals and steam

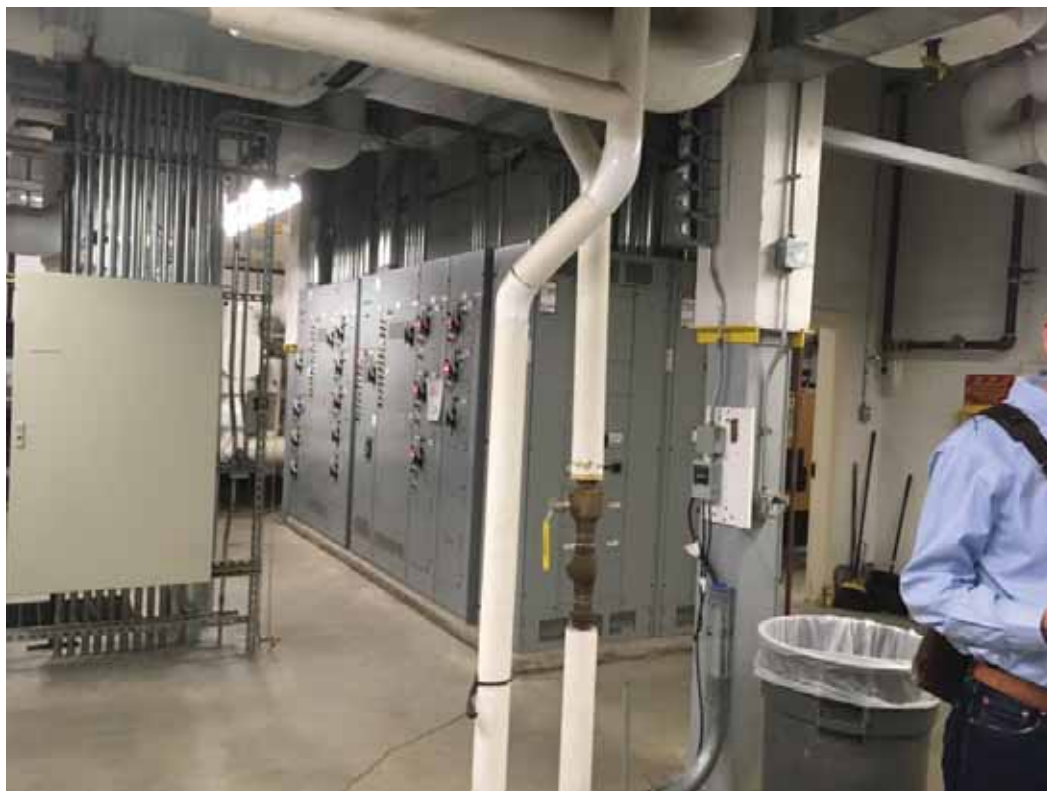
Figure 16: Sub-basement electrical panels
