Building Prioritization: Methodology

BGS Subgrant Project - Priority Building Assessment

FLOOD HAZARD MITIGATION ASSESSMENT & ANALYSIS FOR STATE-OWNED BUILDINGS

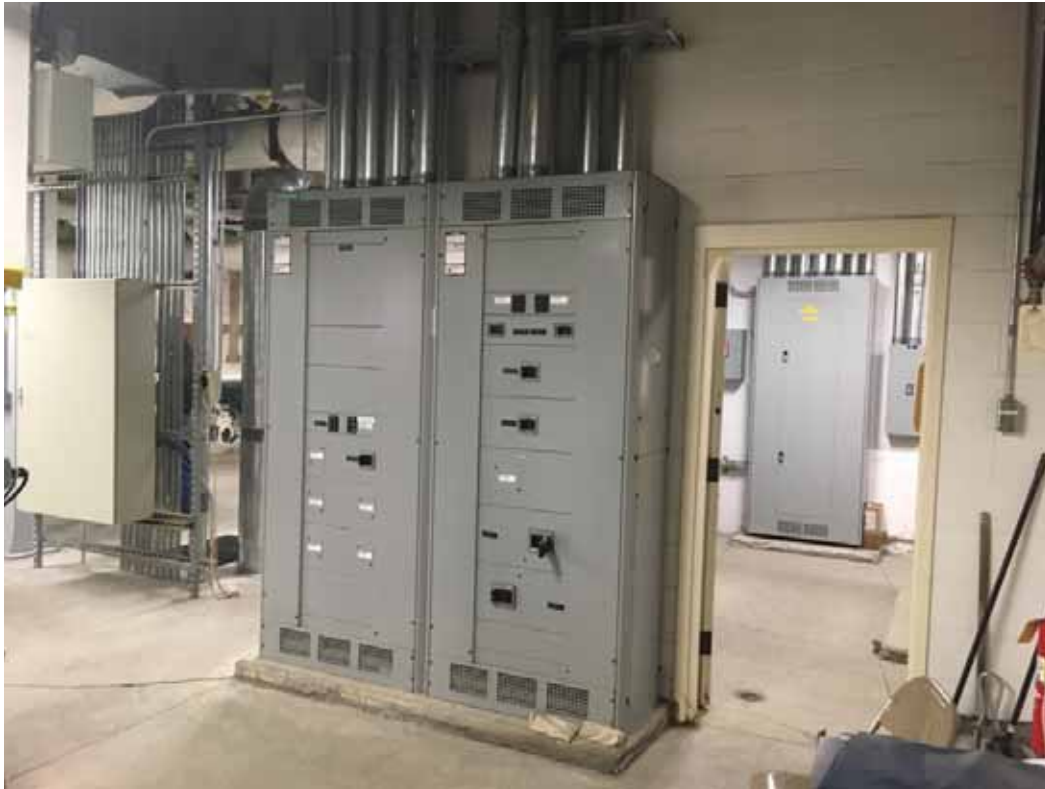
Figure 17: Sub-basement electrical panels

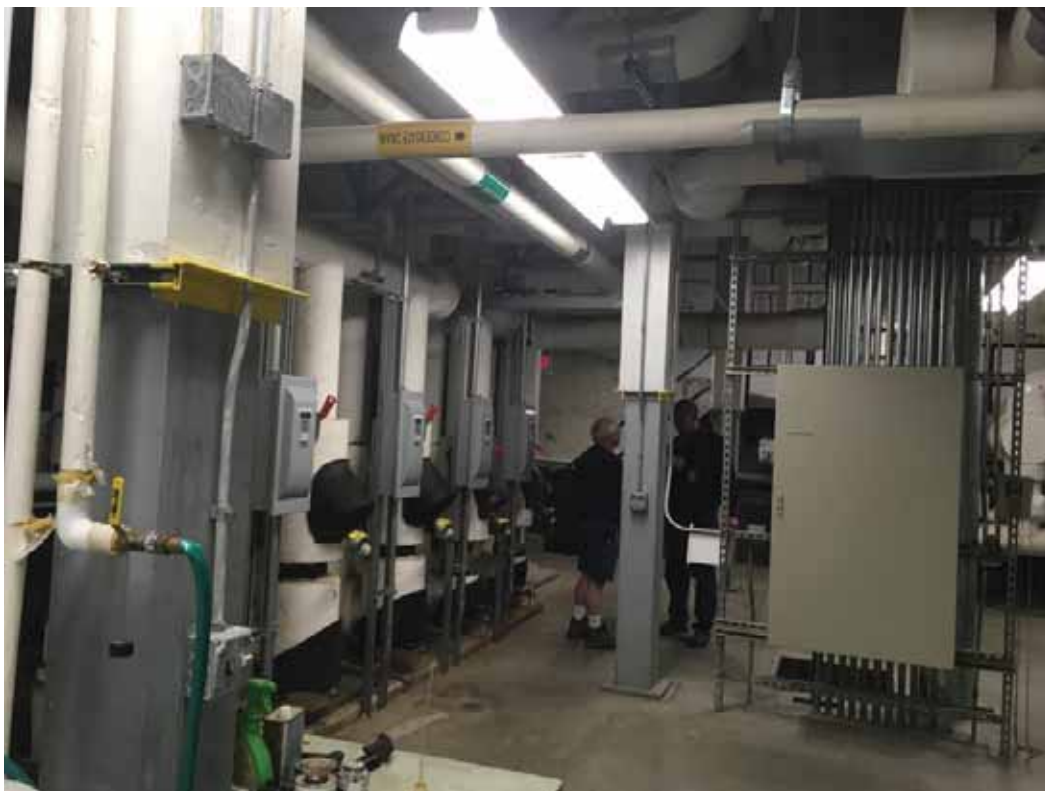
Figure 18: Sub-basement electrical panels / mechanicals

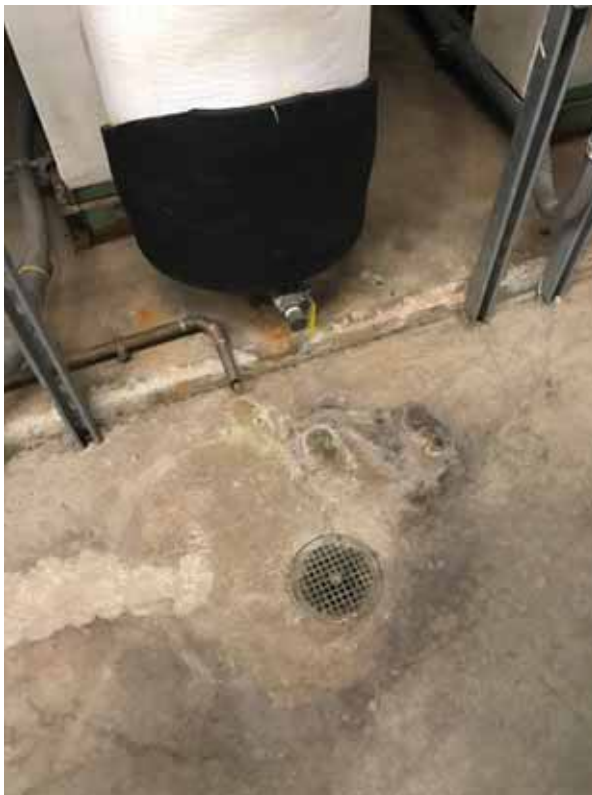
Figure 20: Sub-basement floor drain

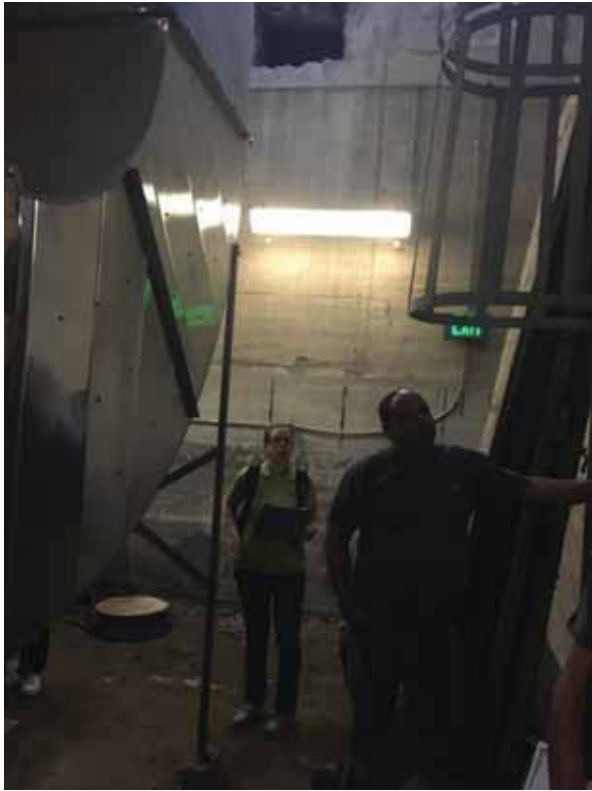
Figure 23: Roofed areaway (former ice storage tower) from sub-basement to rear parking area

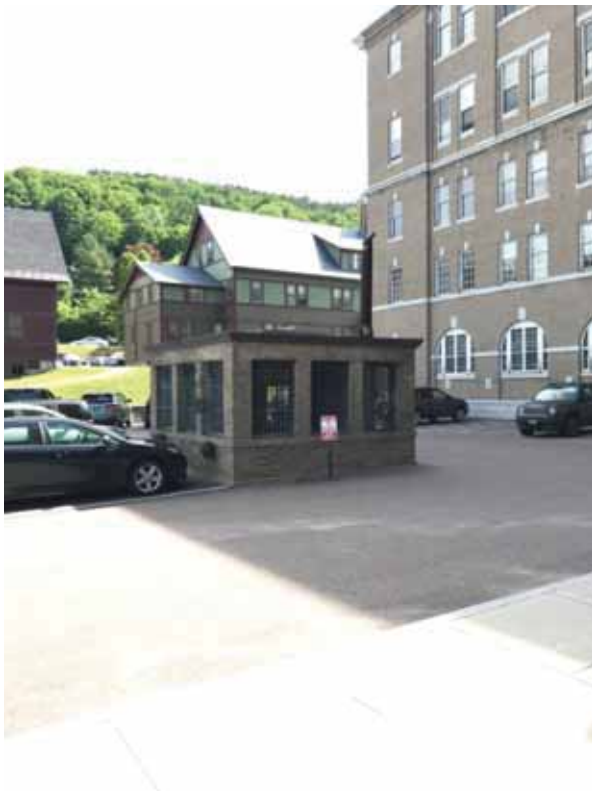
Figure 24: Roofed areaway (former ice storage tower) at the rear parking area

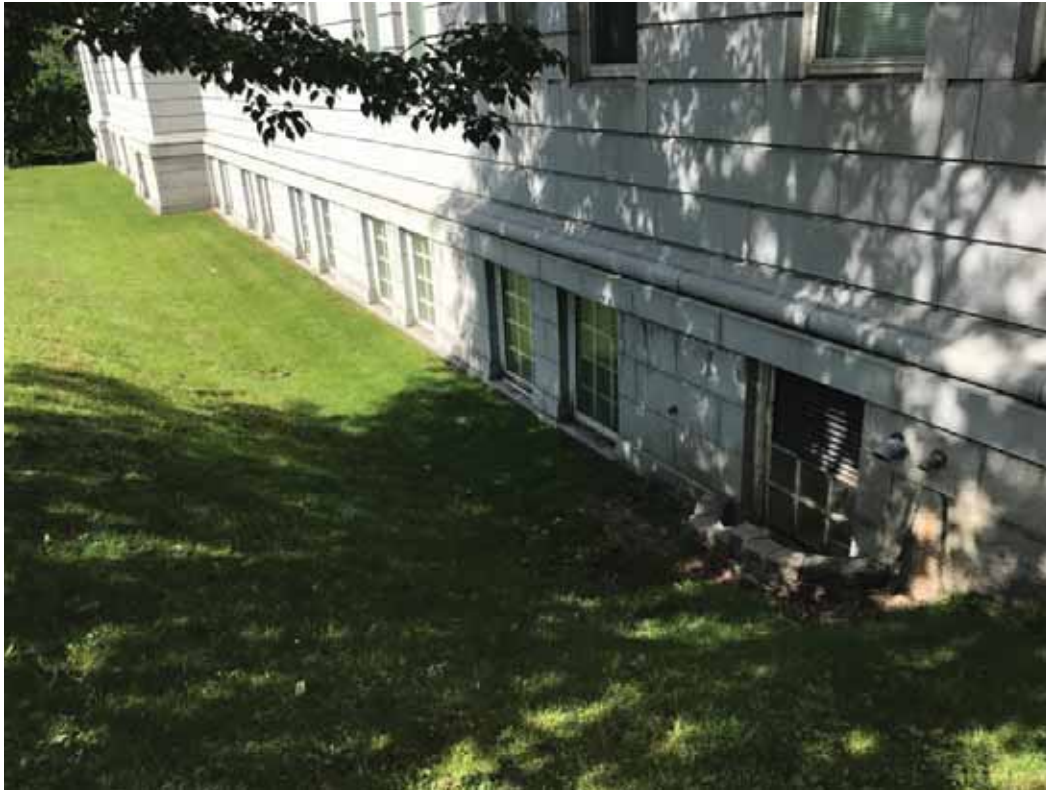
Figure 25: Basement windows at building perimeter (east façade)

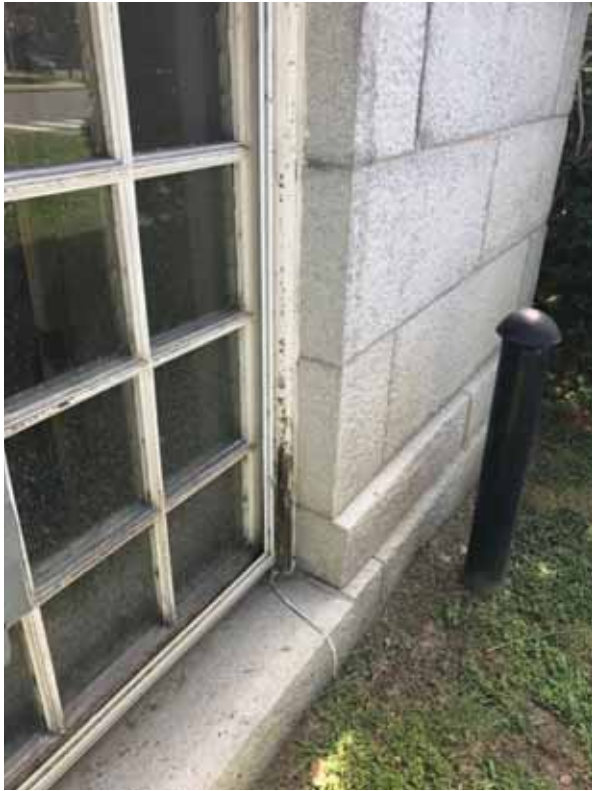
Figure 27: Basement window (typical)

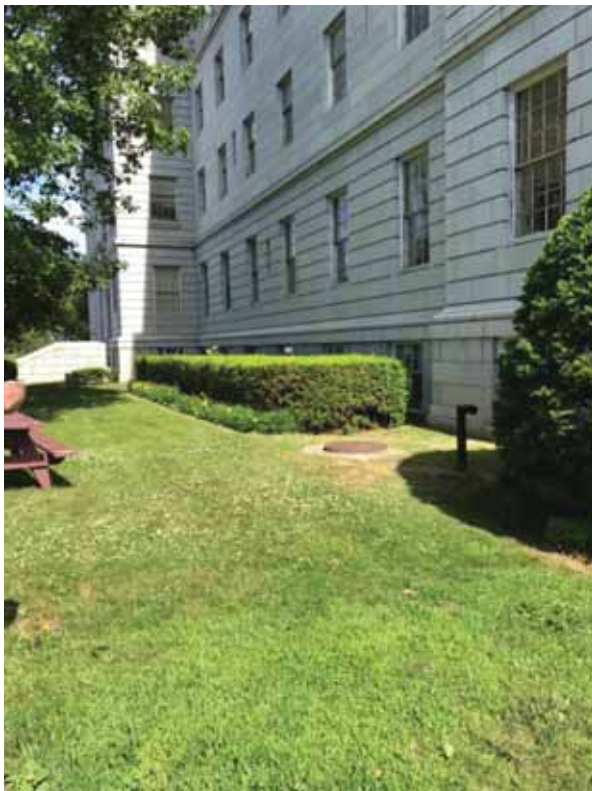
Figure 28: Basement windows (north facade), first floor at top of stairs

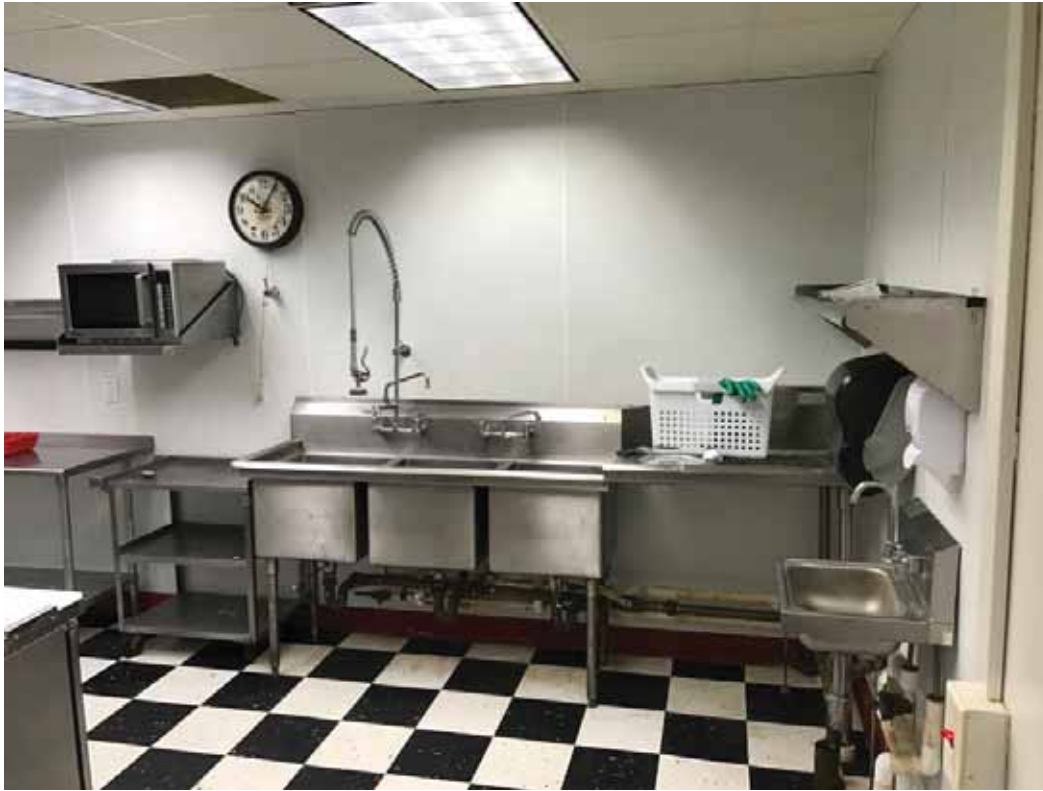
Figure 29: Basement kitchen

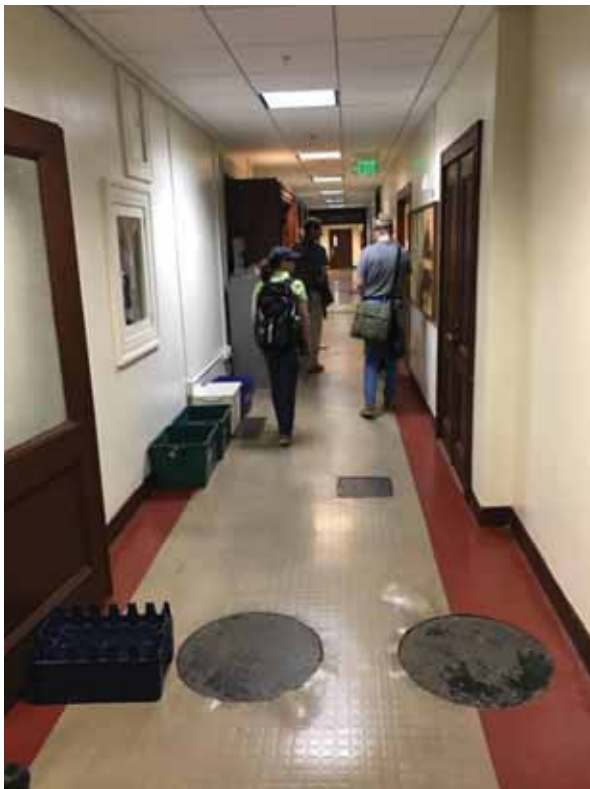
Figure 30: Basement hallway and access panels

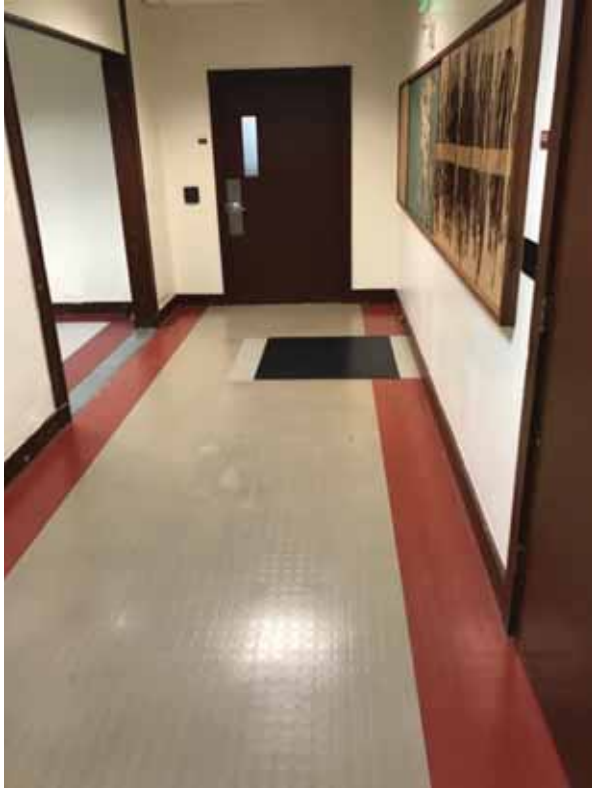
Figure 31: Basement hallway with floor access panels

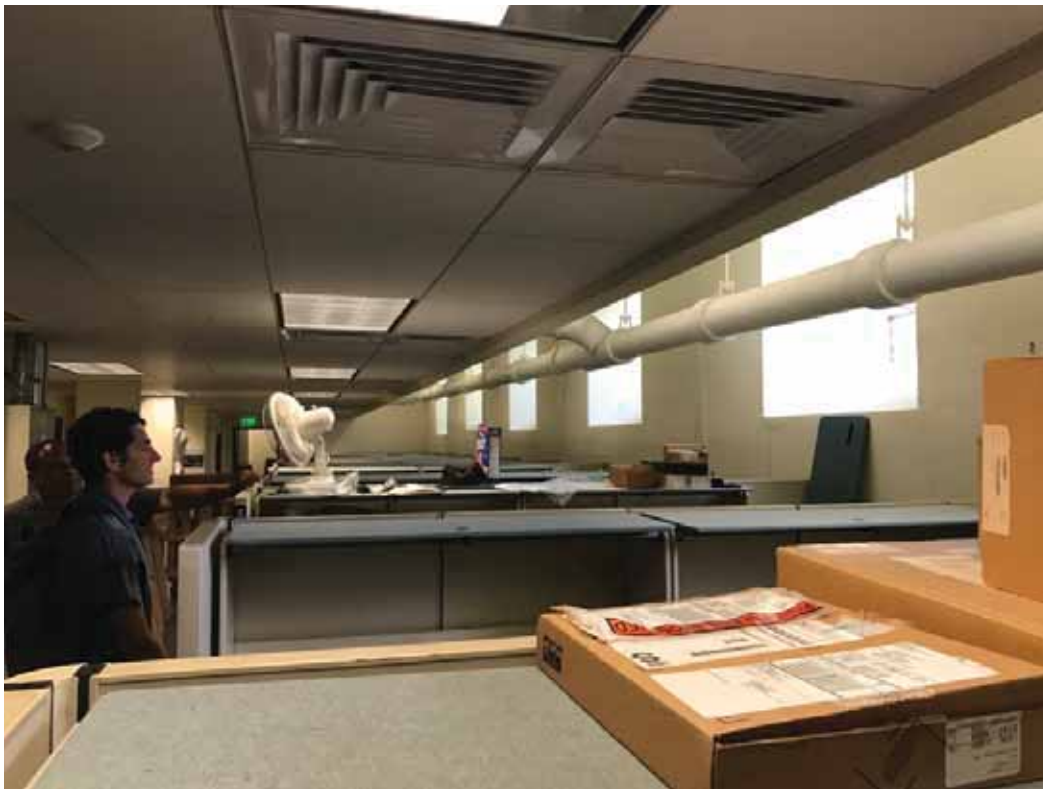
Figure 32: Basement-level office space adjacent to perimeter basement windows

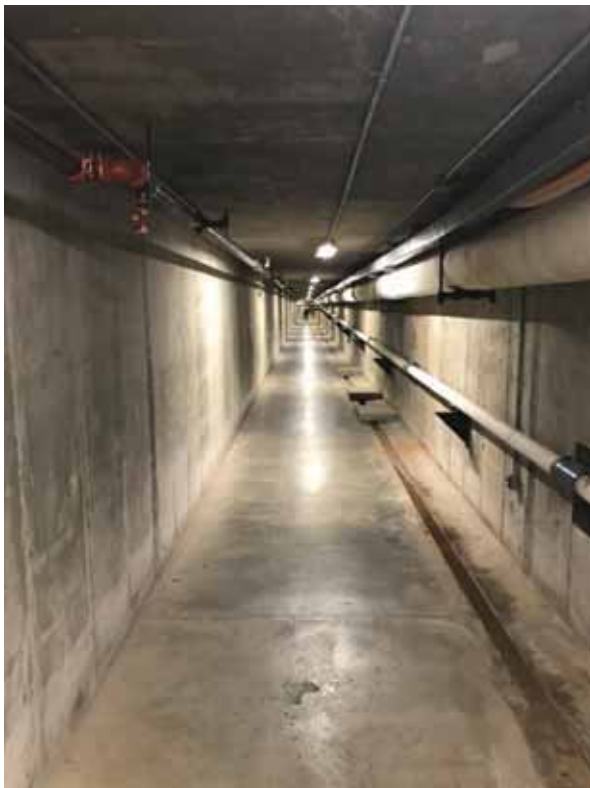
Figure 38: Basement-level tunnel across Statehouse Green

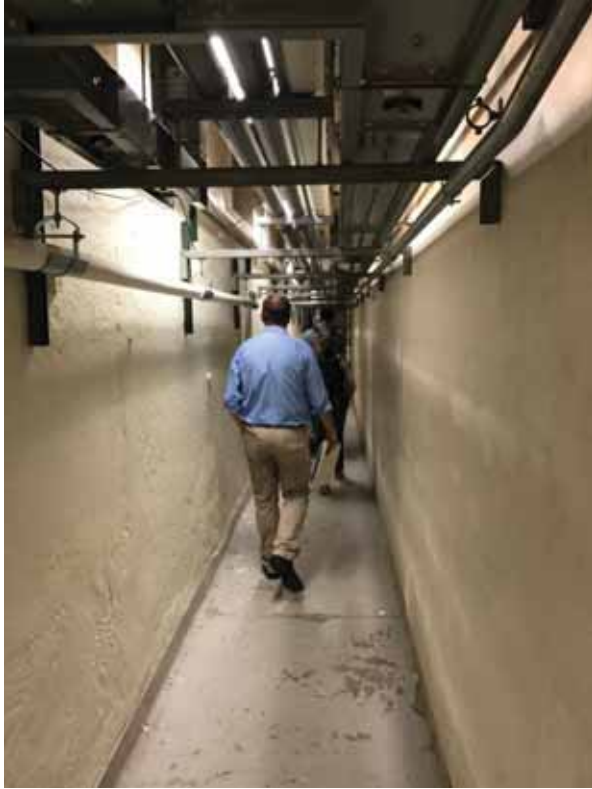
Figure 39: Basement-level passageway

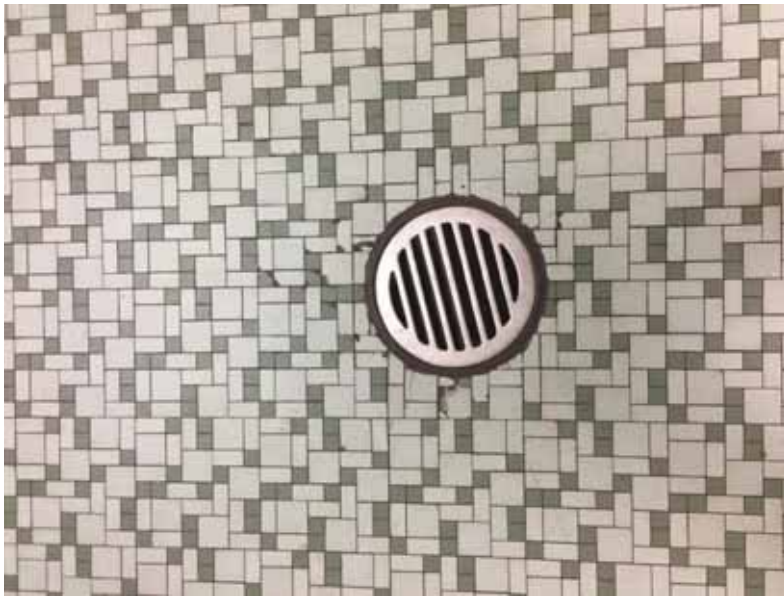
Floor Drain

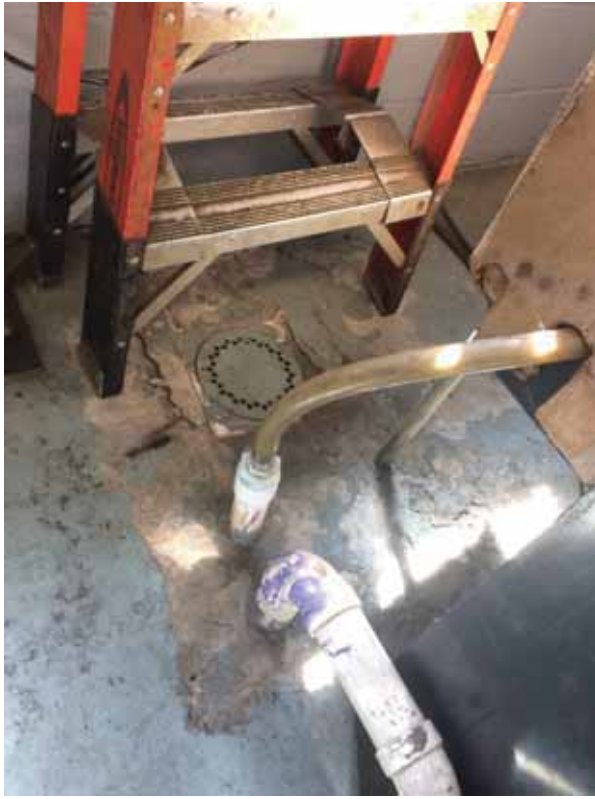
Floor drain and piping

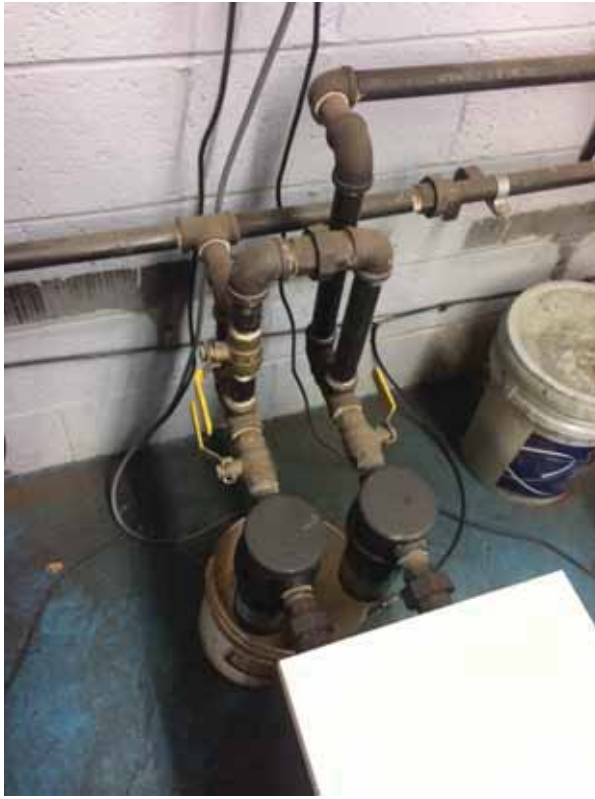
Low piping

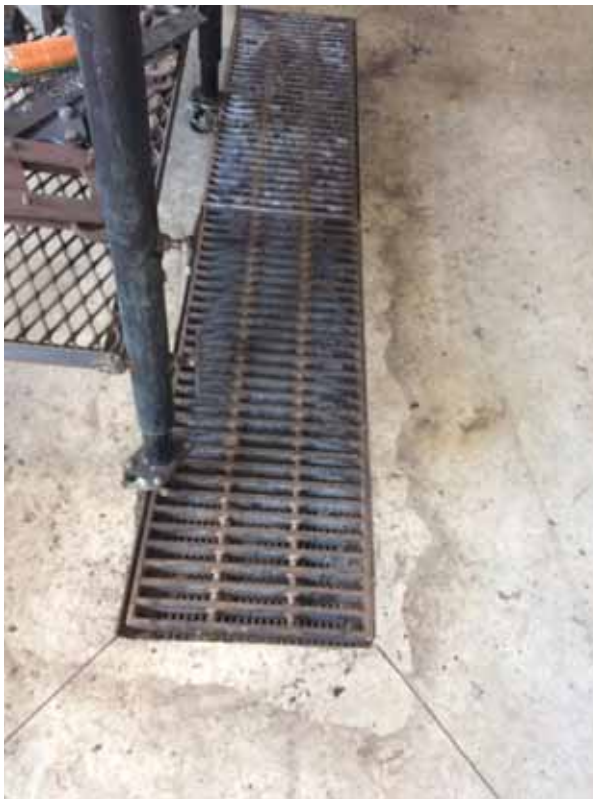
Floor trench drain
